U.S. DEPARTMENT OF COMMERCE  
National Oceanic and Atmospheric Administration  
National Weather Service - Forecast Office  
2579 South Loop 289 Suite 100  
Lubbock, Texas 79423

FOR IMMEDIATE RELEASE  
Monday, August 11, 2008

The National Weather Service in Lubbock continues to receive a number of inquiries following the damaging thunderstorm that impacted Childress on the evening of Sunday, 15 June 2008. The destructive winds and hail that accompanied the Father's Day storm, which caused six minor injuries and at least \$20 million dollars in damages, resulted from a weather phenomenon known as a wet microburst. Meteorologists at the National Weather Service in Lubbock would like to take this opportunity to present a few facts concerning the event in a public forum.

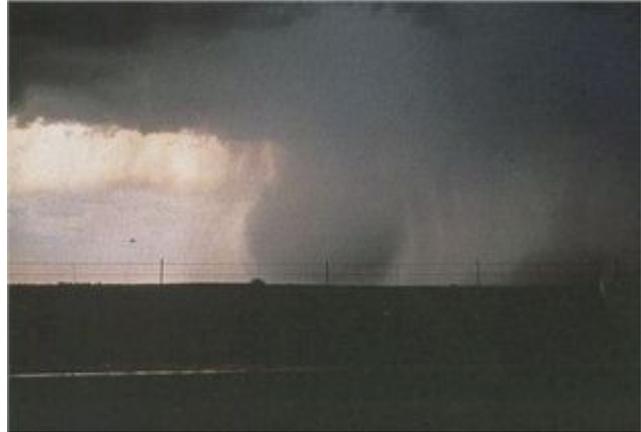
*A photograph of a descending wet microburst core taken in Childress on 15 June 2008 (left) is compared to a classic photograph of a similar wet microburst (right) that has been used to train National Weather Service Skywarn storm spotters for more than a decade. The Childress photo above was provided to the National Weather Service in Lubbock by KVII-TV in Amarillo and KAMC-TV in Lubbock.*
