April 16, 2016 Hermleigh, Texas Tornado and Big Spring, Texas Severe Wind Event:

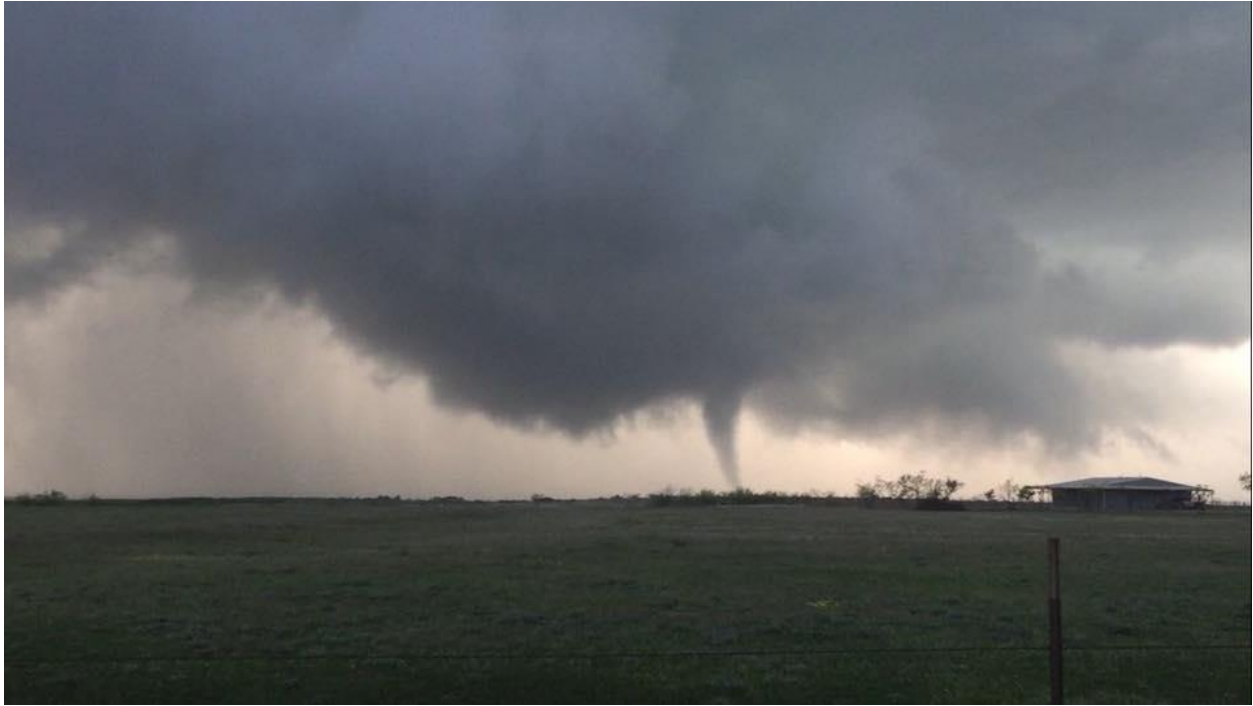
National Weather Service Meteorologists conducted a storm survey for the tornado near Hermleigh, Texas (in Scurry County) that occurred during the early evening of April 16, 2016. No damage was seen during the survey from the Hermleigh tornado (Figure 1), therefore it will be rated an EF-0.

Figure 1 – Hermleigh tornado (Courtesy of Derrick Jack).

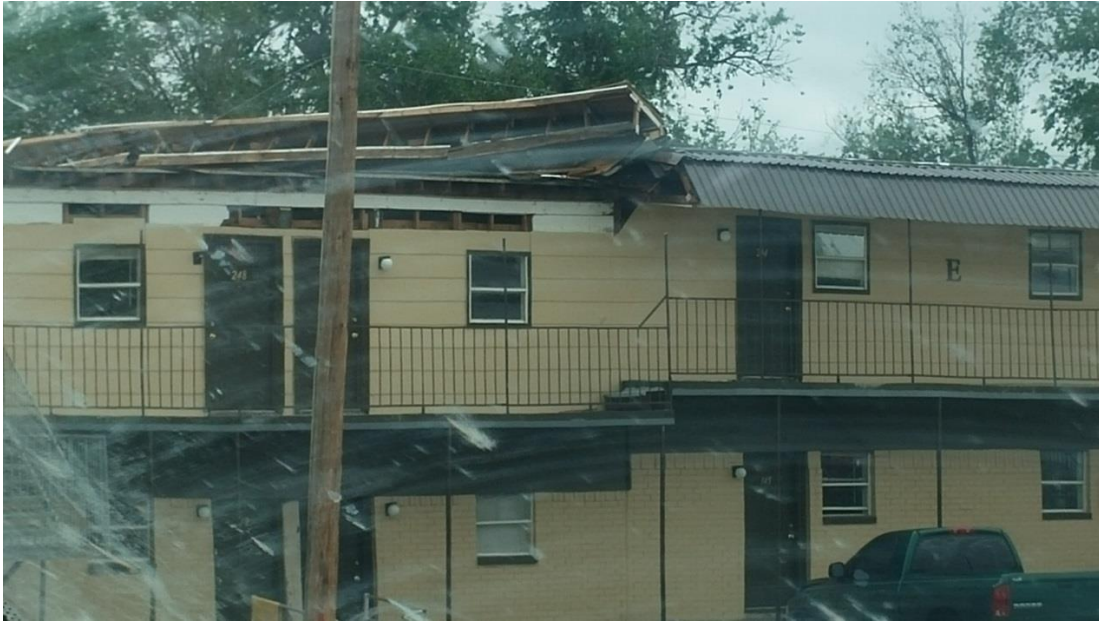
- Mobile Home off blocks – 81 mph
- Barn with roof uplifted – 90 mph
- Apartment threshold visible damage – 76-95 mph
- Broken wood poles – 100-120 mph

Figure 5 – Damage to Apartment Complex in Big Spring, Texas (Courtesy of David Hennig).

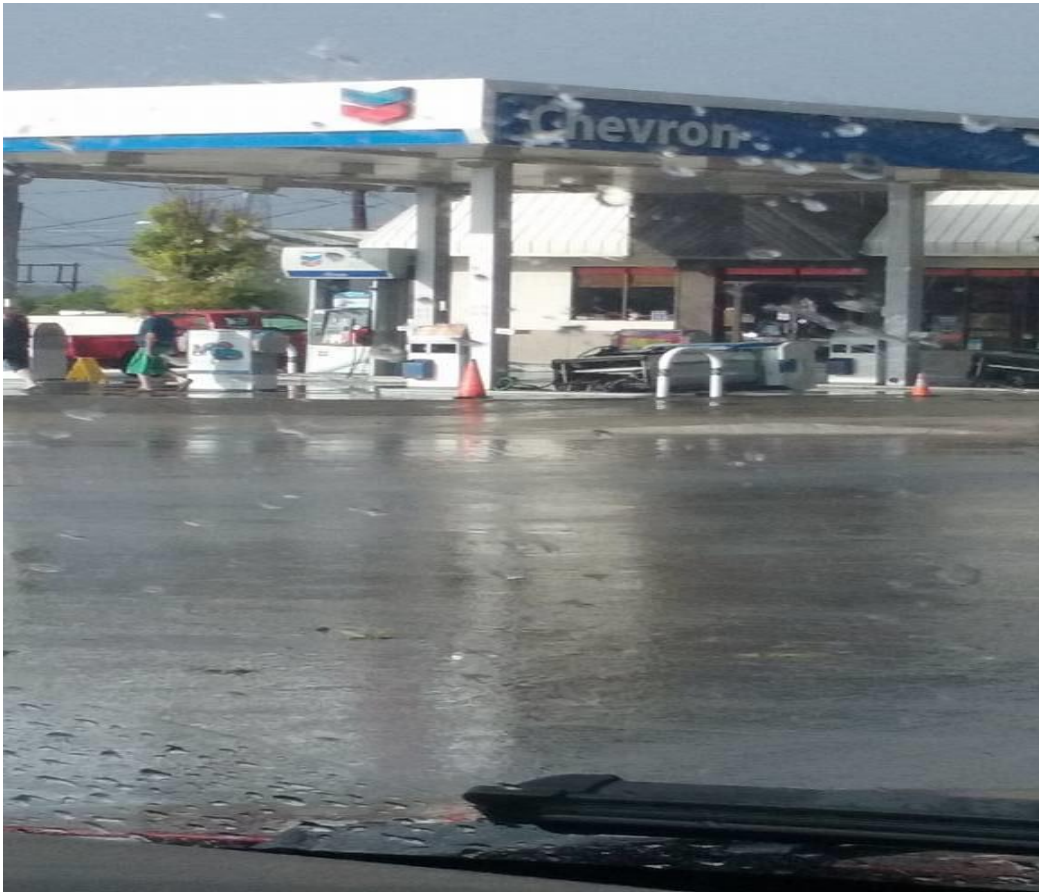
Figure 6 – Damage to Chevron Station in Big Spring, Texas (Courtesy of Laura Murphy).

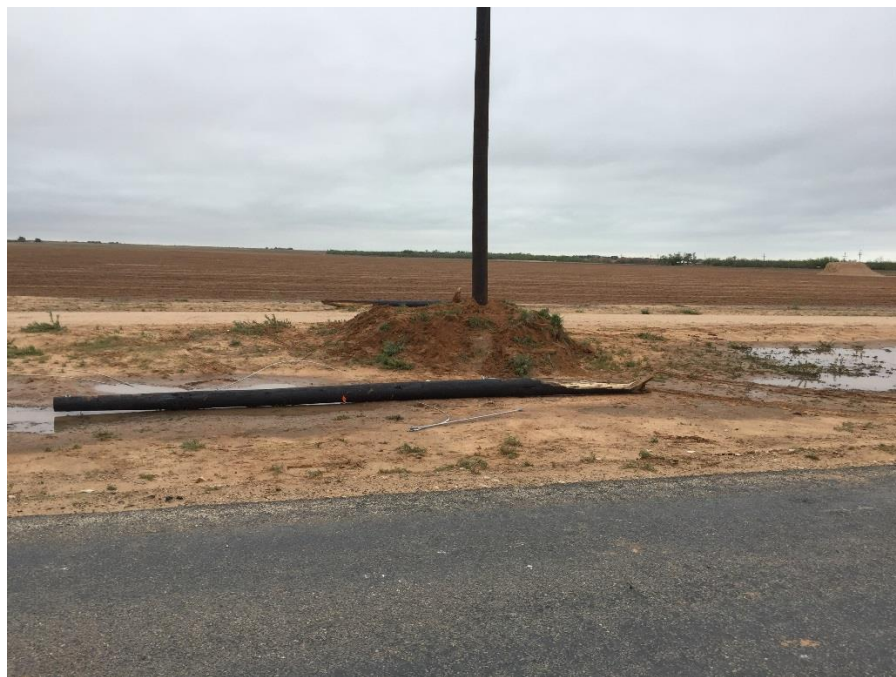
Figure 11 – Snapped telephone pole (Courtesy of Mark Strobin).

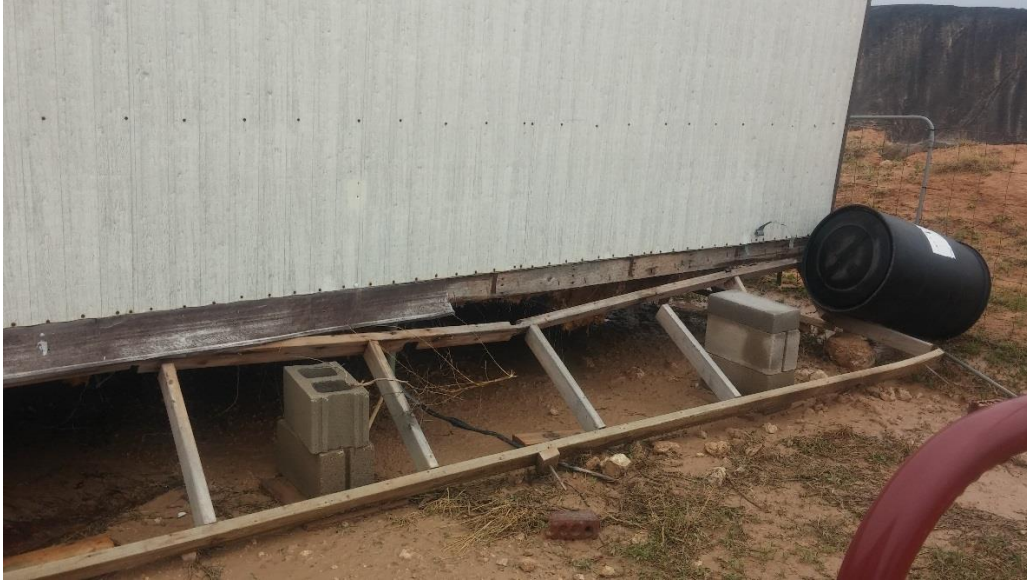
Figure 12 – Mobile home pushed off its foundation (Courtesy of David Hennig).

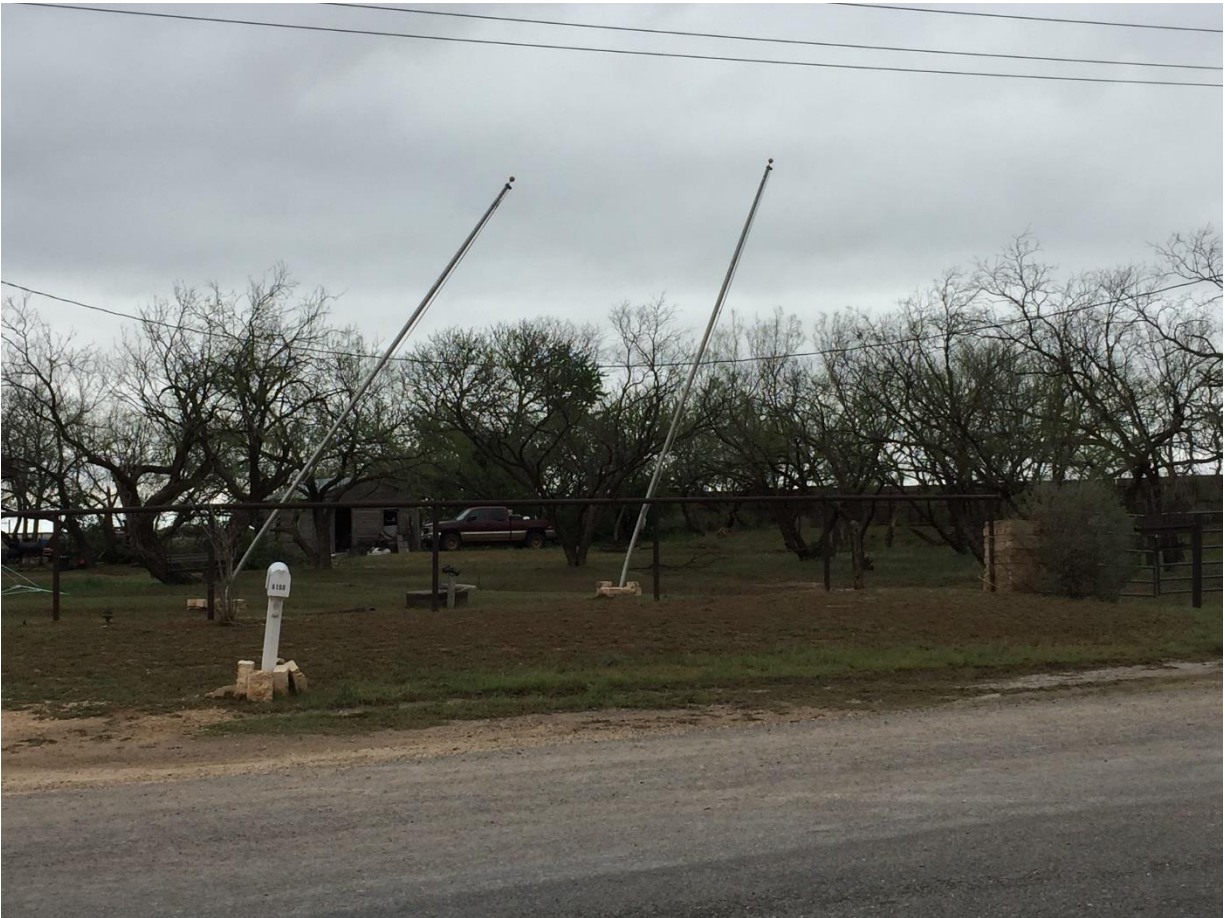
The Lomax 1SSE Texas Tech Mesonet site (Figure 2) recorded a peak wind gust of 74 mph shortly before 6:00 pm CDT. This site is southwest of the City of Big Spring, Texas (Figure 3). The storm survey noted isolated damage in the City of Big Spring, Texas (Figure 4) that was less than a half mile apart. There was visible damage to the roof of an apartment complex (Figure 5) and to a Chevron Station (Figure 6). However, the greatest concentration of damage occurred near the Elbow region (Figure 7); which is southwest of the City of Big Spring. Radar imagery from WFO Midland shows the progression of the Supercell as it moved northeast over the area (Figures 8-10). In the area of the greatest concentration of damage there was damage to wood telephone poles (Figure 11), a mobile home was moved off its foundation (Figure 12), flag poles were bent over (Figure 13), a large tank was overturned (Figure 14), and a barn had its roof uplifted (Figure 15).

Figure 13 – Bent flagpoles (Courtesy of Mark Strobin).

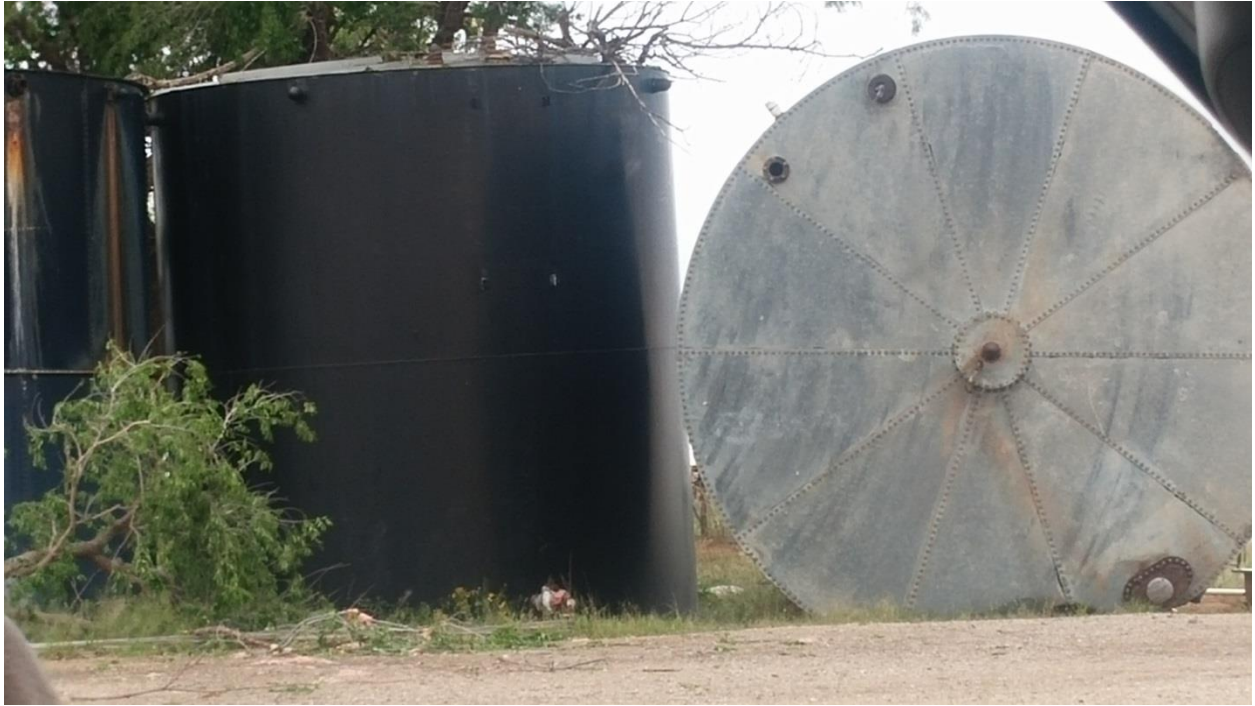
Figure 14 – Overturned large tank (Courtesy of David Hennig).

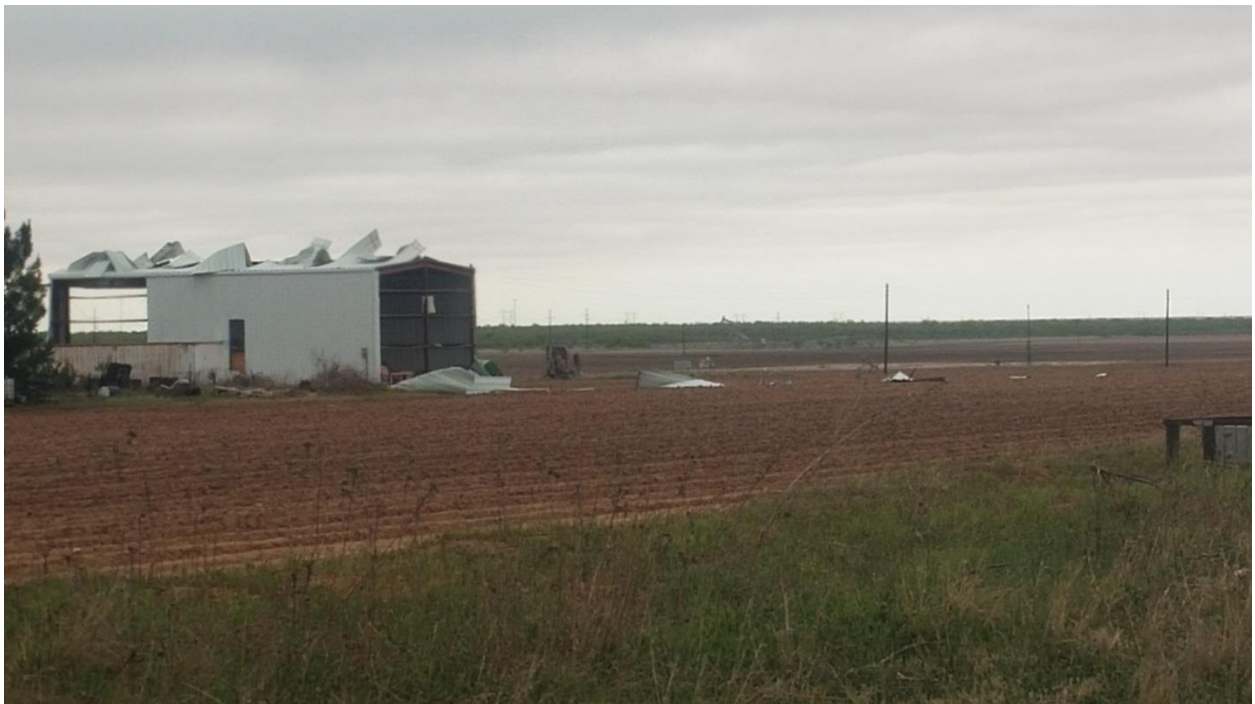
Figure 15 – Barn with its roof uplifted (Courtesy of David Hennig).
