NOAA, NATIONAL WEATHER SERVICE, WEATHER FORECAST OFFICE

...TORNADO CONFIRMED IN THE SUNRISE/PLANTATION AREA...

PUBLIC INFORMATION STATEMENT
NATIONAL WEATHER SERVICE MIAMI FL
230 PM EDT WED OCT 19 2011

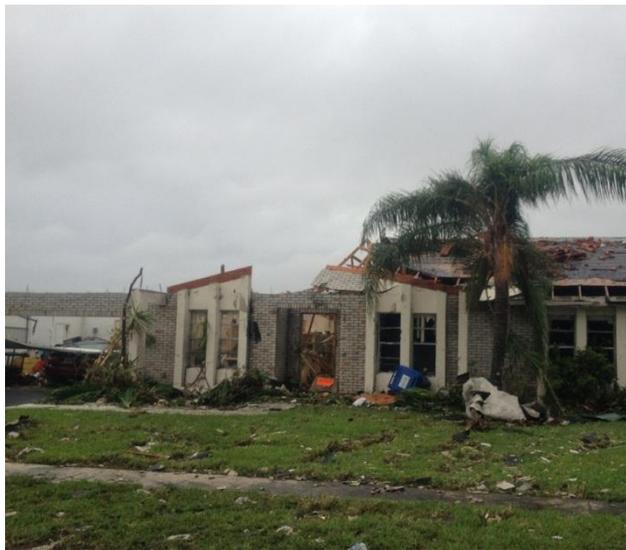
Tornado Damage

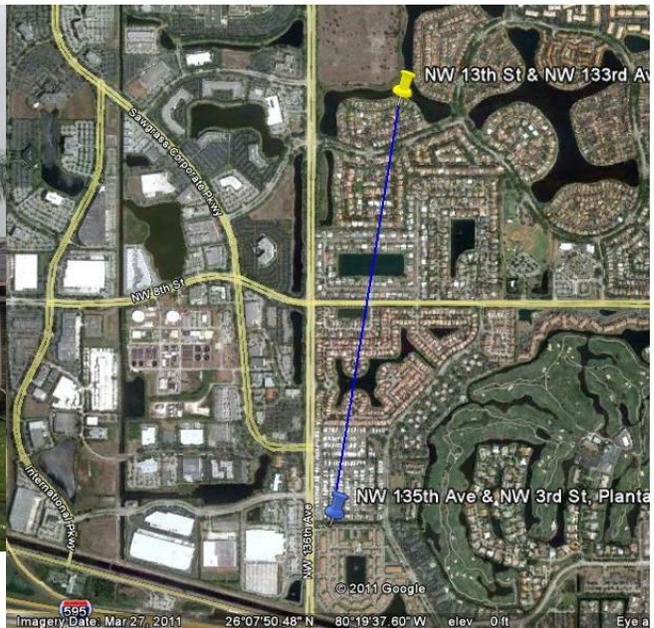
Tornado path across Plantation and Sunrise

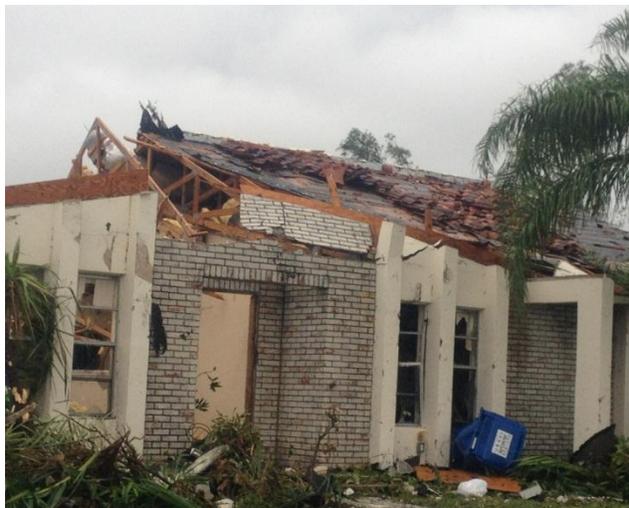
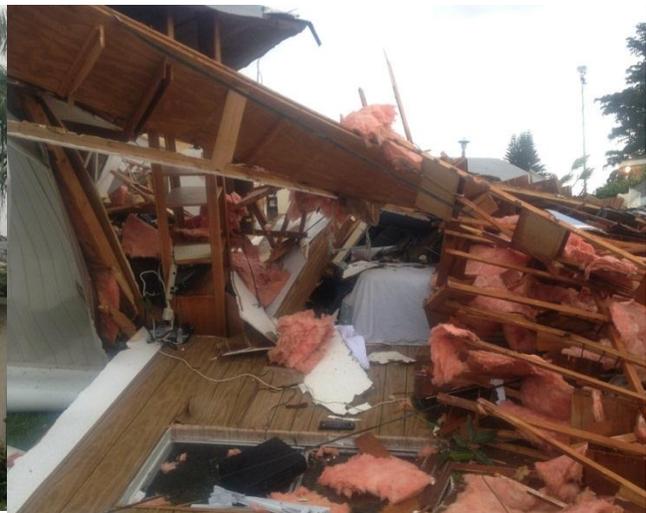
UP TO 50 HOMES WERE DAMAGED ALONG THE TORNADO'S PATH WITH DAMAGE TO ROOFS, GARAGE DOORS, AND WINDOWS. AT LEAST A DOZEN HOMES HAD SIGNIFICANT TO SEVERE DAMAGE. ROOFS OF TWO HOMES WERE COMPLETELY REMOVED. TWO TRAILER HOMES WERE SHIFTED OFF THEIR FOUNDATIONS WITH MOST OF THE WALLS COLLAPSED. ONLY A FEW MINOR INJURIES WERE REPORTED, CONSISTING OF CUTS AND BRUISES.
