Okeechobee Storm

August 1, 2003

ON FRIDAY EVENING...A NATIONAL WEATHER SERVICE DAMAGE SURVEY TEAM INVESTIGATED WIND DAMAGE WHICH OCCURRED APPROXIMATELY BETWEEN 2:30 AND 2:40 PM IN AND NEAR THE TAYLOR CREEK ESTATES ON THE SOUTH SIDE OF THE CITY OF OKEECHOBEE.

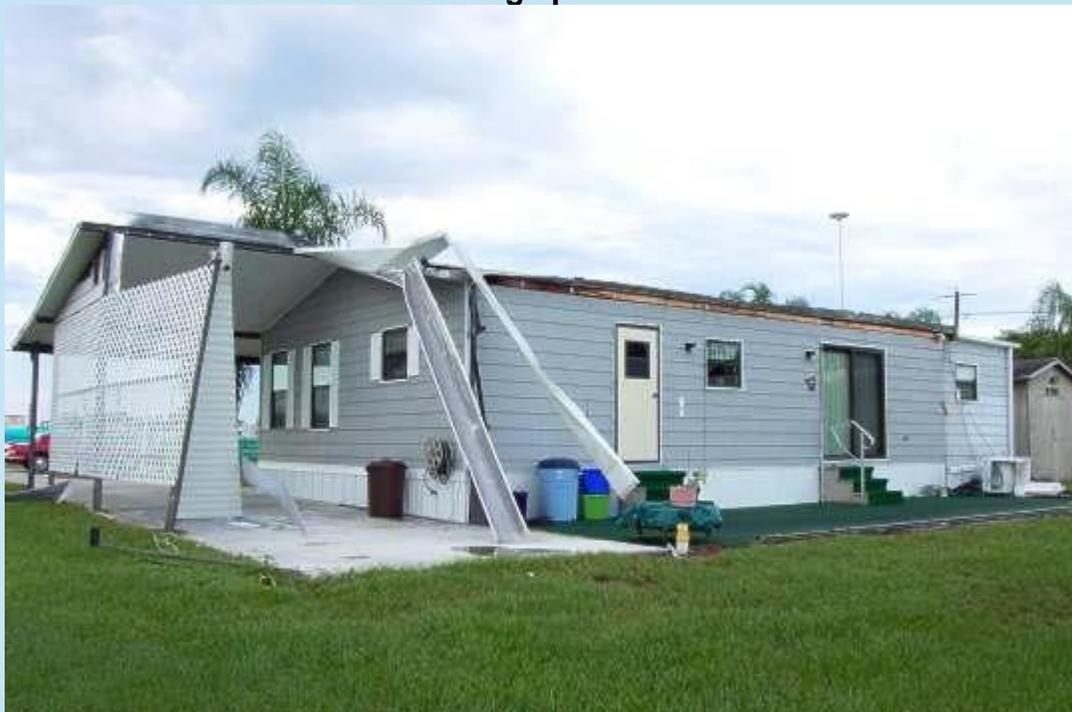
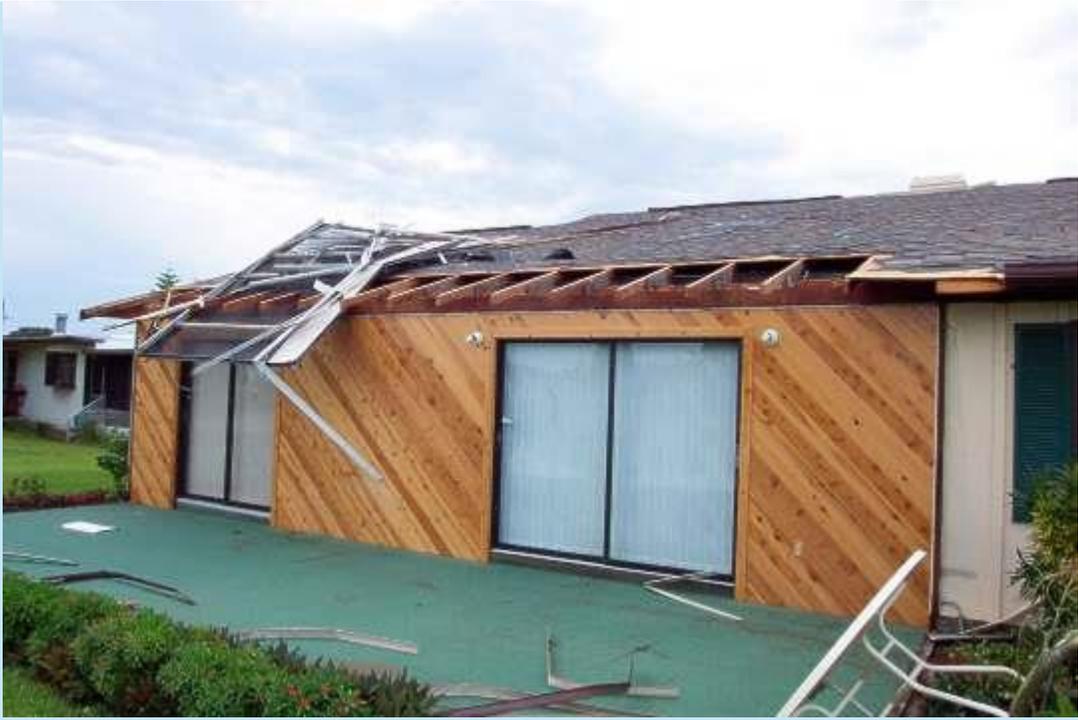
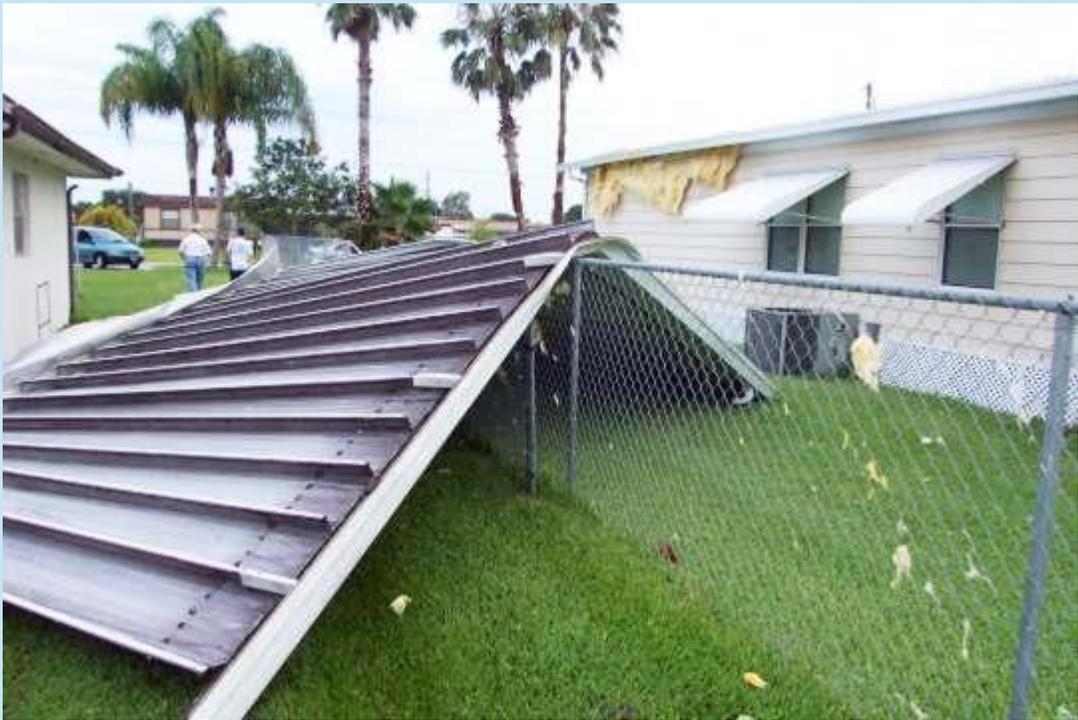
Damage photos:

THE DAMAGE TRAIL WAS PICKED UP AT THE CORNER OF SOUTHEAST 18TH TERRACE AND SOUTHEAST 30TH STREET...WHERE AN EAST-FACING CARPORT AND ADJACENT PORCH WAS TORN FROM A RESIDENCE AND BLOWN WESTWARD ACROSS SOUTHEAST 18TH STREET INTO A CONSTRUCTION SITE...WITH SOME ALUMINUM DEBRIS BEING WRAPPED AROUND ELECTRICAL POLES AND WIRES.

TO THE EAST-NORTHEAST OF THIS DAMAGE ON SOUTHEAST 29TH STREET A CARPORT AND TRAMPOLINE WERE DAMAGED, BLOWN TOWARD THE EAST. TREES AND MARSH GRASS WERE OBSERVED TO BE BLOWN DOWN TOWARD THE NORTHEAST. ON THE SOUTH SIDE OF SOUTHEAST 27TH STREET A PORCH AND A SECTION OF ROOF AND SHEATHING WAS PICKED UP AND CARRIED OVER TO THE NORTH SIDE OF THE HOUSE, WITH A PIECE OF THE ROOF SHEATHING CARRIED OVER THE TOP OF A HOUSE ACROSS THE STREET; A DISTANCE OF ABOUT 30 YARDS. SOME OF THE ALUMINUM PORCH WAS BLOWN TO THE NORTHEAST. ON THE SOUTH SIDE THE HOUSE IMMEDIATELY TO THE EAST AN OUTBUILDING SECURED WITH TIE DOWNS SLID ABOUT ONE FOOT OFF IT'S BLOCKS.

FINALLY, ANOTHER HOUSE ON THE NORTH SIDE OF SOUTHEAST 24TH BLVD HAD A LARGE SECTION OF IT'S CORRUGATED ALUMINUM ROOF WAS PEELED OFF AND DEPOSITED IN AN ADJACENT YARD, WITH ALUMINUM DEBRIS AND FIBERGLASS INSULATION SCATTERED TOWARD THE NORTHEAST.

THE DAMAGE PATTERN, WHICH WAS DIVERGENT ALONG THE ENTIRE LENGTH OF THE STORM TRACK, FITS FUJITA'S MODEL OF A TRAVELING MICROBURST. MUCH OF THE DAMAGE WAS DONE BY WIND SPEEDS ESTIMATED BETWEEN 55 AND 65 MPH WHILE THE MOST SIGNIFICANT DAMAGE WAS ASSUMED TO HAVE BEEN CAUSED BY WIND SPEEDS AS HIGH AS 75 TO 85 MPH.

IT IS NOTABLE THAT EXTENT OF DAMAGE WAS HIGHLY DEPENDENT UPON THE ANGLE AT WHICH THE WIND BLEW INTO THE RELATIVELY WEAK STRUCTURES (PORCHES AND CARPORTS). DAMAGE TO ADJACENT

ROOFING MATERIAL WAS ALSO DEPENDENT UPON HOW WELL THE ADJACENT WEAKER STRUCTURE WAS ATTACHED TO THE ROOF. FINALLY, THE EAST-WEST ORIENTATION OF CANALS UPWIND FROM THE DAMAGE AREAS SEEMED TO HAVE ALLOWED THE MICROBURST WINDS TO ACCELERATE AND FOCUS THE MORE SIGNIFICANT DAMAGE DOWNWIND FROM THEM.
