National Weather Service Melbourne, Florida

NWS Melbourne Damage Survey EF-1 Tornado | July 25, 2014 Edgewater, FL

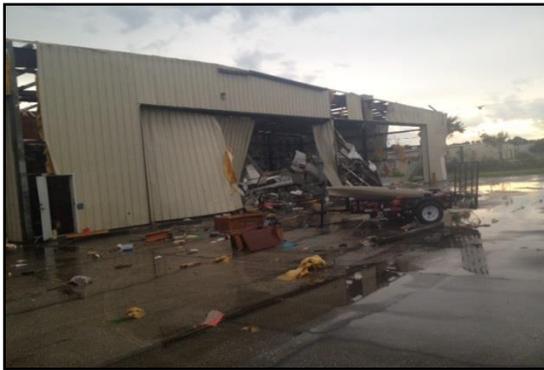
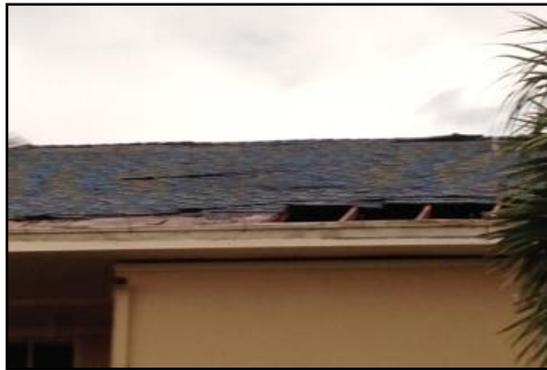
Damage photos below courtesy Central Florida News 13:

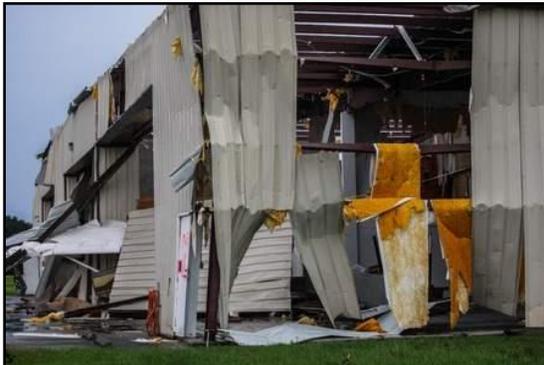
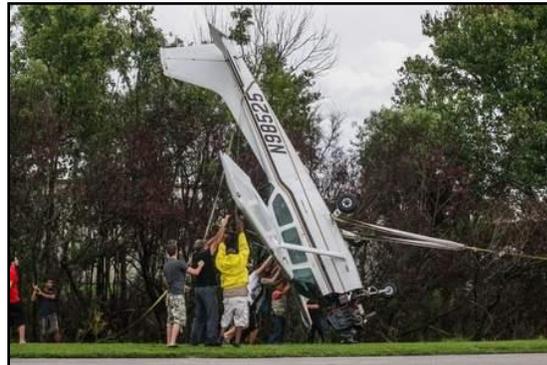
Damage photos below courtesy Daytona Beach News Journal:

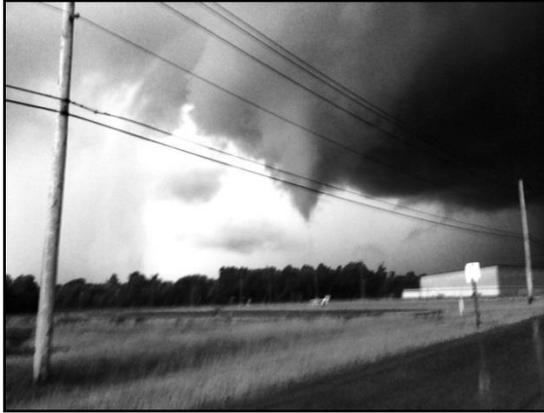
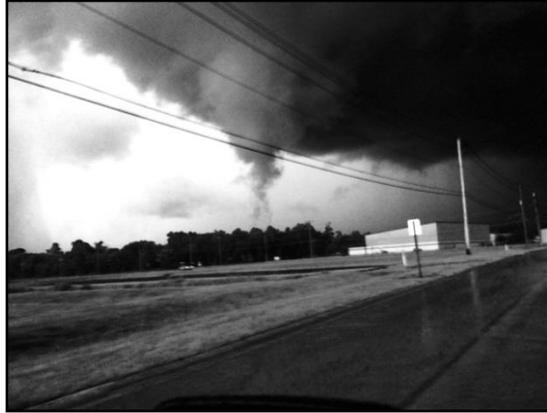
Photos below courtesy of Donald Smith:
