December 22, 2012 EF-0 Watsonville Tornado

At 7:00 AM PST on the morning of December 22, 2012 a weak waterspout/tornado moved inland from Monterey Bay into coastal Santa Cruz County near the town of Watsonville. Damage survey results conclude the damage to be consistent with a tornado of EF-0 intensity, produced by winds estimated at 75 MPH. Damage consisted of tree damage, and moderate to significant damage to several commercial greenhouses on a large farm about a quarter of a mile inland from Monterey Bay. From a combination

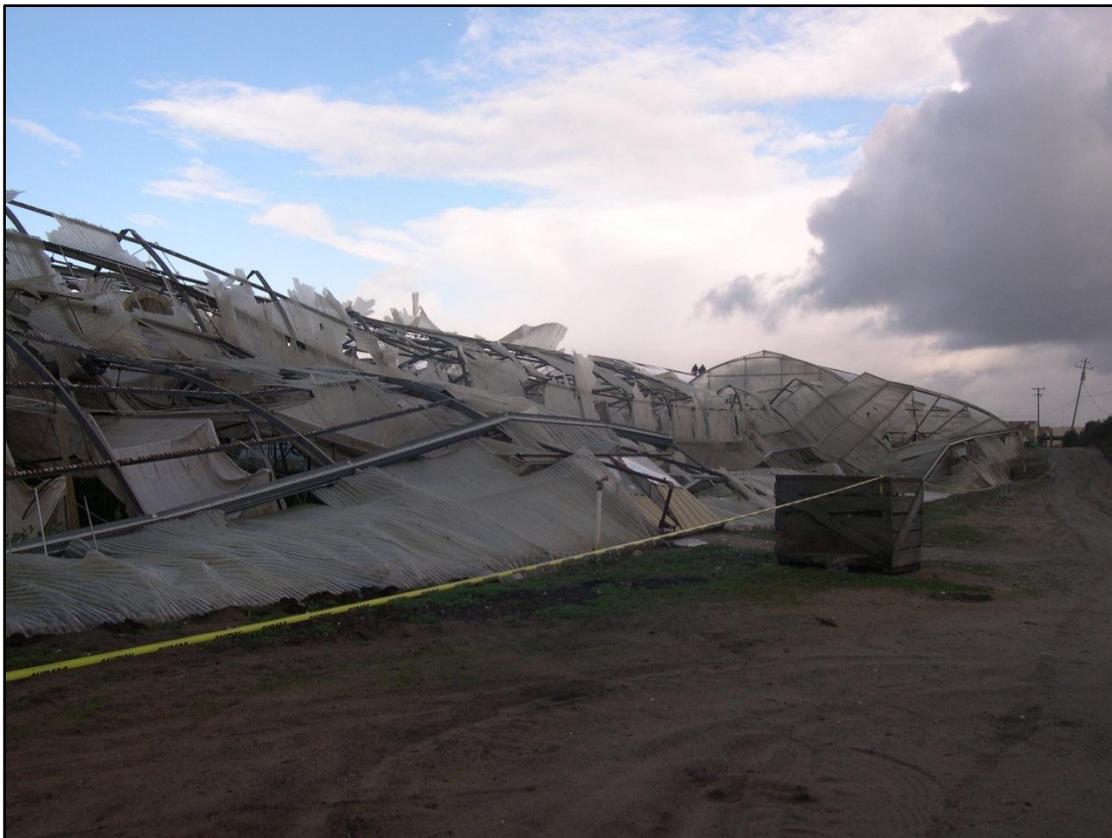
- A) **Tree damage** reported by employees of farm – consisting of some trees uprooted, damaged, branches broken in small wooded area between farm and beach area. It is believed the tornado originated as a waterspout over Monterey Bay and came onshore at the beach and moved through the wooded area on its way inland.
- B) **Significant Greenhouse Damage**: Damage to commercial greenhouse structure. Fiberglass panels and plastic sheeting from structures were cracked and broken and thrown for several dozen yards around the site. Metal pole support structure of the greenhouse was collapsed, with some poles bent. Crops inside of greenhouse suffered damage from falling structure debris.

Damage to greenhouse structure at commercial farm showing collapsed metal structure and fiberglass/plastic sheeting damage.

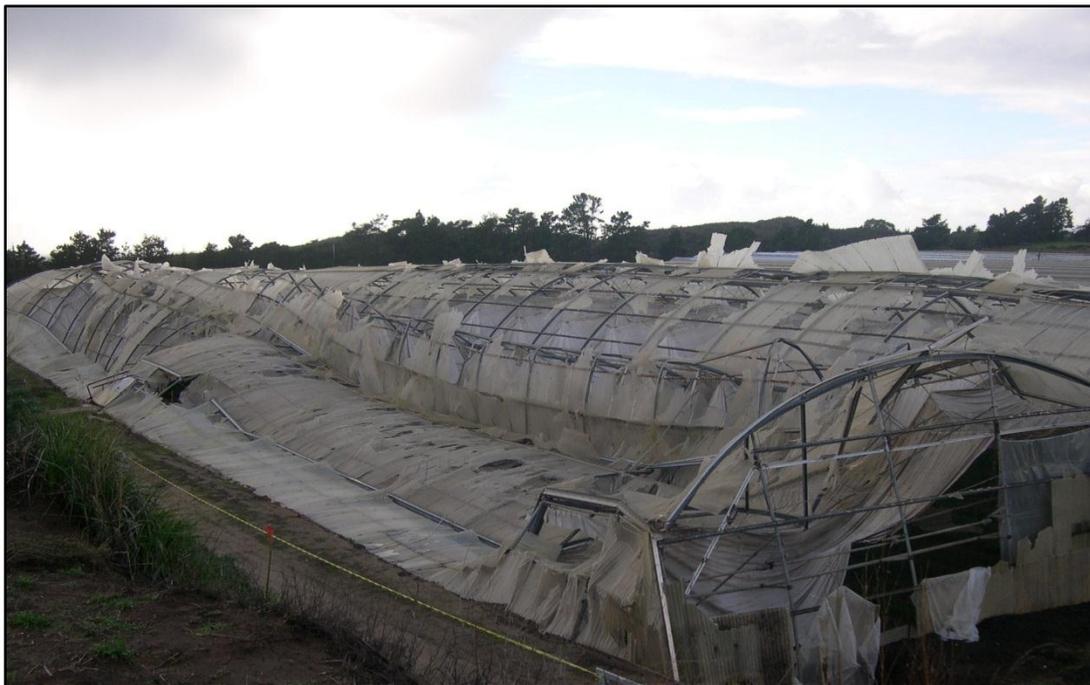
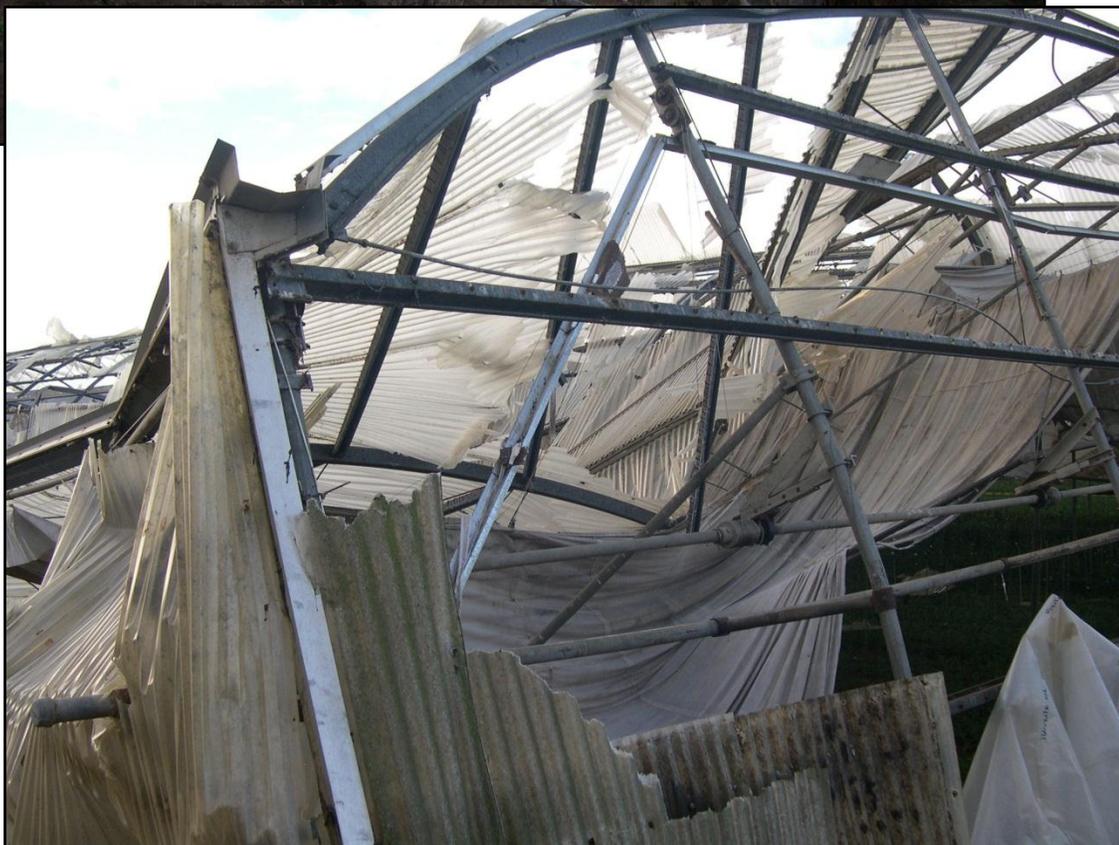
Point B (Continued)

Significant damage to greenhouse structure on commercial farm at point B on map. Images from NWS Damage Survey.

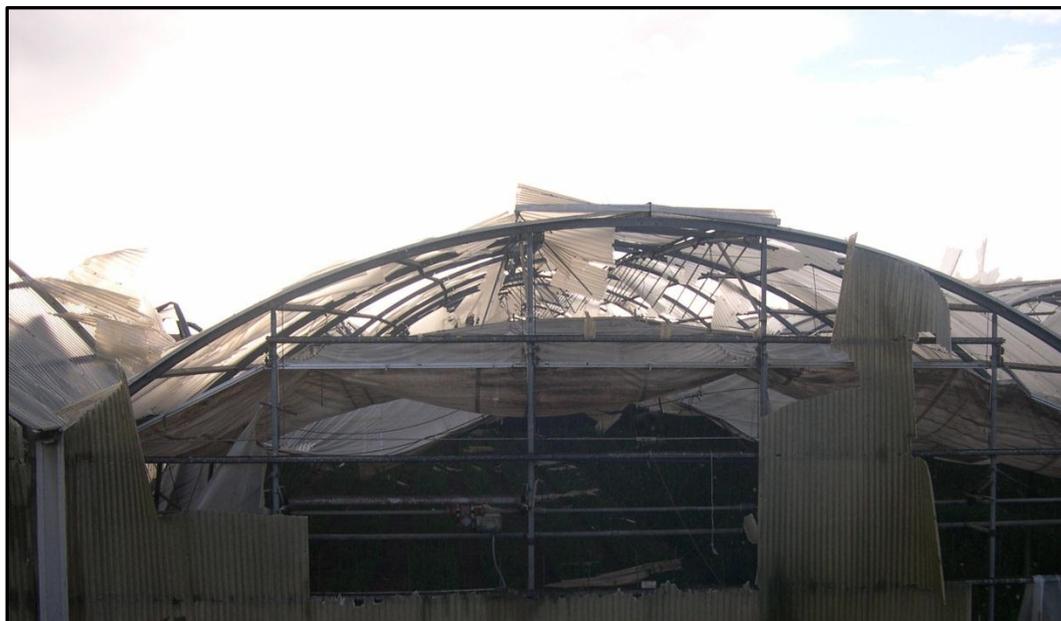
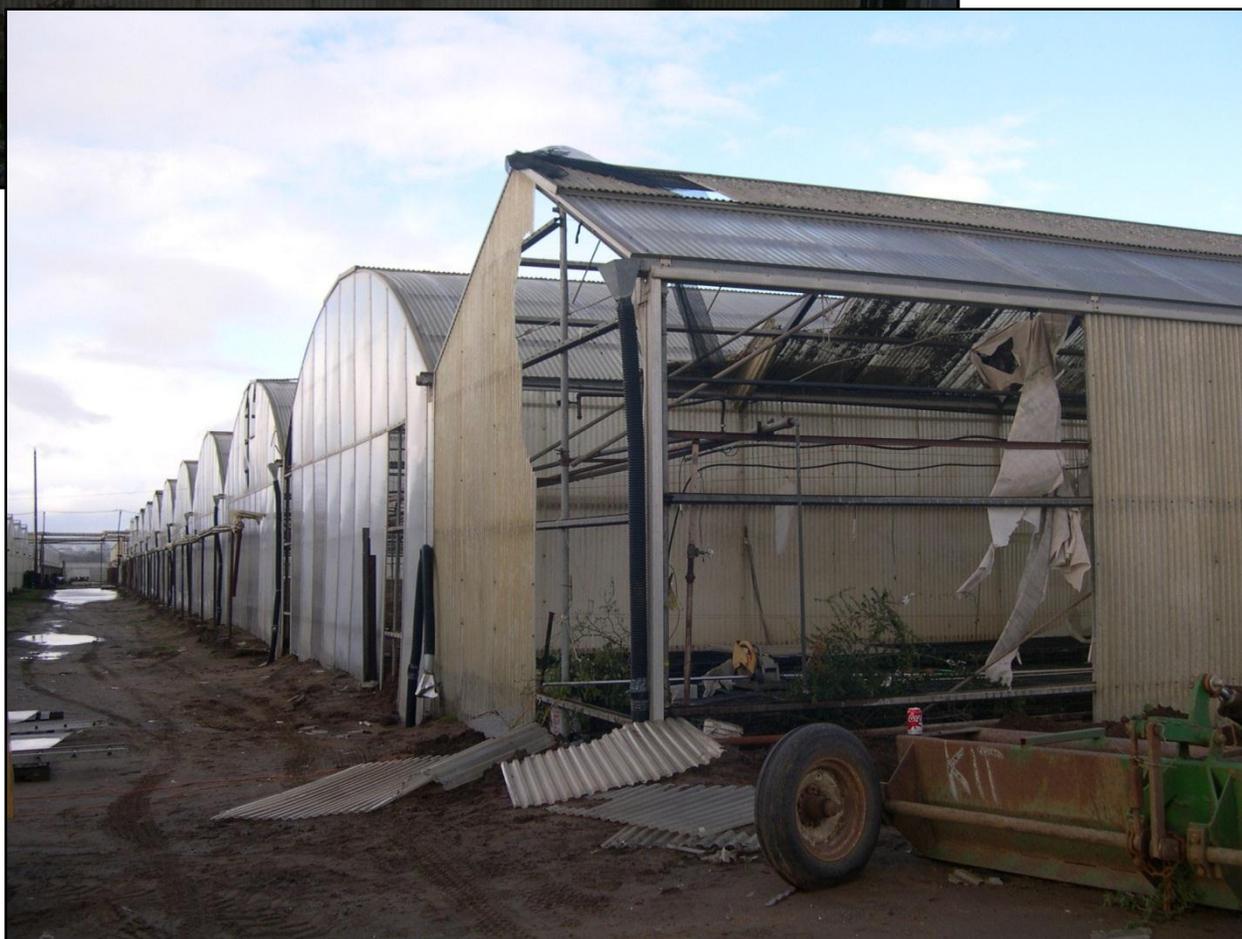
C) **Minor Greenhouse Damage:** Additional damage to adjacent greenhouses was noted. Damage was less severe and was limited to panels and sheeting. Structural damage to poles not noted here.

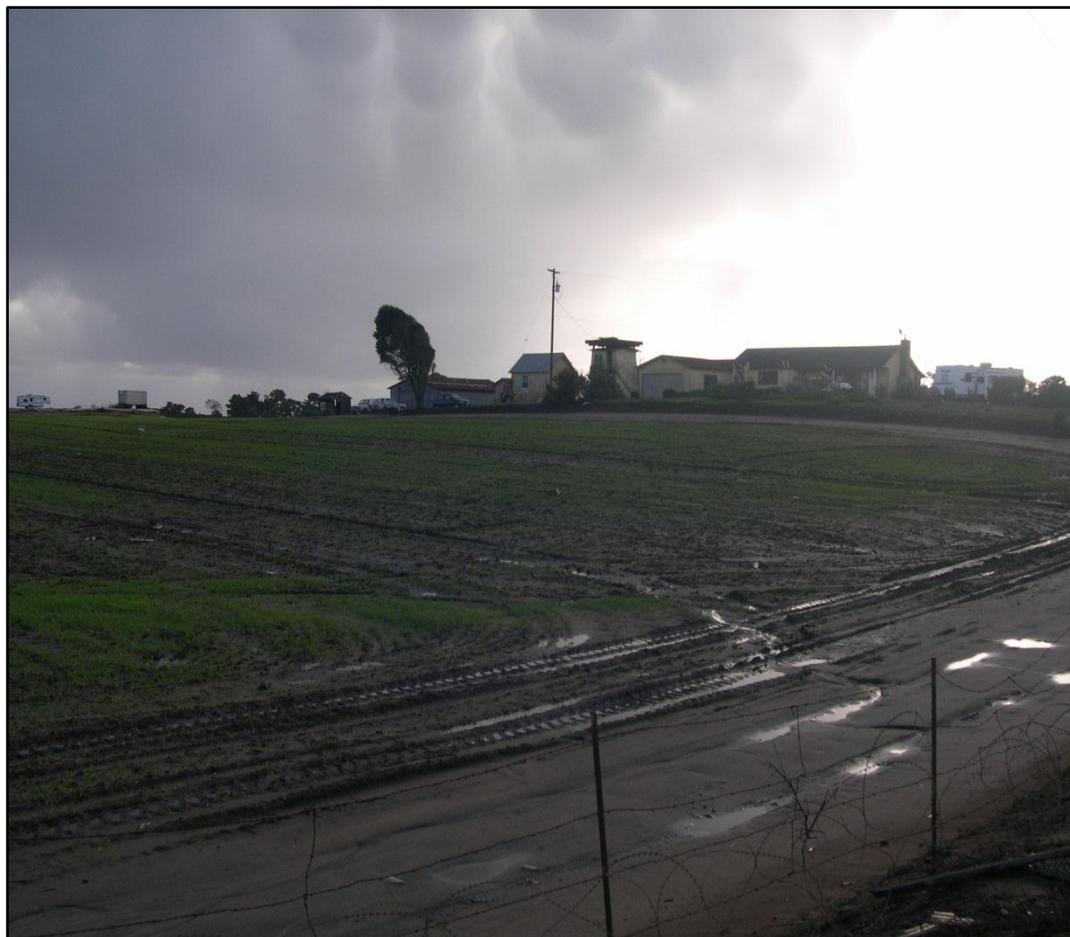
D) **Debris in Fields**: At these two locations in the adjacent field, debris was noted spread out across the ground at distances of up to approximately 30-50 yards from the greenhouse damage. Debris consisted of fiberglass and plastic sheeting from greenhouses. The debris was located south of the damage path.

Though difficult to see in this image, there was fiberglass and plastic debris in the field, south of the damage path through the greenhouses. Debris looks like white spots in the muddy field in this picture. Image from NWS Damage Survey.

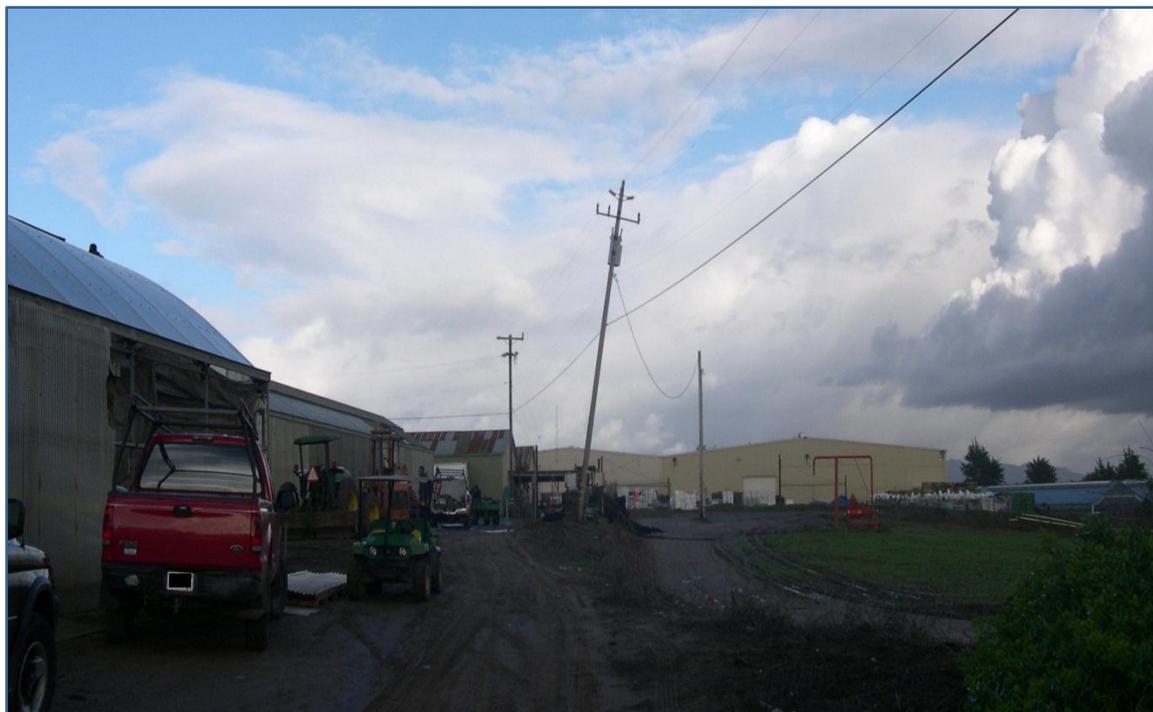
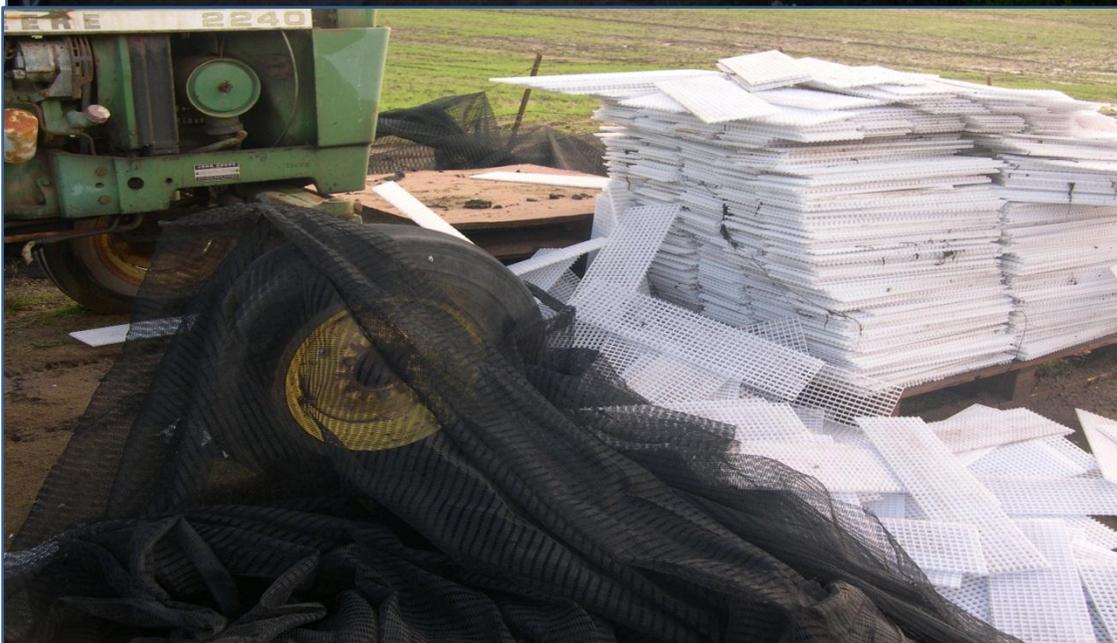
E) **Power pole wrapped with debris**- Immediately following the incident, employees of the farm noted that the power pole at this location was wrapped with debris, which was some agricultural cloth related to greenhouse operations. By the time of the damage survey this was no longer there. The pole is south of the damage path.

Power pole was wrapped with debris. Image below shows type of debris that was around pole but was down by the time of the picture. Images from NWS Damage Survey.

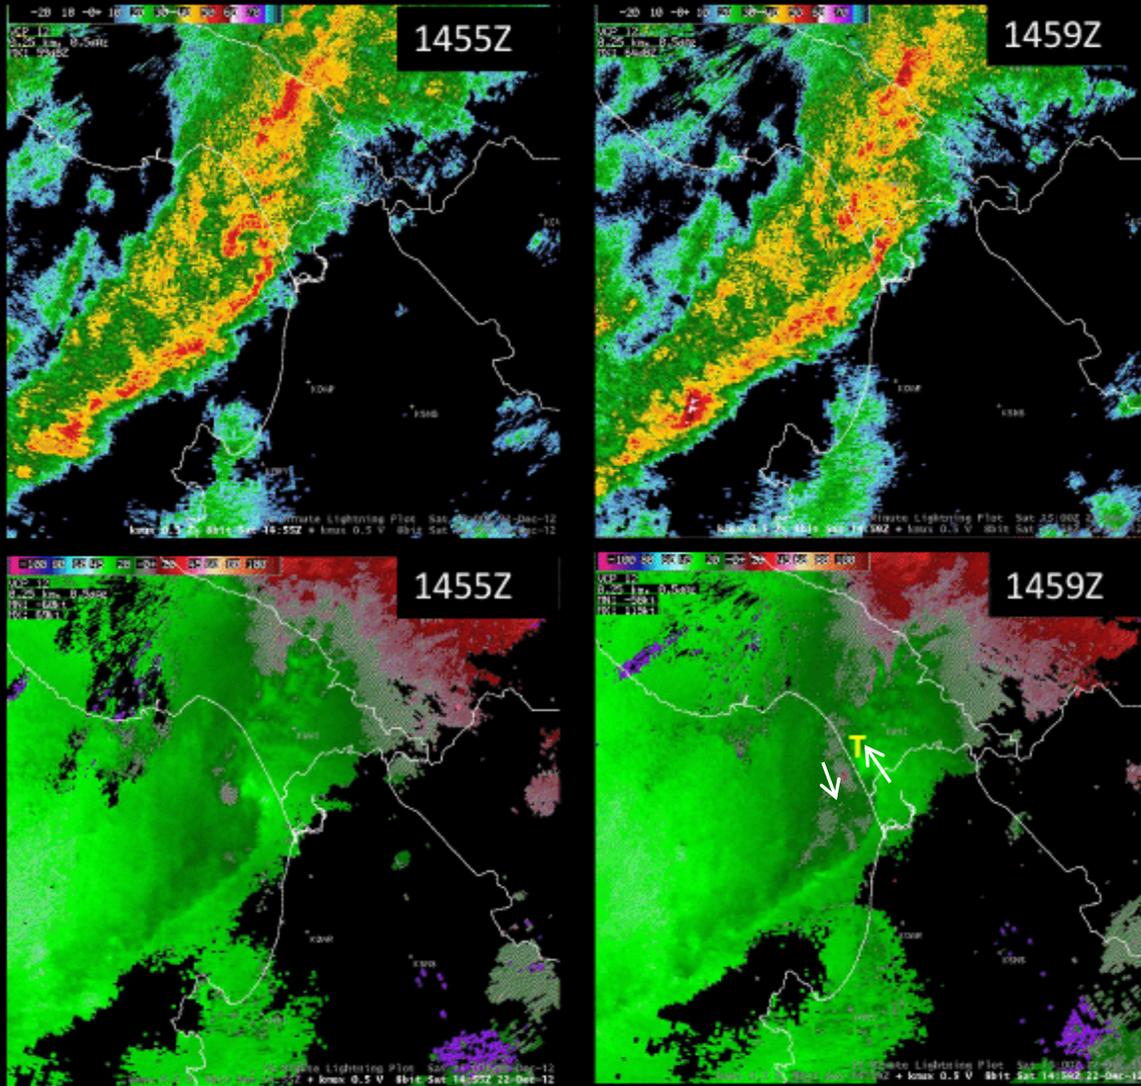
December 22 2012 Watsonville Tornado: KMUX base Z and V

Images above compiled by Science and Operations Officer – NWS San Francisco Bay area. These images show the KMUX radar data at the time of the tornado, between 6:55 and 6:59 AM on December 22, 2012. Top images show reflectivity observed (intensity and location of rainfall) and bottom images indicate velocity of winds observed from KMUX with the Yellow T marking the position of the tornado at 6:59 AM on December 22, 2012. Arrows were added to illustrate the wind direction present in the tornadic circulation. The top left image of the comma head looking structure is indicative of a storm that could potentially produce waterspouts/tornadoes. A Special Marine Warning was in effect beginning at 6:03 AM for Monterey Bay to highlight the threat from dangerous thunderstorms over the Bay.
