NWS Guam

**Meteorological Report on the Effects of Super Typhoon
Mawar (02W) in Micronesia and the Marianas
20-28 May 2023**

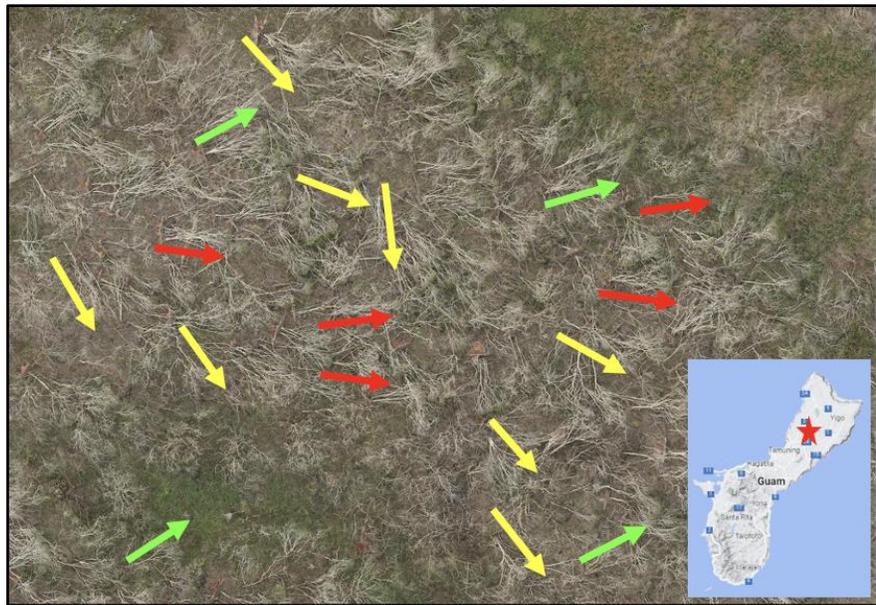
Figure 25: Aerial drone imagery from the Dededo/Astumbo area of north-central Guam shows numerous downed trees. Snapped and uprooted trees falling to the south/southeast (yellow arrows) are related to the initial destructive north/northwest winds as Mawar approached the eastern side of Guam; trees fallen toward the east (red arrows) are a result of the west winds as Mawar passed the northern tip of Guam; trees fallen to the northeast (green arrows) resulted from the southwesterly winds as Mawar moved away from Guam.

While many trees snapped from winds of these directions, stronger trees were snapped or blown down by west and southwest winds.

Additionally, the number of uprooted trees falling from west to southwest could also be partly related to the saturation of the ground from the torrential rains.

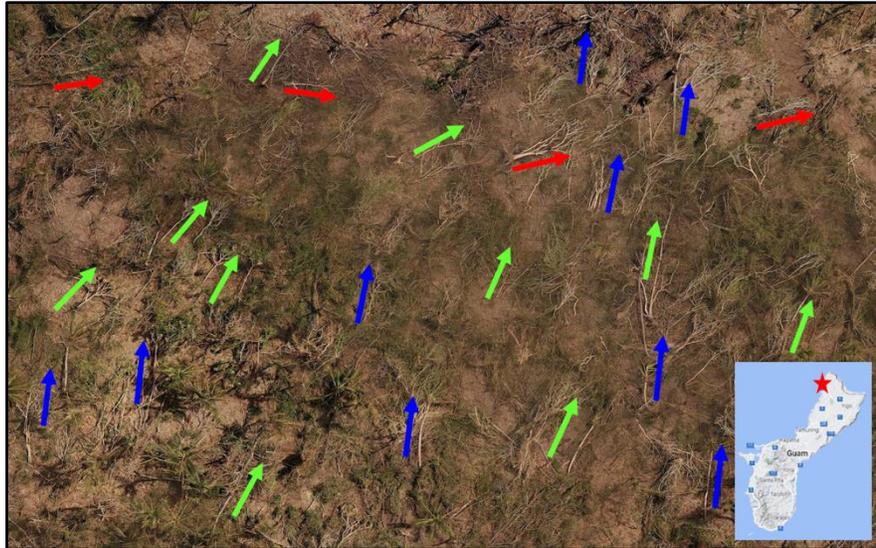
Figure 26: Aerial drone imagery from the Ritidian, Guam, area. A significant majority of tree falls, here, were the result of southwesterly winds (green arrows) with some notable tree falls coming from nearly due-south (blue arrows) as Mawar began rapidly intensifying in its departure from Guam.

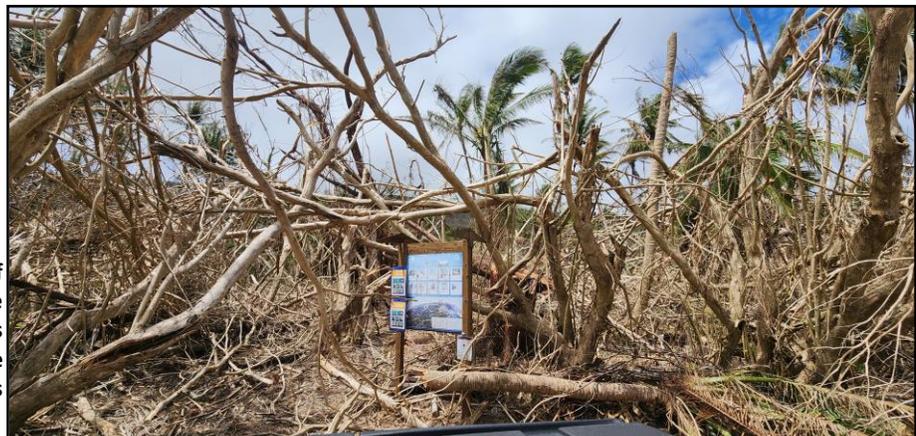
Figure 42: The ravaged forest of the northwestern extent of the Ritidian Wildlife Refuge reflects the destructive winds that were experienced for multiple hours as the eye of Mawar passed nearby.

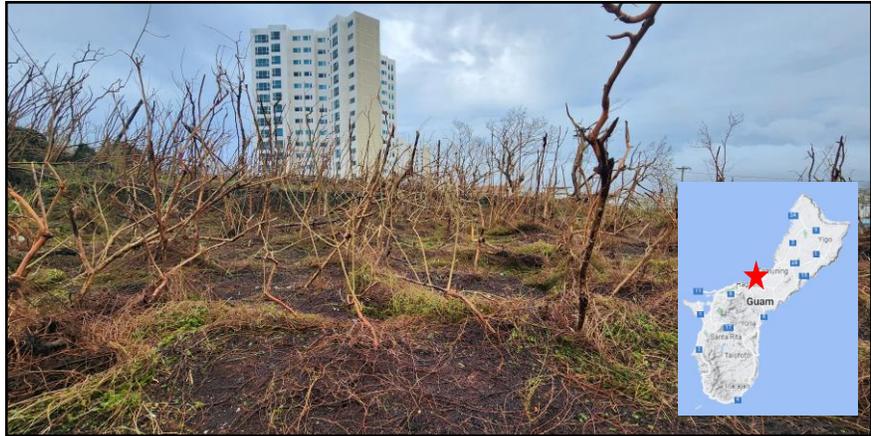
Figure 43: What used to be thick and lush jungle vegetation in the Jonestown area of Tamuning was laid bare by the vicious winds of Mawar. All trees in this area of the cliff line were fully defoliated.

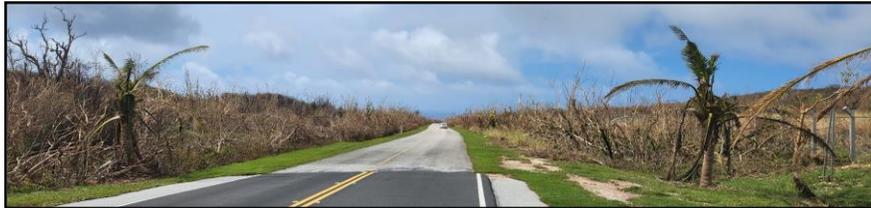
Figure 44: The road above the descent into the Ritidian Wildlife Refuge shows a complete defoliation of the jungle.

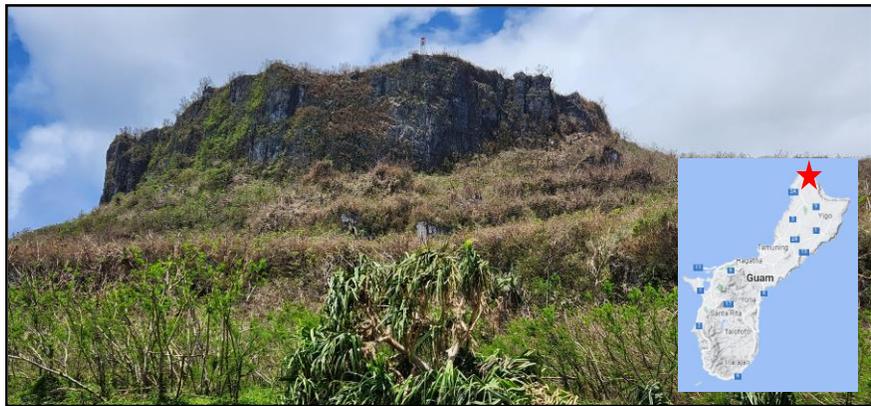
Figure 45: Despite the eye of Mawar having passed very near Ritidian, quite a bit of tree foliage survived in the northernmost extent of Ritidian and farther east toward Tarague where the terrain served as a buffer from the thrashing winds.

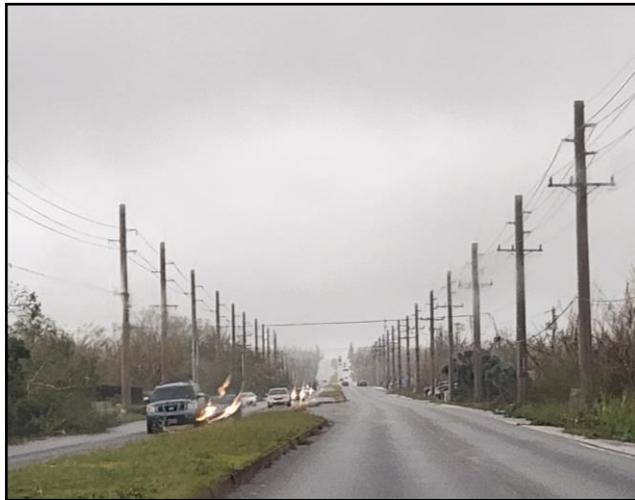
Figure 48: Concrete power poles, as seen along Marine Corps Drive in Yigo, withstood the destructive typhoon force winds.

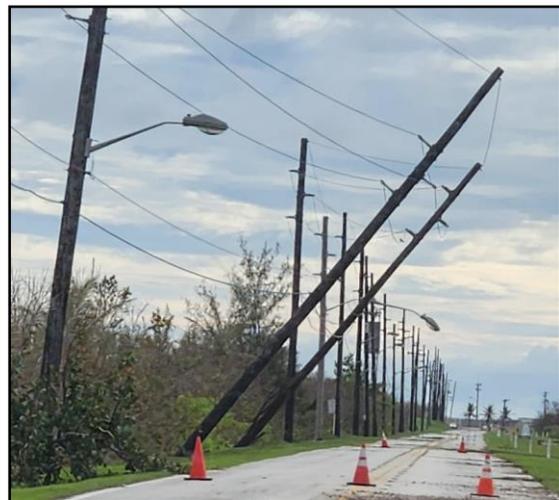
Figure 49: Wooden poles around the island fared worse with a number either tilted, like these along Route 18 toward the Marianas Yacht Club, or snapped.

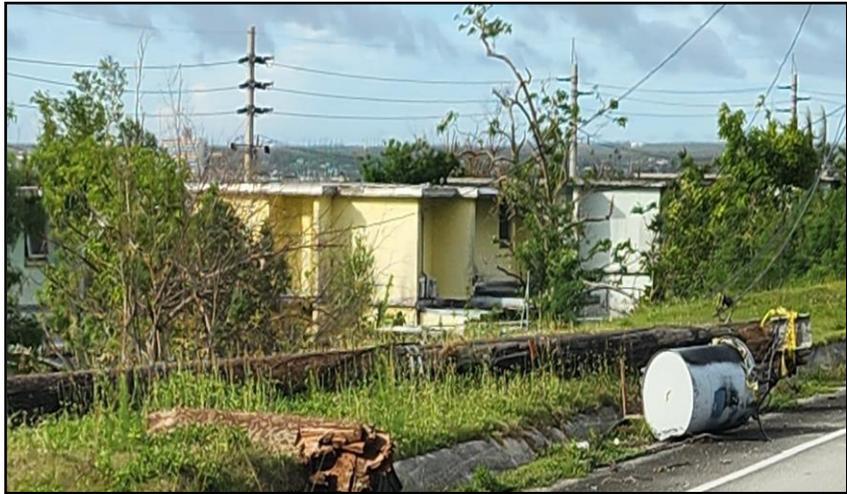
Figure 50: A downed wooden utility pole along East Sunset Blvd.

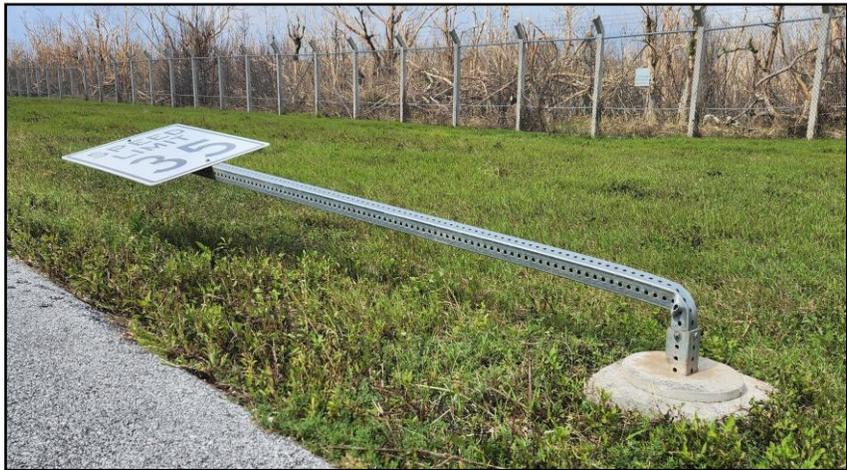
Figure 51: A speed limit sign along the road to Ritidian Wildlife Refuge completely bowed over.

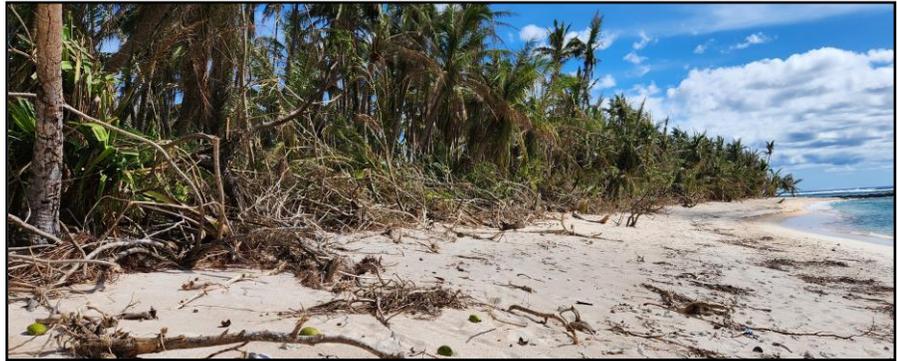
Figure 54: The beach between Tanguisson and Shark's Cove: what used to be a lush, shade-providing jungle is now a defoliated and ravaged collection of nearly-bared trees.
