**Ice Breakup Flooding in May 2009**

**Alaska - Pacific**

**River Forecast Center**

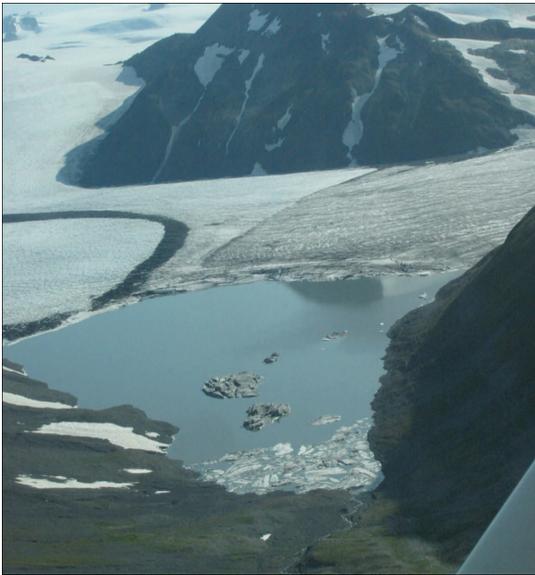
Skilak GDL; full of ice and water before release.  
Photo taken August 1, 2009 by Seward CAP.

Skilak Glacier Dammed Lake (GDL) drained earlier in the year than normal when it began releasing on or around August 8, 2009. Skilak GDL typically releases later in the fall, but it had not emptied since January 2007, when approximately 90,000 acre-ft of water was released mid-winter. This year, approximately 102,000 acre-ft of water drained from Skilak GDL and caused water levels on the Kenai River below Skilak Lake to rise above minor flood stage. River levels crested on August 17<sup>th</sup>, about 10 days after the release began. The gage below Skilak Lake recorded an increase of 2.5 ft and crested at 15.0 ft; the water levels crested at 12.5 ft in the Kenai Keys, and 12.0 ft in Soldotna. Minor flooding occurred in the Kenai Keys and Big Eddy areas. Roads were inundated with water, and yards and several garages were flooded, but no significant damage to household structures was reported. A special thanks to our observer in the Kenai Keys, Jim Jolin. We greatly appreciate all the information and extra river observations that Jim provided to us during and after the flooding.

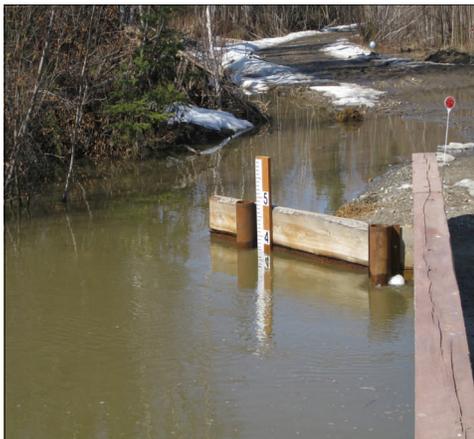
A new flood staff gage on Pile-driver Slough in Salcha helped emergency personnel and NWS forecasters respond to the 2009 spring breakup flooding.

Salcha, Alaska: this small community situated along the Tanana River about 30 miles southeast of Fairbanks has experienced chronic flooding in recent years. In 2008, the area was hit by significant ice jam flooding during breakup, and then again by heavy summer rains that brought near record flooding to the Tanana River. The complete lack of river gages on the Tanana River in Salcha has made it difficult to forecast, document, and compare the recurring floods. In the spring of 2009, the National Weather Service (NWS) in Fairbanks installed a handful of staff gages in the flood prone areas. Immediately after the installation, ice jams formed on the Tanana River, and Salcha was flooded once again. The usefulness of the new river gages became very obvious as the river began to rise. The gages served as an invaluable tool for monitoring the fluctuating flood waters by the NWS, emergency managers, Salcha Fire and Rescue, and local residents. The gages allowed many people to view and report changes in water levels from specific points within the community, which was extremely important for emergency response and evacuations. The addition of these gages will help to forecast and prepare for future floods in the Salcha area.

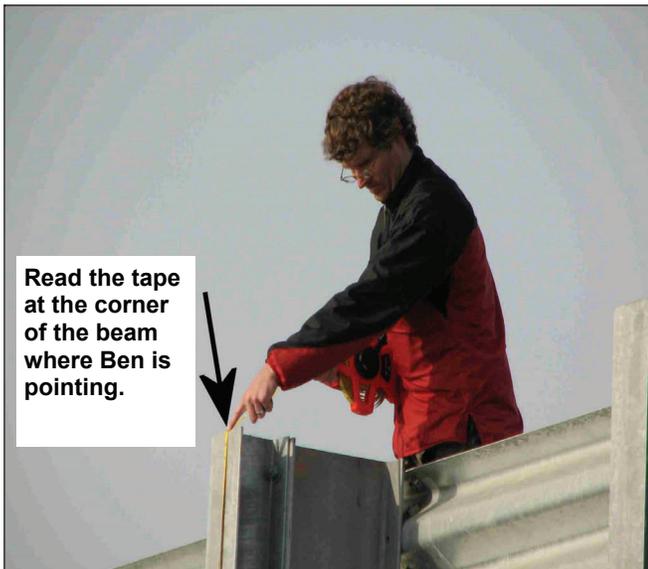
### Wire Weight Gages

This gage involves a brass weight that is lowered down until it touches the water surface. The water level is read from a counter on the left end of the drum to the even foot, with hundredths of a foot read from the left end of the drum. Taking weekly or bi-weekly readings on the check bar ensures that the gage continues to operate properly. Remember to lock your gage up when done to help prevent vandalism.

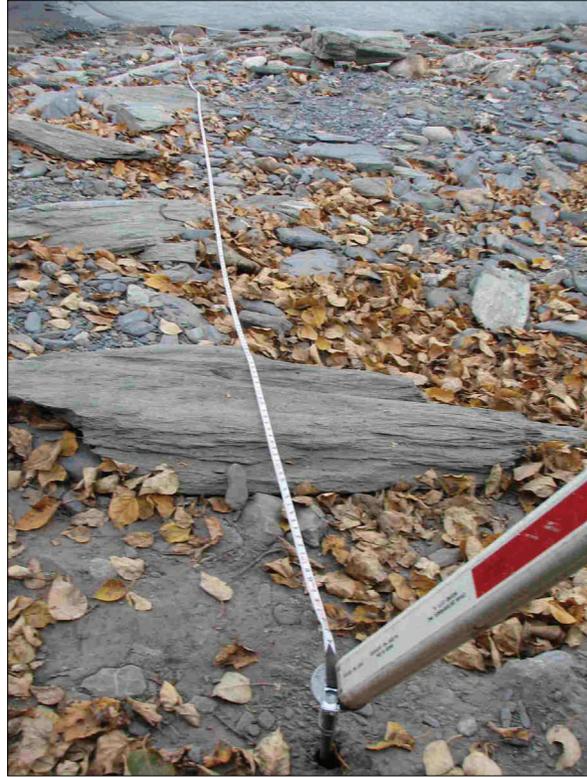
## Slope Profile Gages

When there are no bridges and no good place to put a staff gage, we use geometry to determine the river level. We survey the river bank, install several markers and determine the elevation of those markers, and survey the slope of the bank as far down into the river as we can reach. Our observers measure the distance from the marker down to the river's edge, following the same path that was surveyed. We use our survey information to calculate the elevation of the bank at the edge of the water. This type of gage works well if the bank is stable, but if the bank is eroding, it will need to be resurveyed frequently or the gage may need to be moved to another location. Most of the remote sites in the state have this type of river gage.

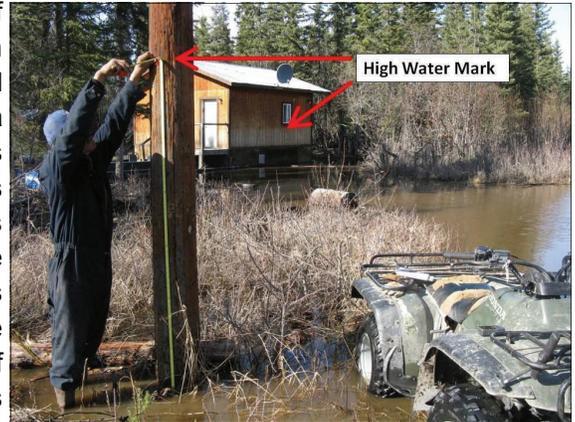
Documenting high water marks in Stevens Village on the Yukon River

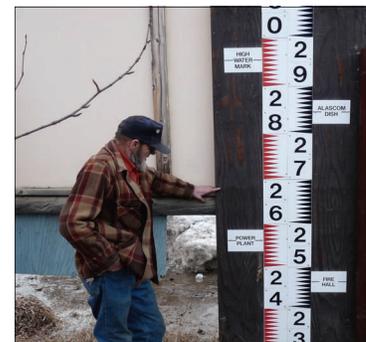
Dick Hutchinson of Circle points out a high water mark caused by flooding during this year's breakup

Getting an estimated peak level during breakup at slope profile gages can be very difficult due to ice on the banks at the gage location. If you can see the high water line on the bank anywhere near your gage site and can mark that location with a spike, this mark can be measured after the ice melts away or surveyed by NWS staff during a field visit.
