## Central Carter County Tornado Southeast Montana July 19<sup>th</sup>, 2019

The following information is based on NWS storm survey results.

Magnitude: EF-1

**Location:** 3 miles northeast of Ridgeway, MT

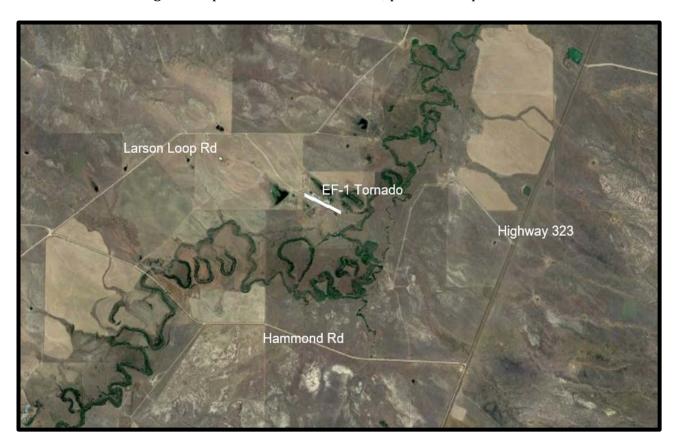
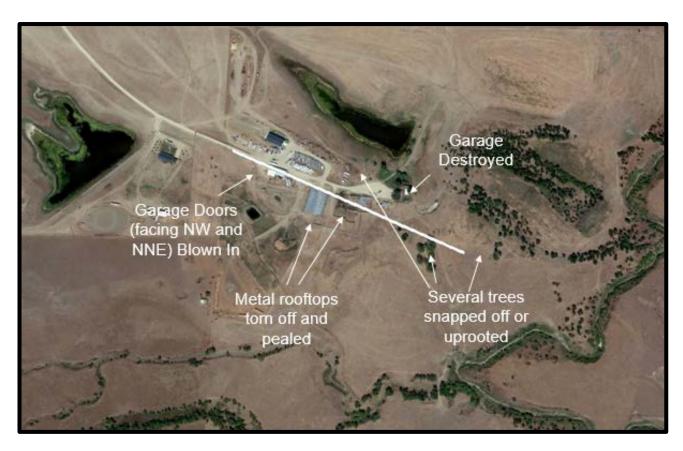
The following are maps that show the location, path and impacts of the tornado.

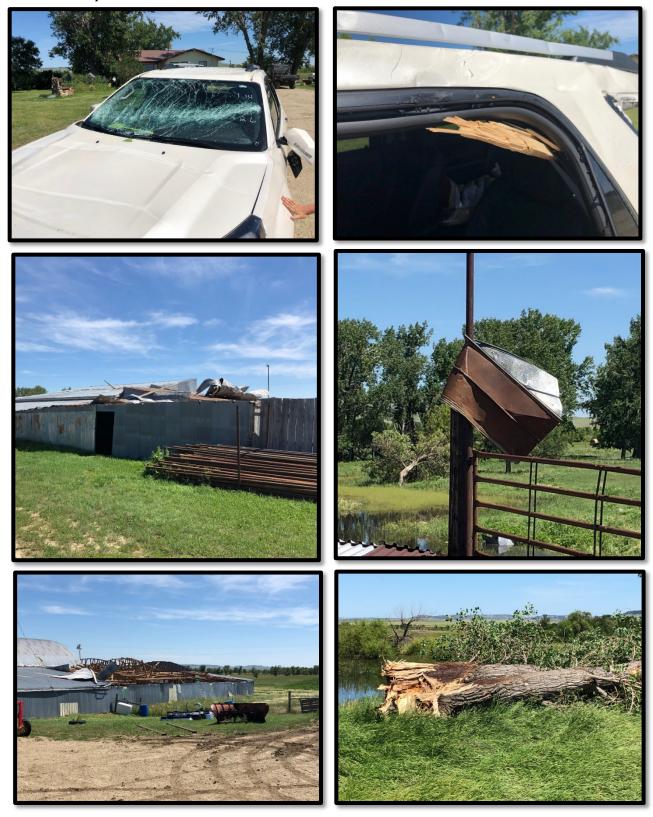
There was considerable damage to buildings on a local ranch. A shop building had 2 doors blown in and roof damage. Two other sheds had significant roof damage. Several metal rooftops were torn off and peeled back. A small garage was destroyed with a vehicle displaced inside, turned and moved by a couple feet. Several trees were snapped (approximately 1 foot diameter), with other smaller trees blown over or uprooted.
