June 14-15, 2013 Flash Flood Event

A very moist atmosphere combined with a weak upper level low pressure system resulted in very heavy rainfall and significant flooding across portions of the Rio Grande Plains on June 14 and 15. From late Friday morning through Saturday, an incredible 17.05" of rain fell in Eagle Pass, Texas.

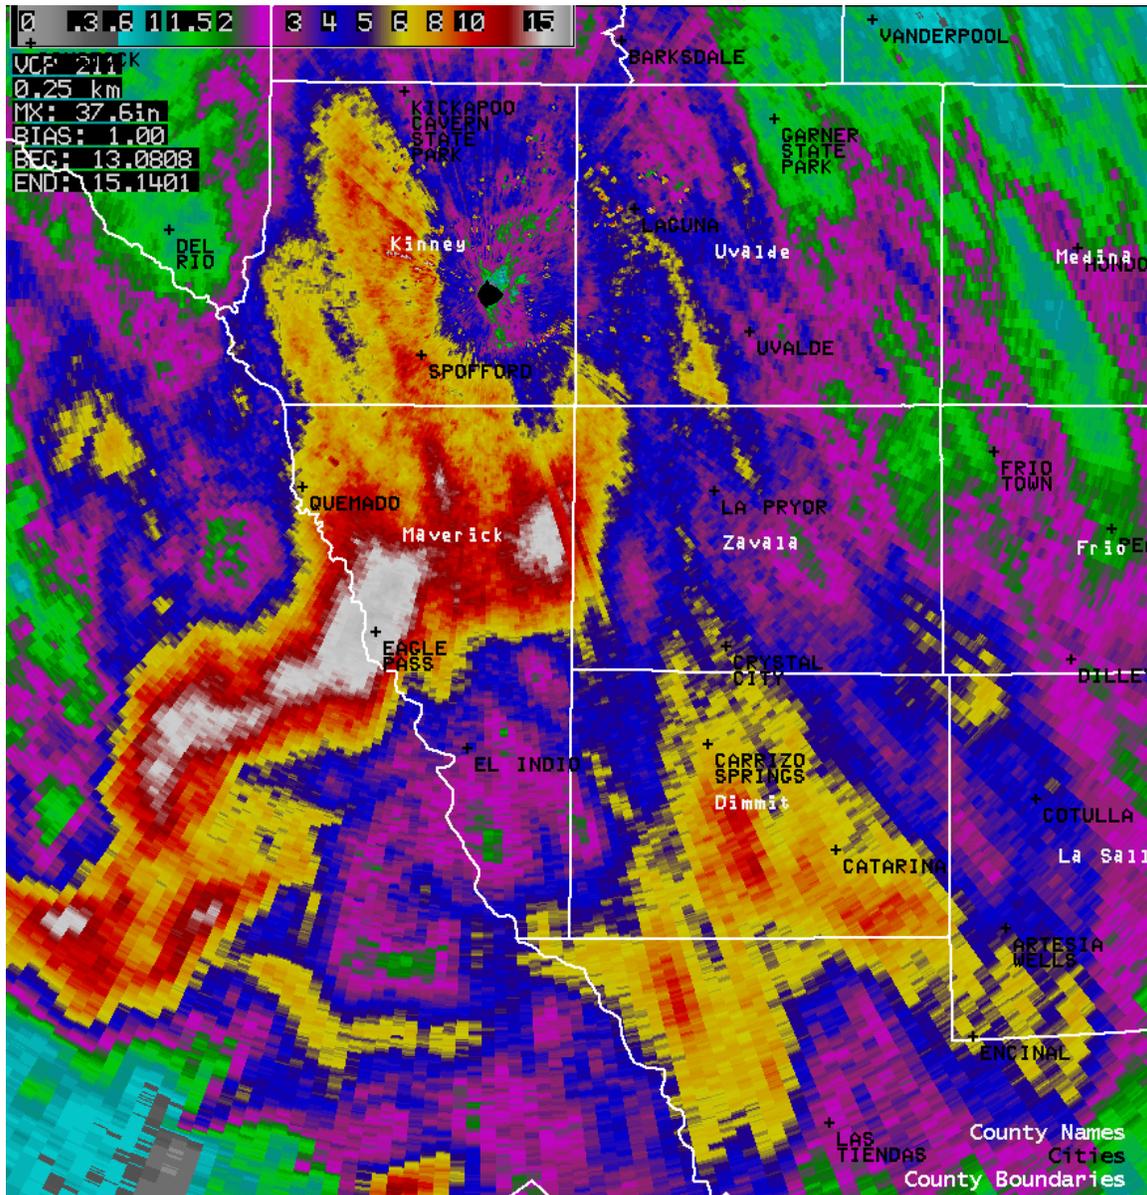
The image above shows radar estimated precipitation amounts across the Rio Grande Plains on June 14 and 15, 2013. Radar estimates show widespread 6 to 10" rainfall totals across the northern half of Maverick County. Significant rains also fell across the western half of Kinney County as well as much of Dimmit County.

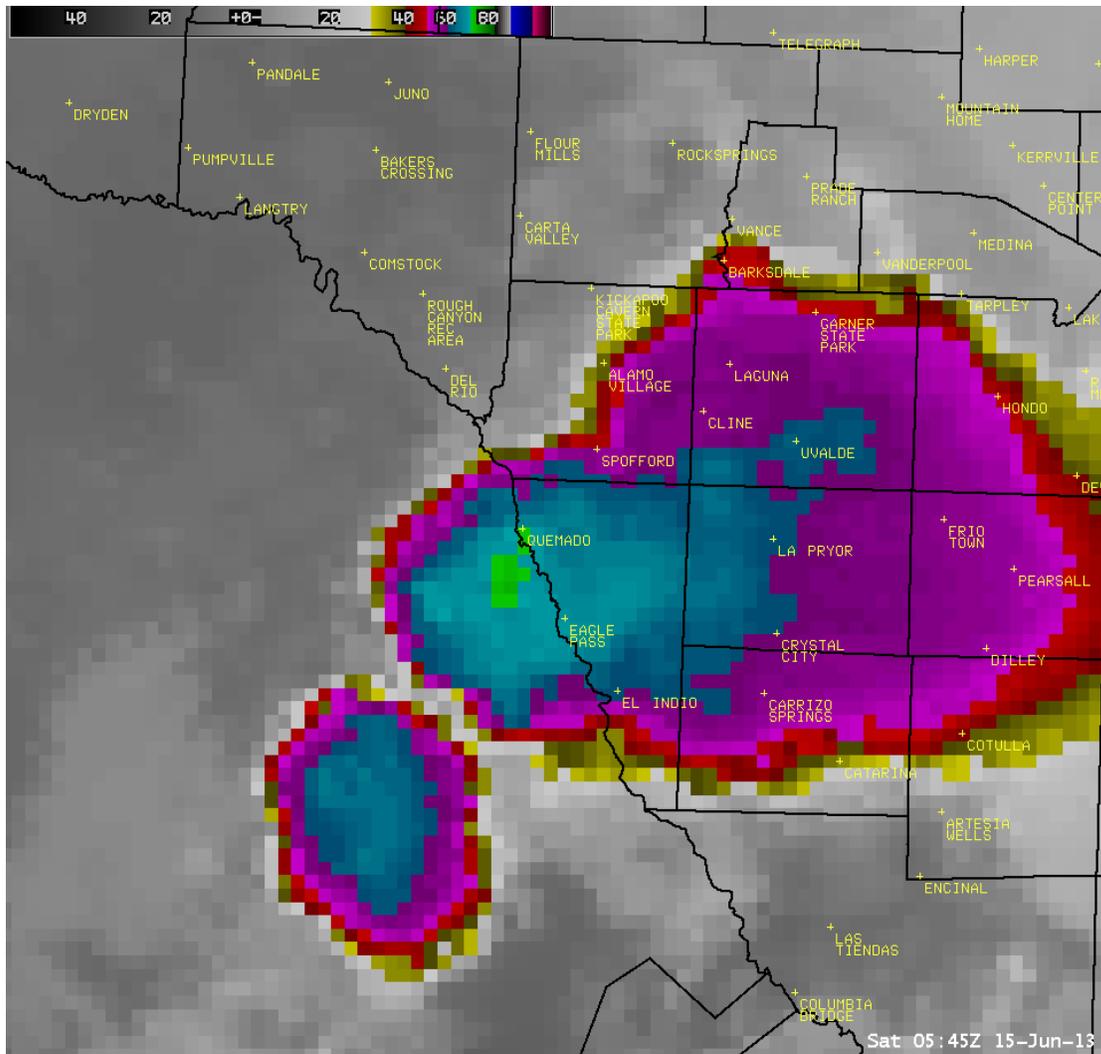
The image above shows an area of thunderstorms along the Rio Grande during the early morning hours on June 15, 2013. The brighter blue and green colors indicate stronger thunderstorms and more intense rainfall rates. This image was taken at 12:45 AM on Saturday, June 15. At the time of this image, these thunderstorms extended to roughly 50,000 feet above ground and were producing rainfall rates near 3” per hour in Eagle Pass, TX.

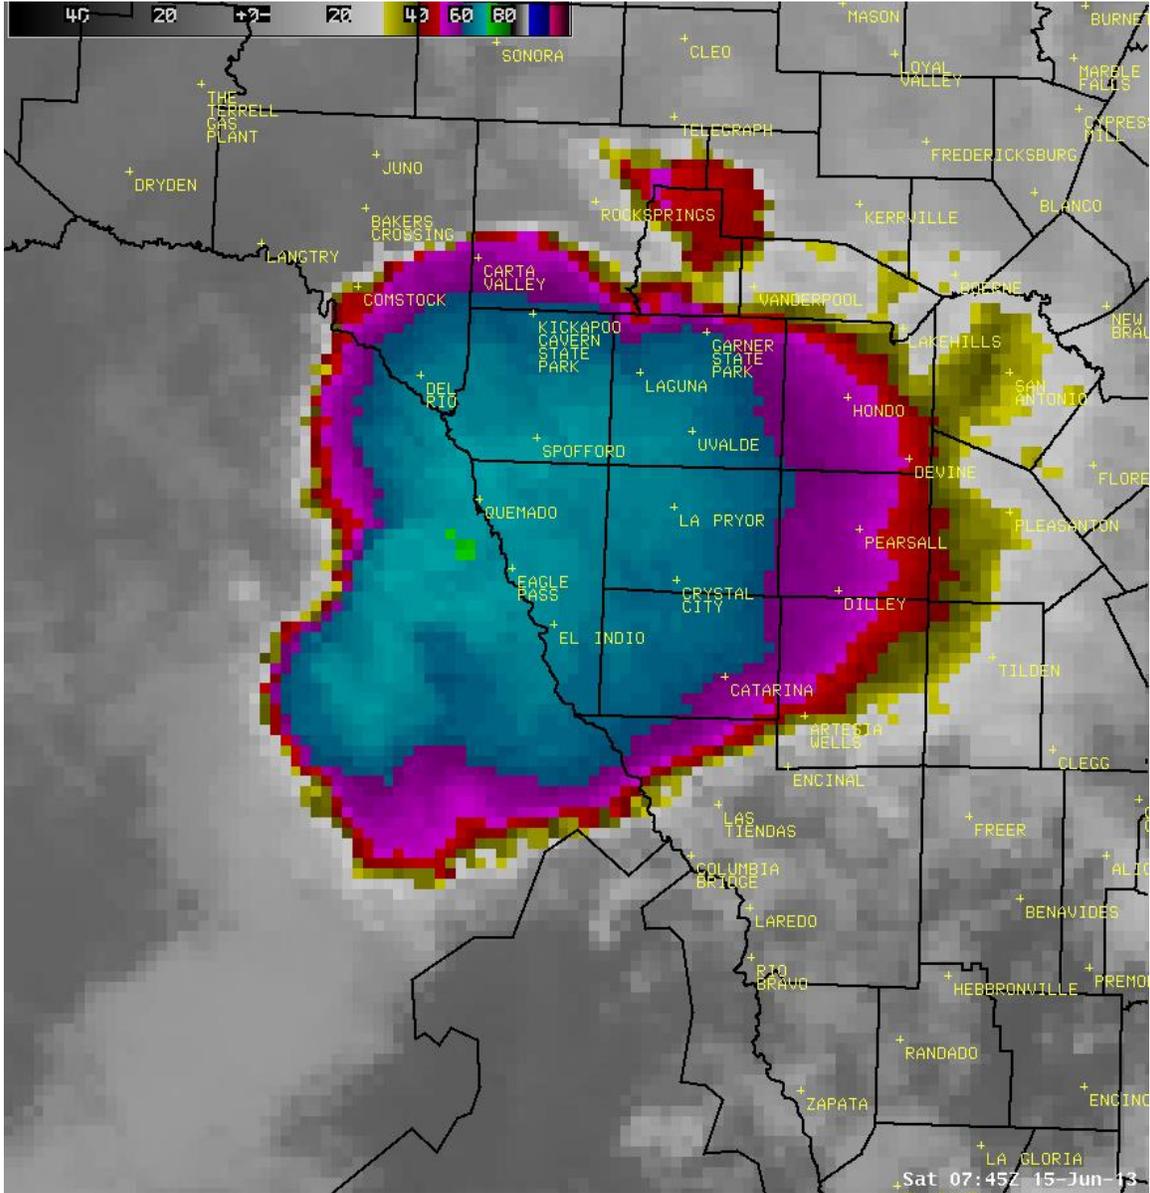
This satellite image was taken two hours later at 2:45 AM on the morning of June 15, 2013. Strong thunderstorms and very heavy rainfall continue over the Rio Grande Plains, including Maverick County and the city of Eagle Pass.

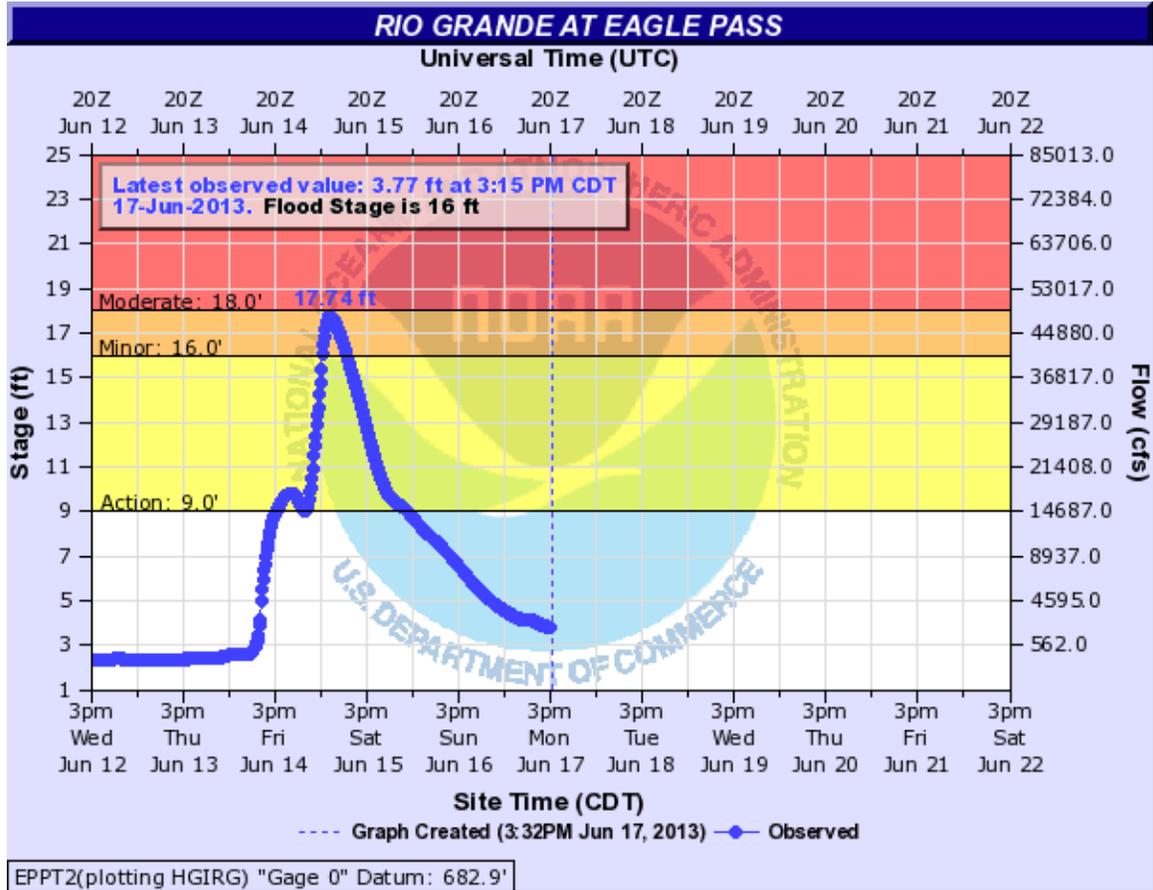
This graph above shows the rise in river levels at the gauge located near Eagle Pass, Texas.

The heavy rains also brought significant river rises to the Rio Grande at Eagle Pass.

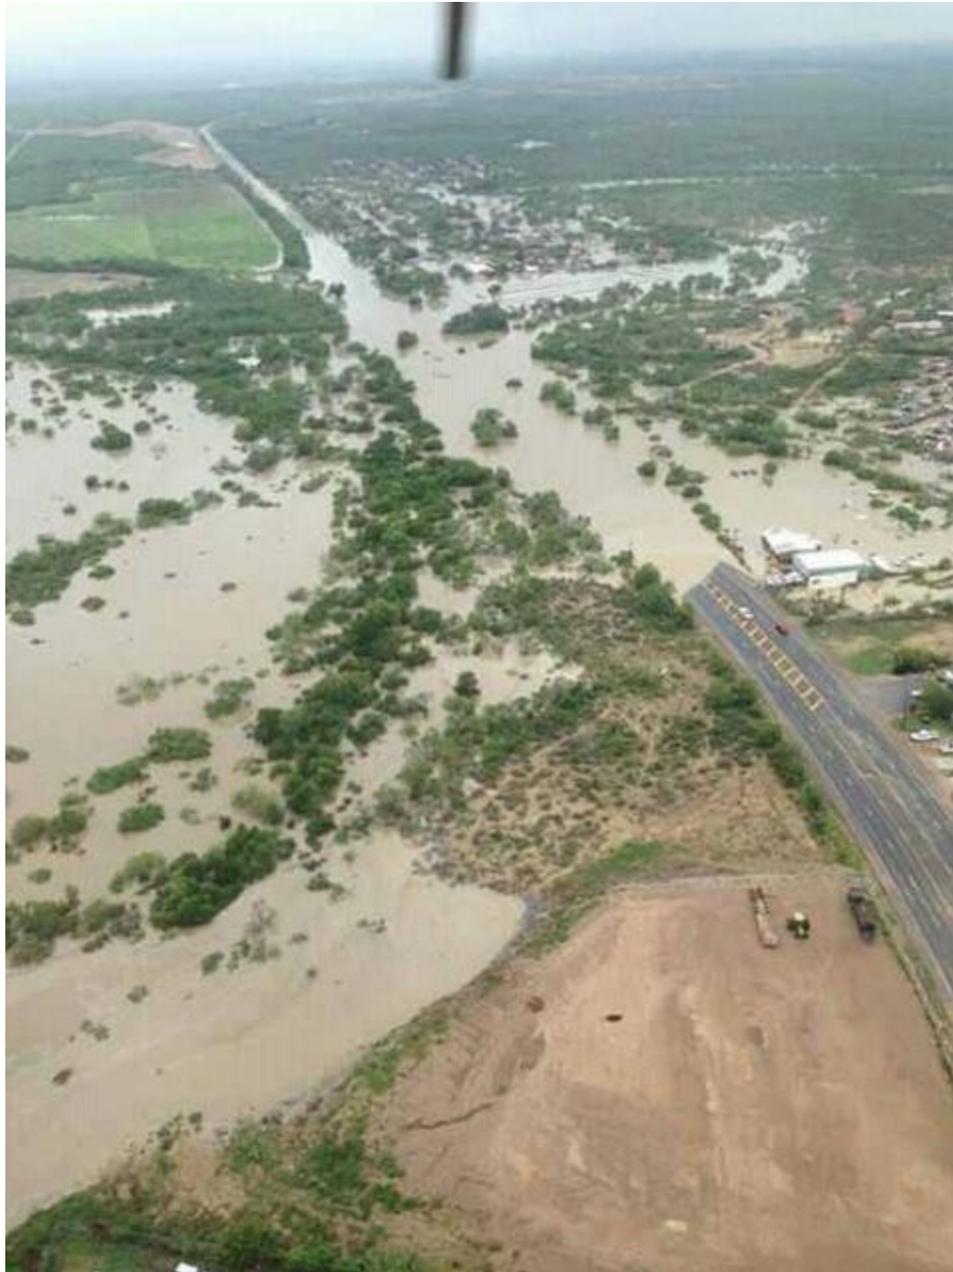
The photo above shows flooding along U.S. Highway 277 and Elm Creek. This photo is courtesy of the Eagle Pass Daily News.

The first round of heavy rainfall started Friday morning, June 14 around 8 AM and continued until Noon. The automated river gauge on the Rio Grande at Eagle Pass recorded just over 4" of rain during this time period. As a result of this initial round of rainfall, Highway 277 between Quemado and Eagle Pass was closed due to flooding. In addition, water began entering homes located near flooded irrigation canals.

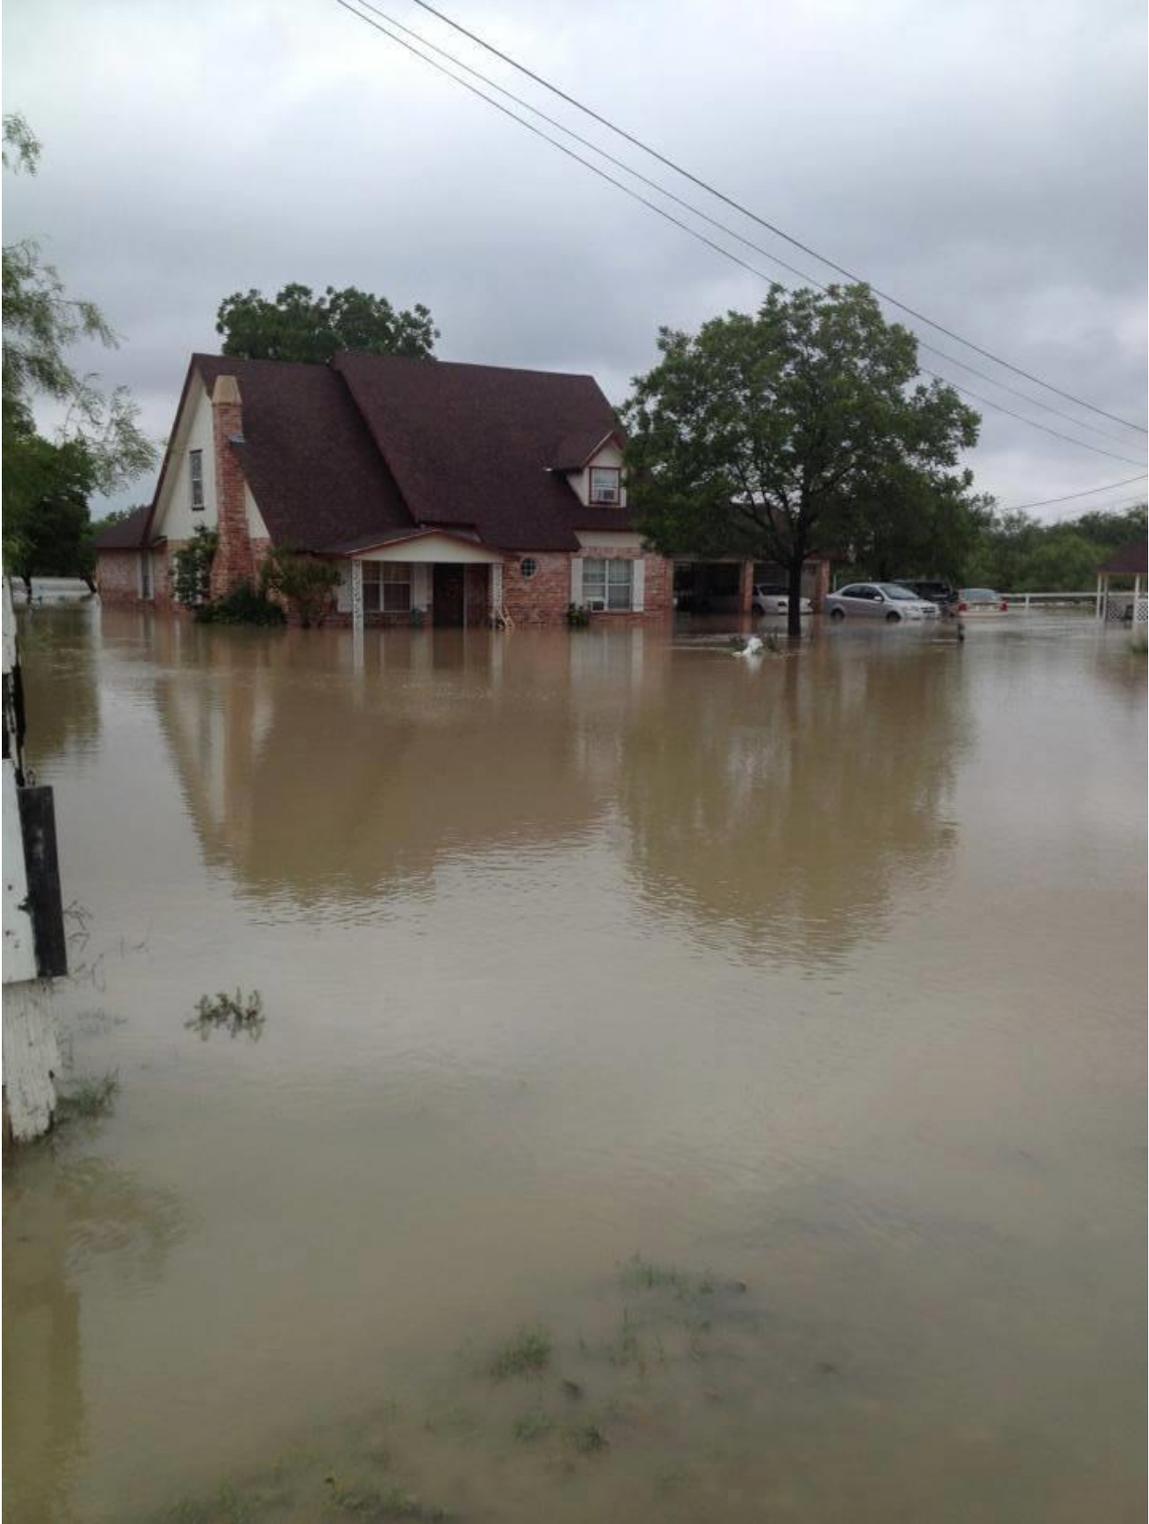
A flooded home in Eagle Pass, Texas. This photo is courtesy of the Eagle Pass Daily News.
