**NOTABLE LOCAL FLOODS OF 1939**

**Part 2. FLOOD OF JULY 5, 1939**

**IN EASTERN KENTUCKY**

**GEOLOGICAL SURVEY WATER SUPPLY PAPER 967-B**

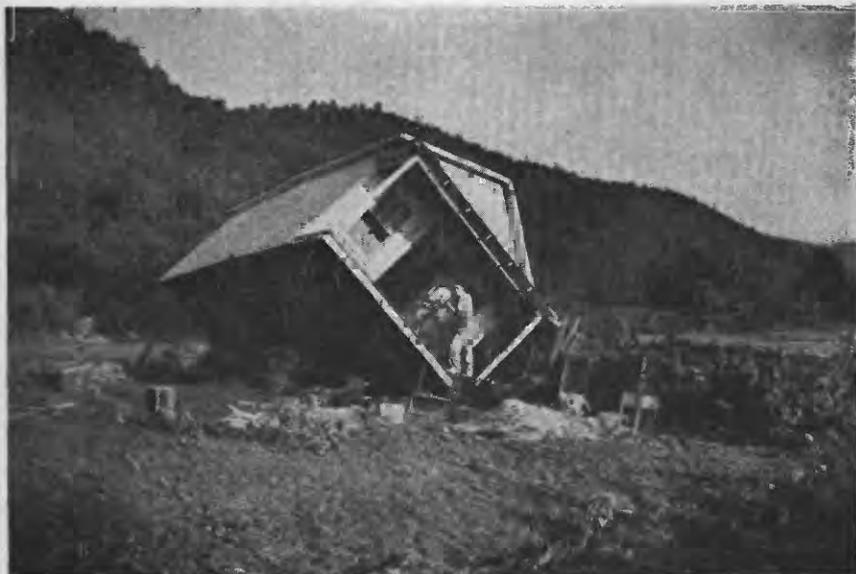
A. HOME OVERTURNED BY FORCE OF FLOOD FLOW.  
Triplett Creek at base of hill in background.

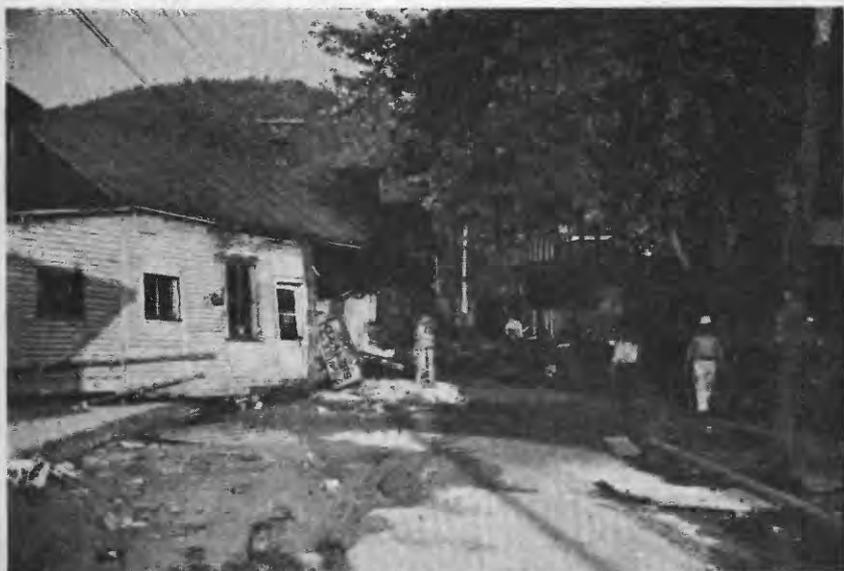
B. STORE FRONTING ON RAILROAD STREET FORCED FROM FOUNDATION  
AND MOVED TO FAIRBANKS AVENUE.  
DAMAGE TO BUILDINGS IN MOREHEAD BY FLOODWATERS OF  
TRIPLETT CREEK.

Photographs taken between 11:30 a.m. and 12 m. on July 5, 1939.  
Courtesy Corps of Engineers, U. S. Army.

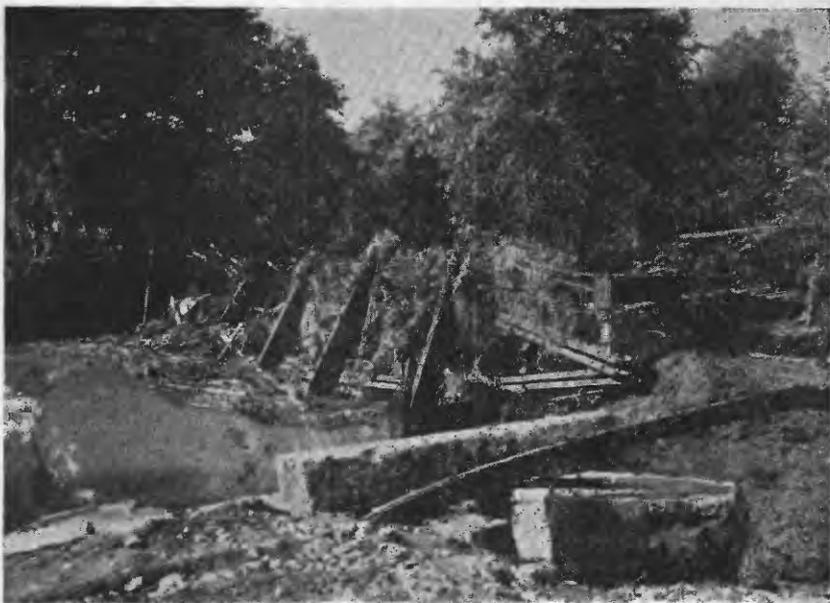
**A. WASH-OUT OF RAILROAD BRIDGE ON TRIPLETT CREEK NEAR MOREHEAD.**

Bridge on spur line of Chesapeake & Ohio Railway was forced from foundations by floating house. Courtesy Corps of Engineers, U. S. Army.

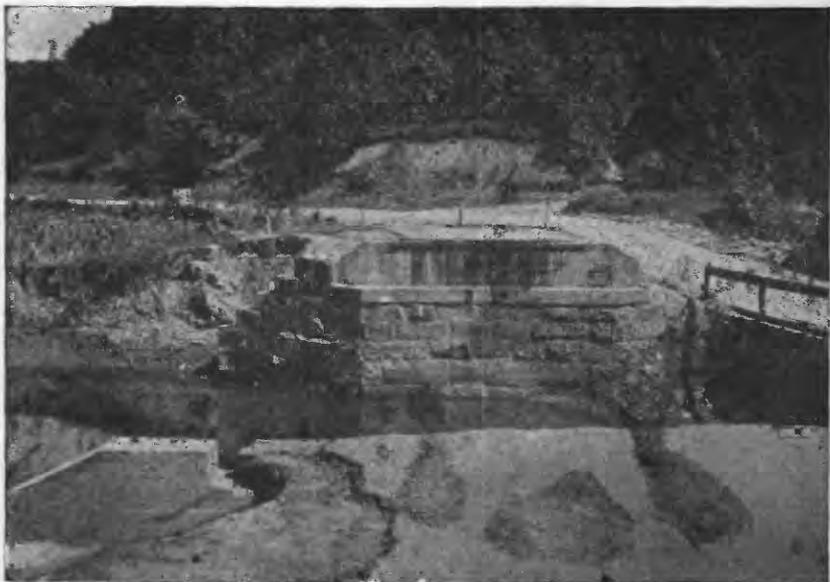
**B. VIEW OF COPE FORK IN FROZEN CREEK BASIN SHOWING REMAINS OF COCKRELL BRIDGE ON STATE HIGHWAY 15.**

Steel truss bridge was carried several hundred feet downstream.

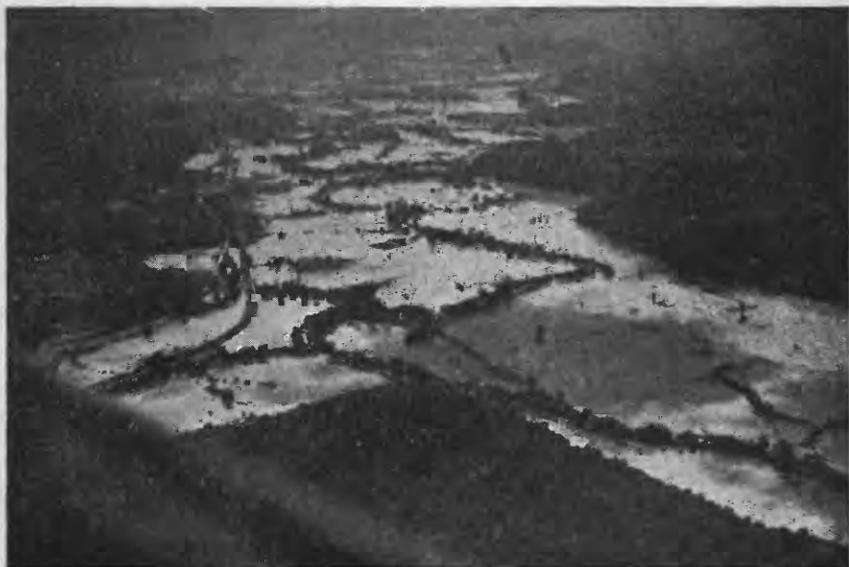
**A. RECEDING FLOODWATERS OF TRIPLETT CREEK.**

View downstream showing North Fork entering at right. Photograph taken between 11:30 a.m. and 12 m. on July 5, 1939. Courtesy Corps of Engineers, U. S. Army.

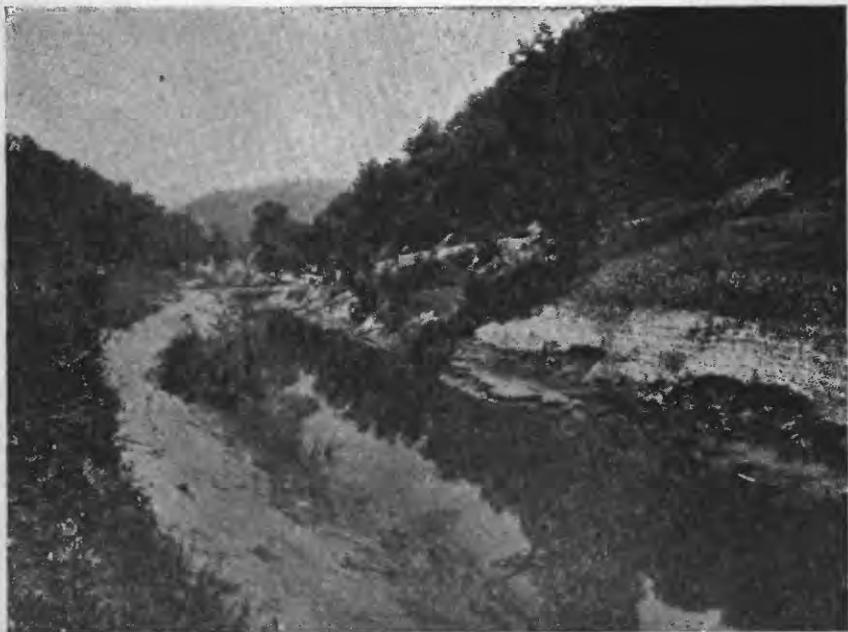
**B. FROZEN CREEK AT THE MOUTH.**

View upstream from railroad bridge near North Fork Kentucky River showing sand deposits and stripped vegetation along banks. Photograph taken July 20, 1939.

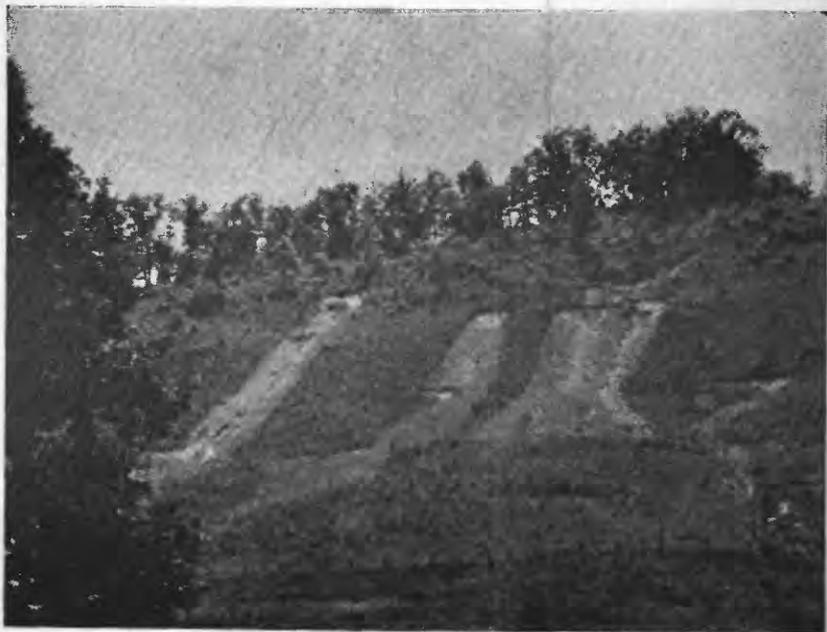
**B. EROSION ON HILLSIDE IN WOLFE COUNTY.**

View from State Highway 15 about 2 miles from Breathitt County Line. Photograph taken July 19, 1939. Courtesy Corps of Engineers, U. S. Army.
