# Upon Further Review...

## The May 18, 1995 Severe Weather Outbreak

John Gordon NWS Louisville  
Cody Moore University of Louisville

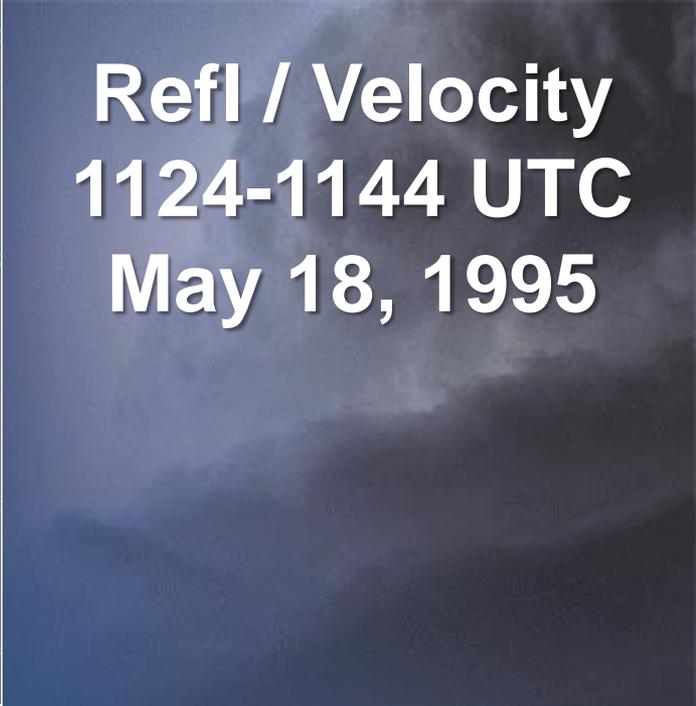
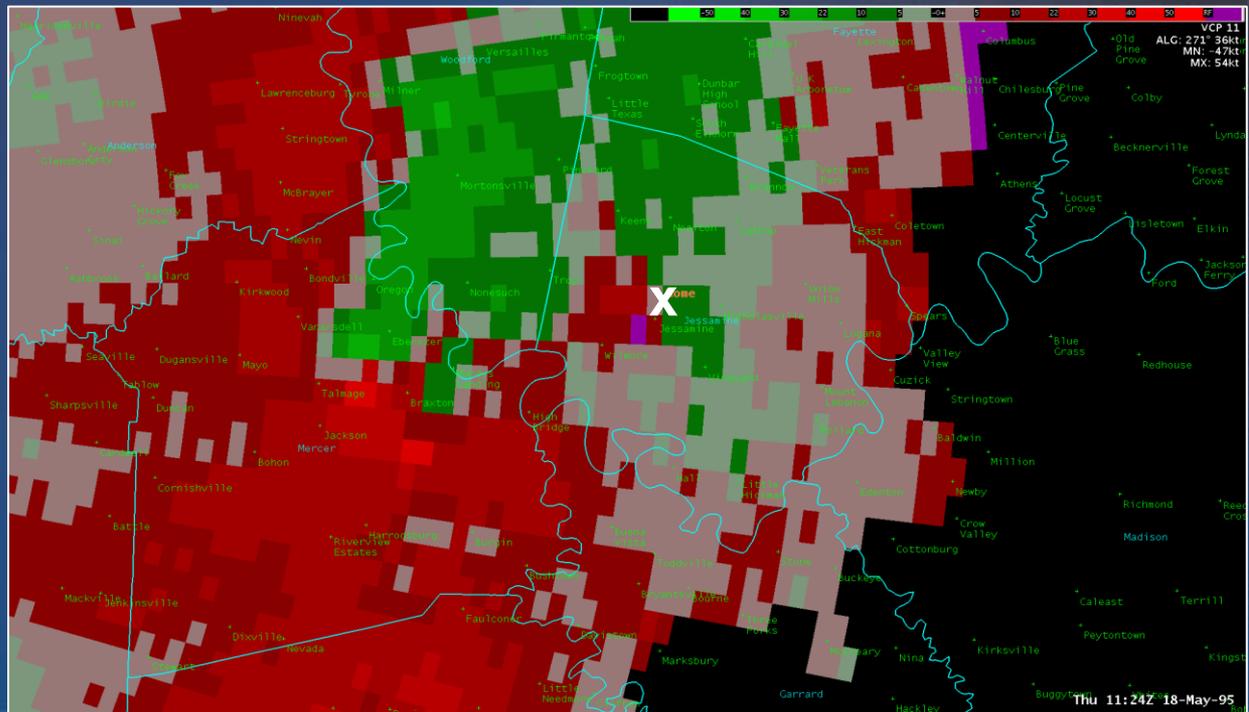
# Refl / Velocity 1124-1144 UTC May 18, 1995

Radar shows a line of thunderstorms, with a “line break” and cyclonic circulation which pass over Jessamine County. These circulations can produce enhanced straight-line wind damage and/or tornadoes.

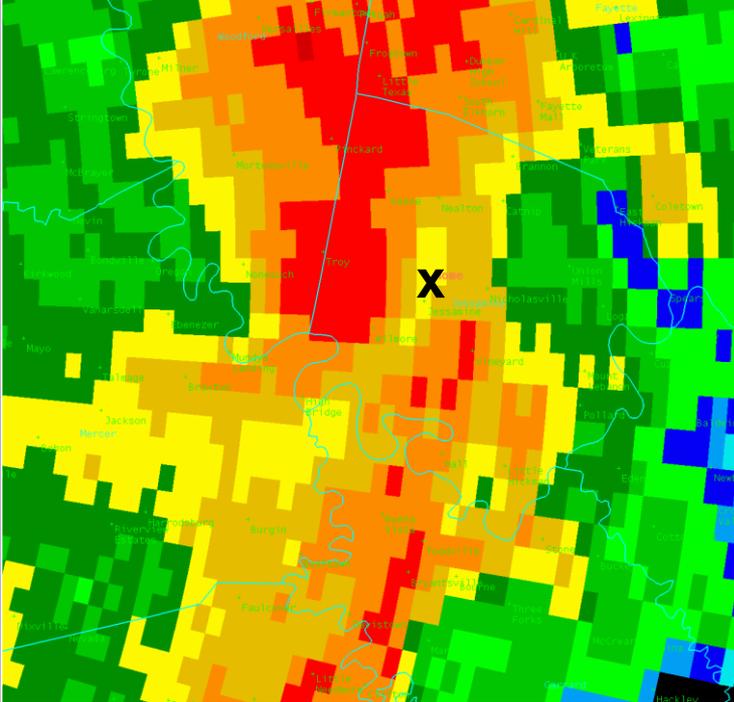
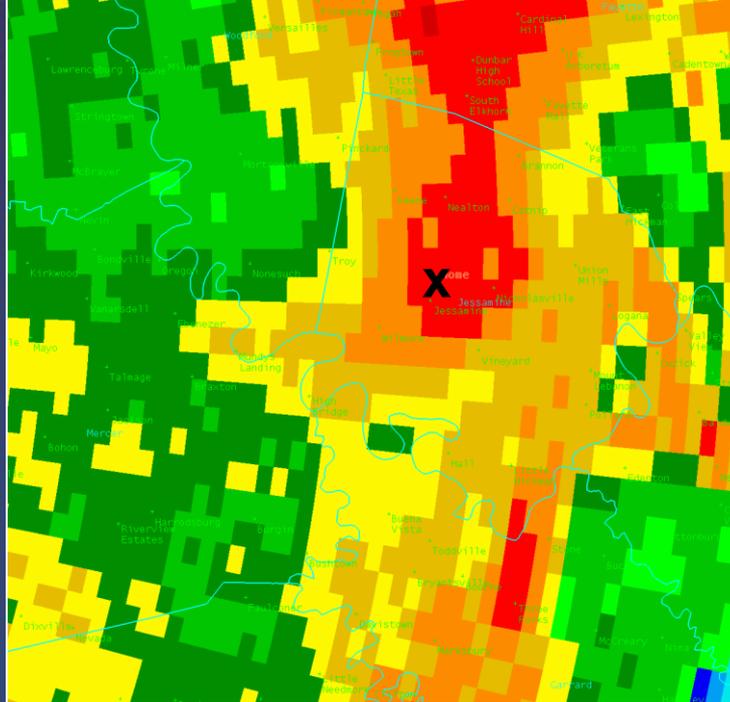
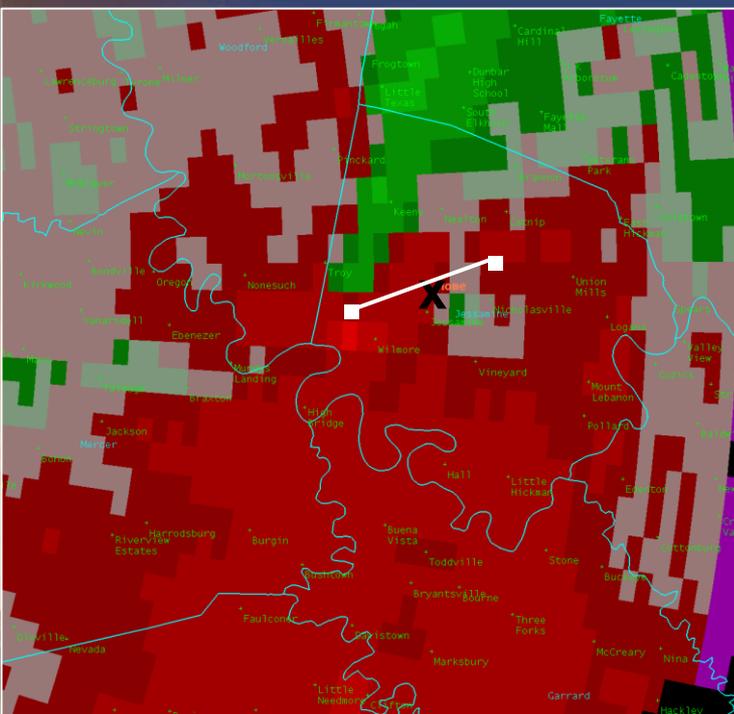
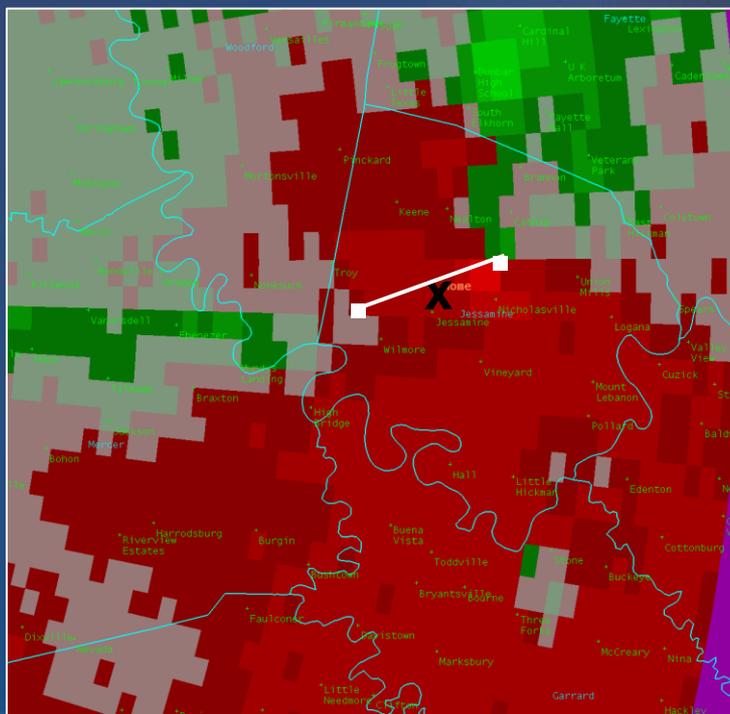
# Refl / Velocity 1134 and 1139 UTC May 18, 1995

X = West Jessamine High School.

White dots and line show location of the circulation that passed over/near the high school associated with the line of storms.

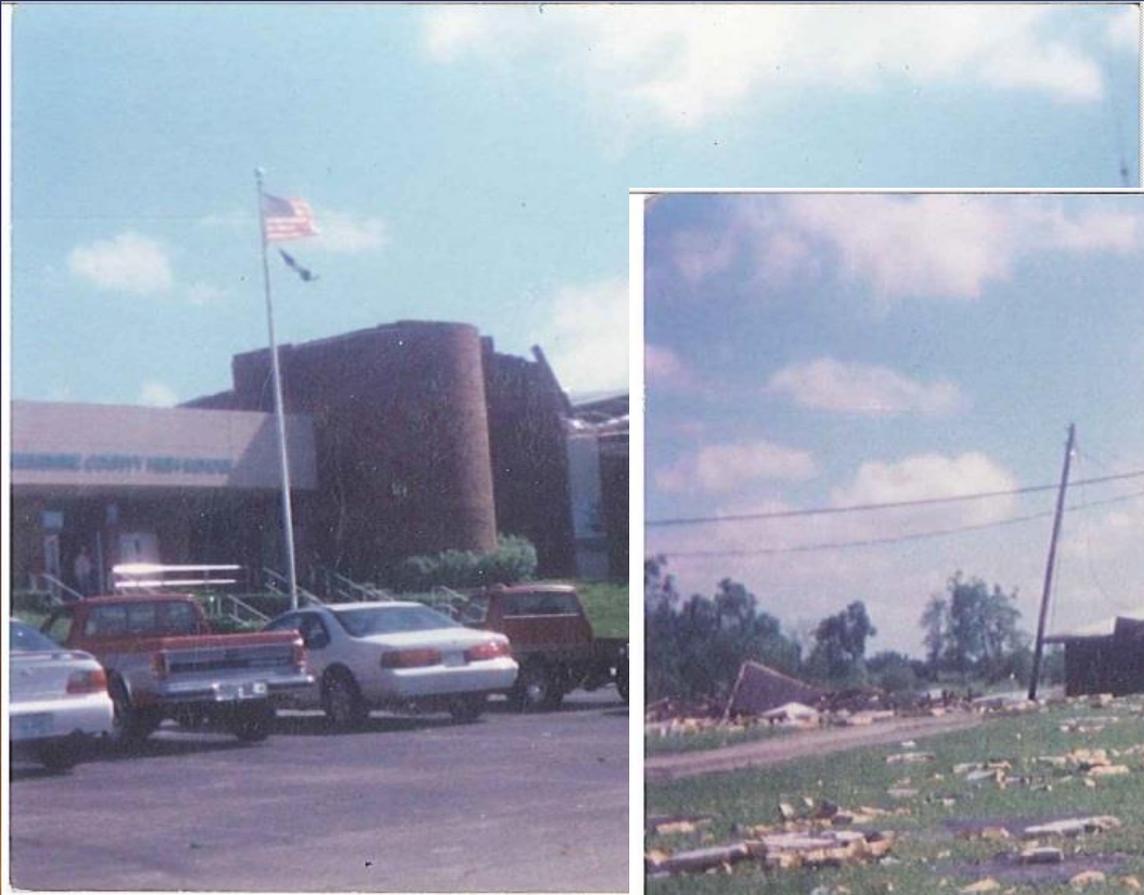
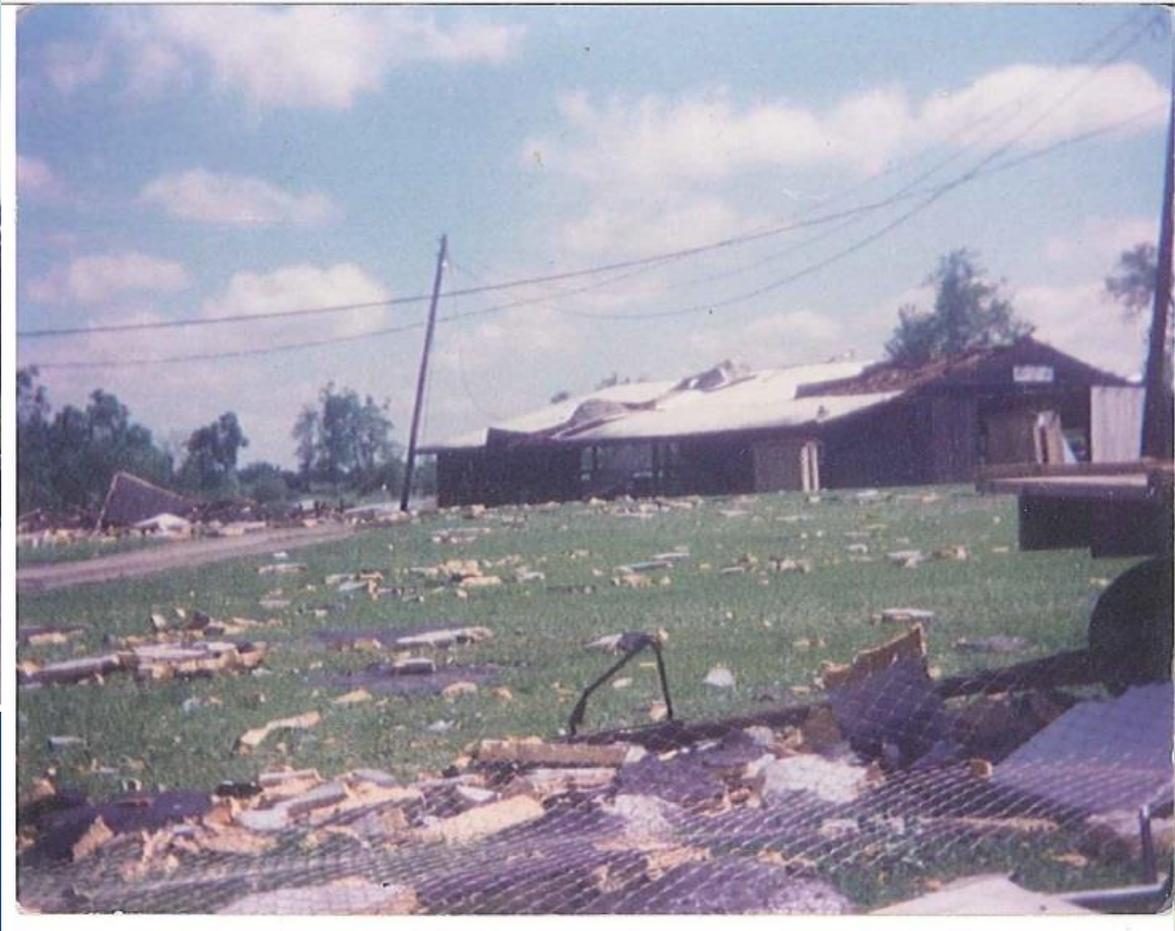
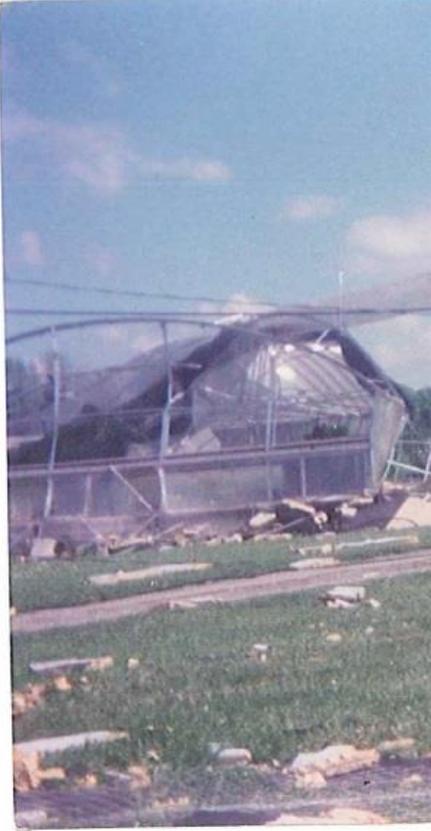
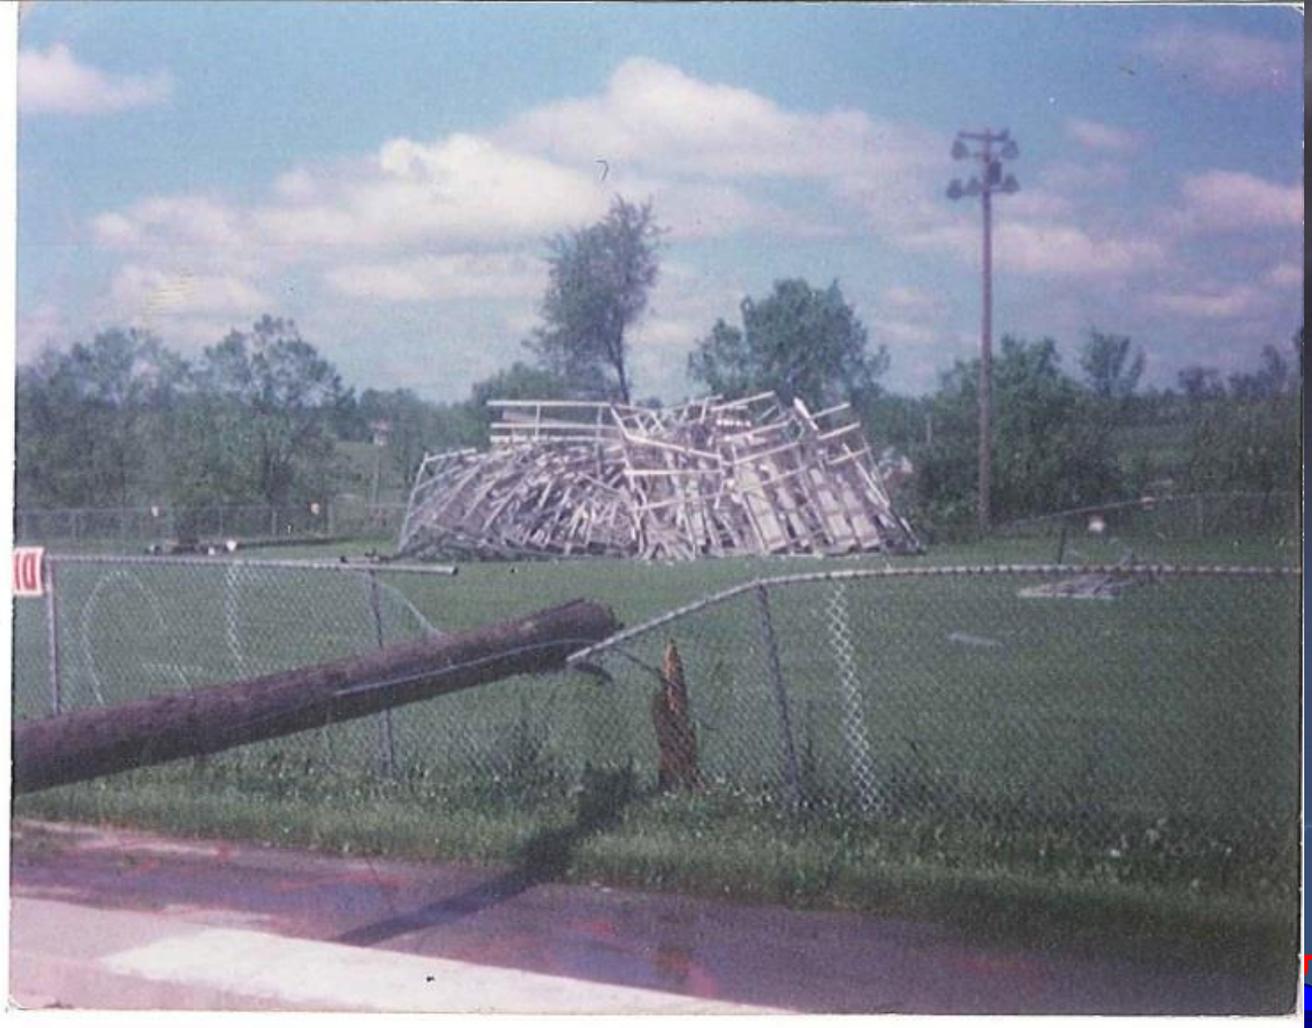
# Aerial View of Damage

- Extensive damage to West Jessamine High School and surrounding buildings
  - \$2 million in damage at high school
  - School roof uplifted
  - 11 buses significantly damaged
  - Tobacco barn and greenhouse destroyed
- 30+ students injured
- Walmart and strip plaza sustained significant damage
- Path of wind damage to West Virginia state line

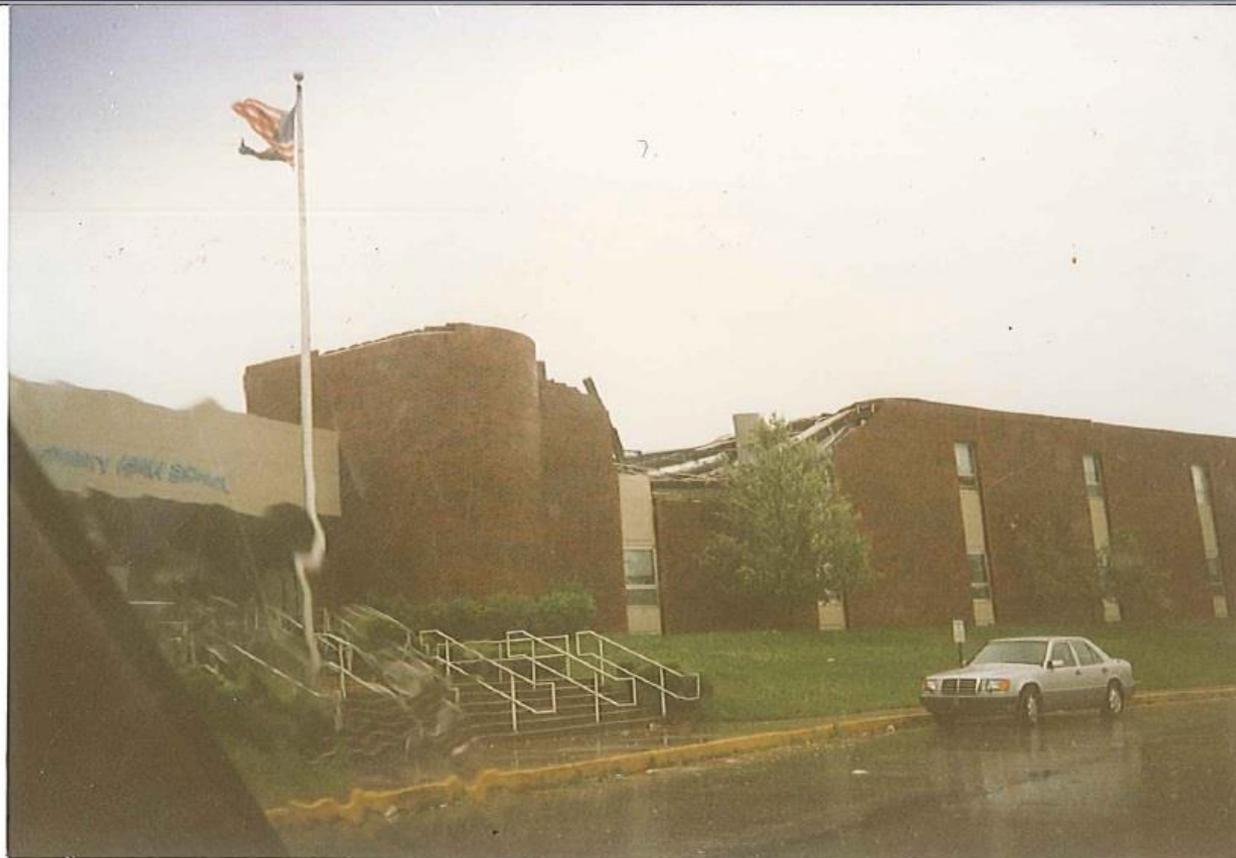
Damage indicator:  
School – Jr. or Sr.  
High School

DOD*	Damage description	EXP	LB	UB
1	Threshold of visible damage	68	55	83
2	Loss of roof covering (<20%)	79	66	99
3	Broken windows	87	71	106
4	Exterior door failures	101	83	121
5	Uplift of metal roof decking; significant loss of roofing material (>20%); loss of rooftop HVAC	101	85	119
6	Damage to or loss of wall cladding	108	92	127
7	Collapse of tall masonry walls at gym, cafeteria or auditorium	114	94	136
8	Uplift or collapse of light steel roof structure	125	108	148
9	Collapse of exterior walls in top floor	139	121	153
10	Most interior walls of top floor collapsed	158	133	186
11	Complete destruction of all or a large section of building	192	163	224

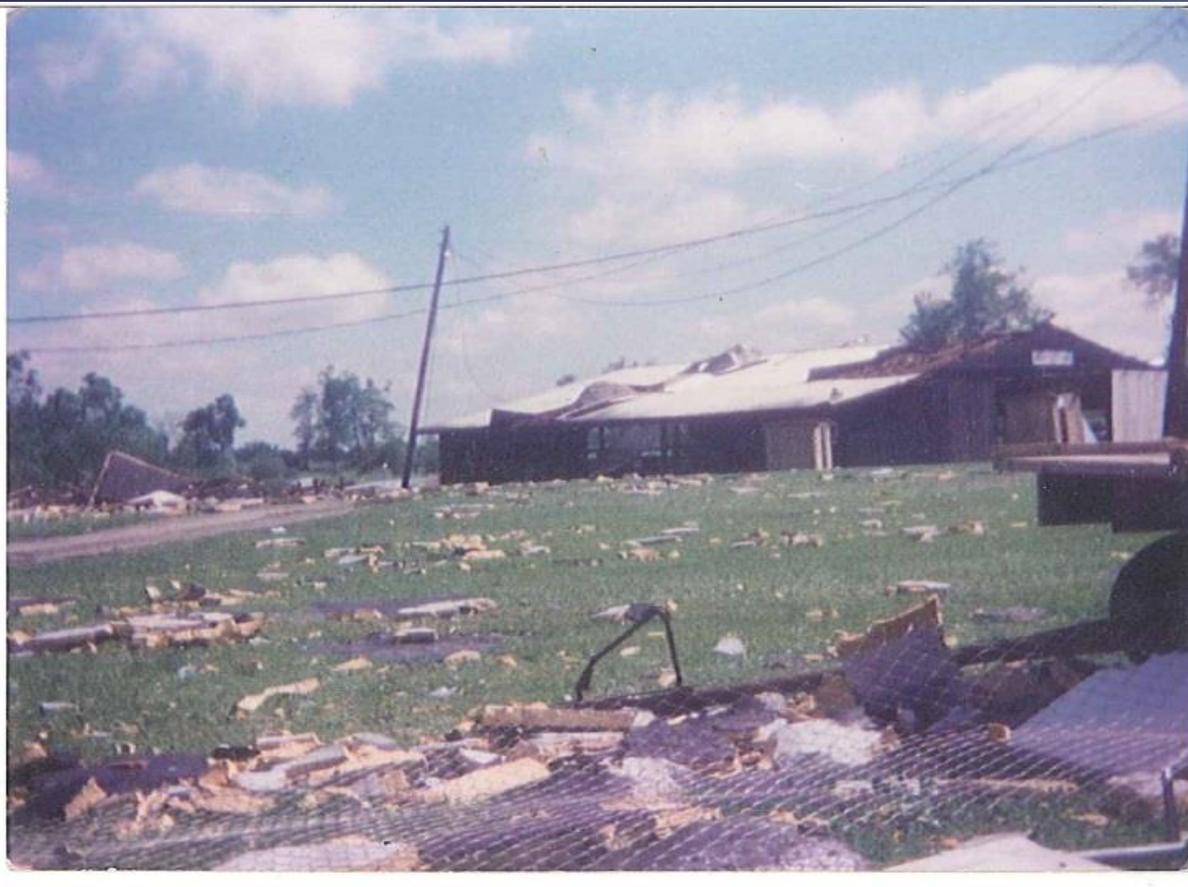
Damage Indicator:  
Warehouse (tilt up  
walls or heavy timber)

DOD*	Damage description	EXP	LB	UB
1	Threshold of visible damage	68	55	83
2	Loss of roofing material (<20%)	83	69	105
3	Inward or outward collapse of overhead doors	88	75	107
4	Uplift of roof deck; significant loss of roofing material (>20%); loss of rooftop HVAC equipment	103	88	122
5	Collapse of other non-bearing exterior walls	114	93	126
6	Collapse of pre-cast concrete tilt-up panels	124	102	144
7	Total destruction of a large section of building or entire building	158	131	186

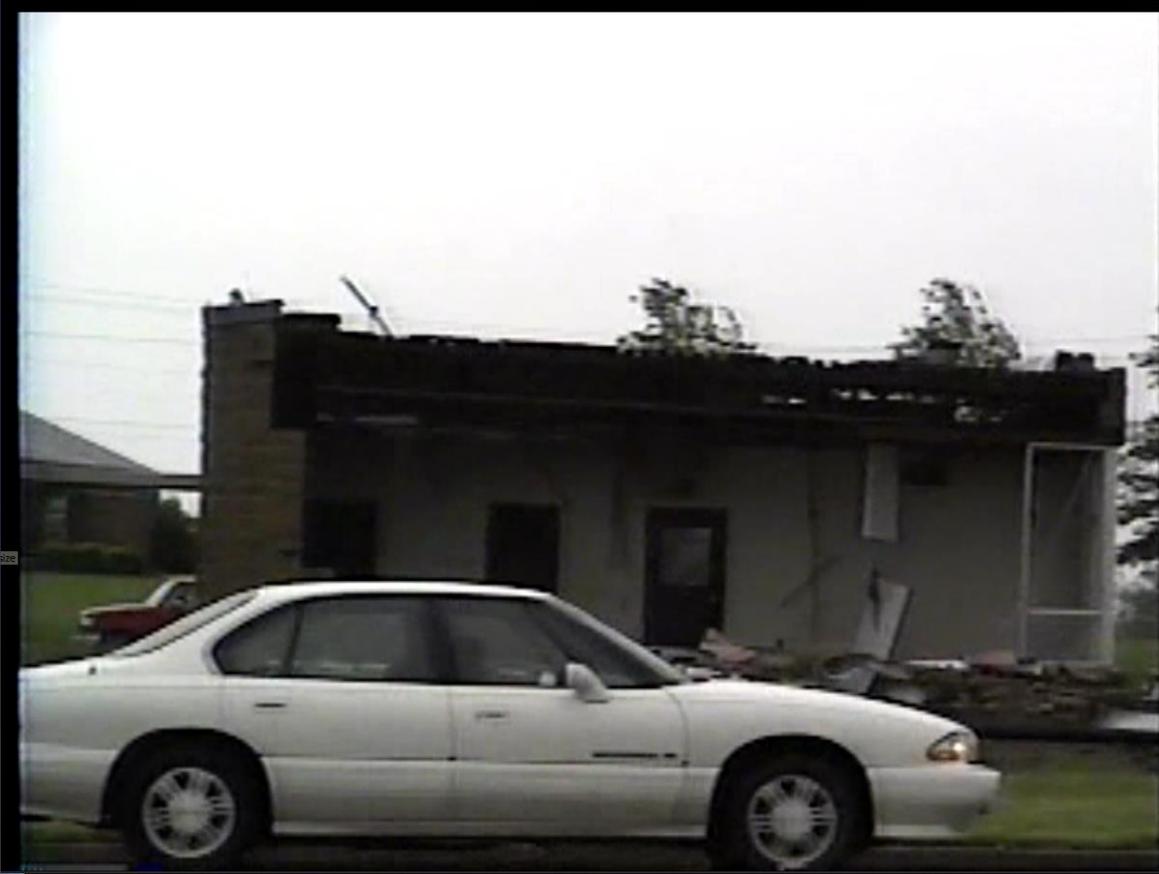
Damage Indicator:  
Large, isolated ("big box") retail building.

DOD*	Damage description	EXP	LB	UB
1	Threshold of visible damage	68	57	83
2	Loss of roof covering (<20%)	81	68	103
3	Uplift of some roof decking; significant loss of roofing material (>20%); loss of rooftop HVAC	103	87	123
4	Long roof spans collapsed downward	122	103	144
5	Uplift and removal of roof structure	134	114	157
6	Inward or outward collapse of exterior walls	137	118	158
7	Complete destruction of all or a large section of the building	173	147	201

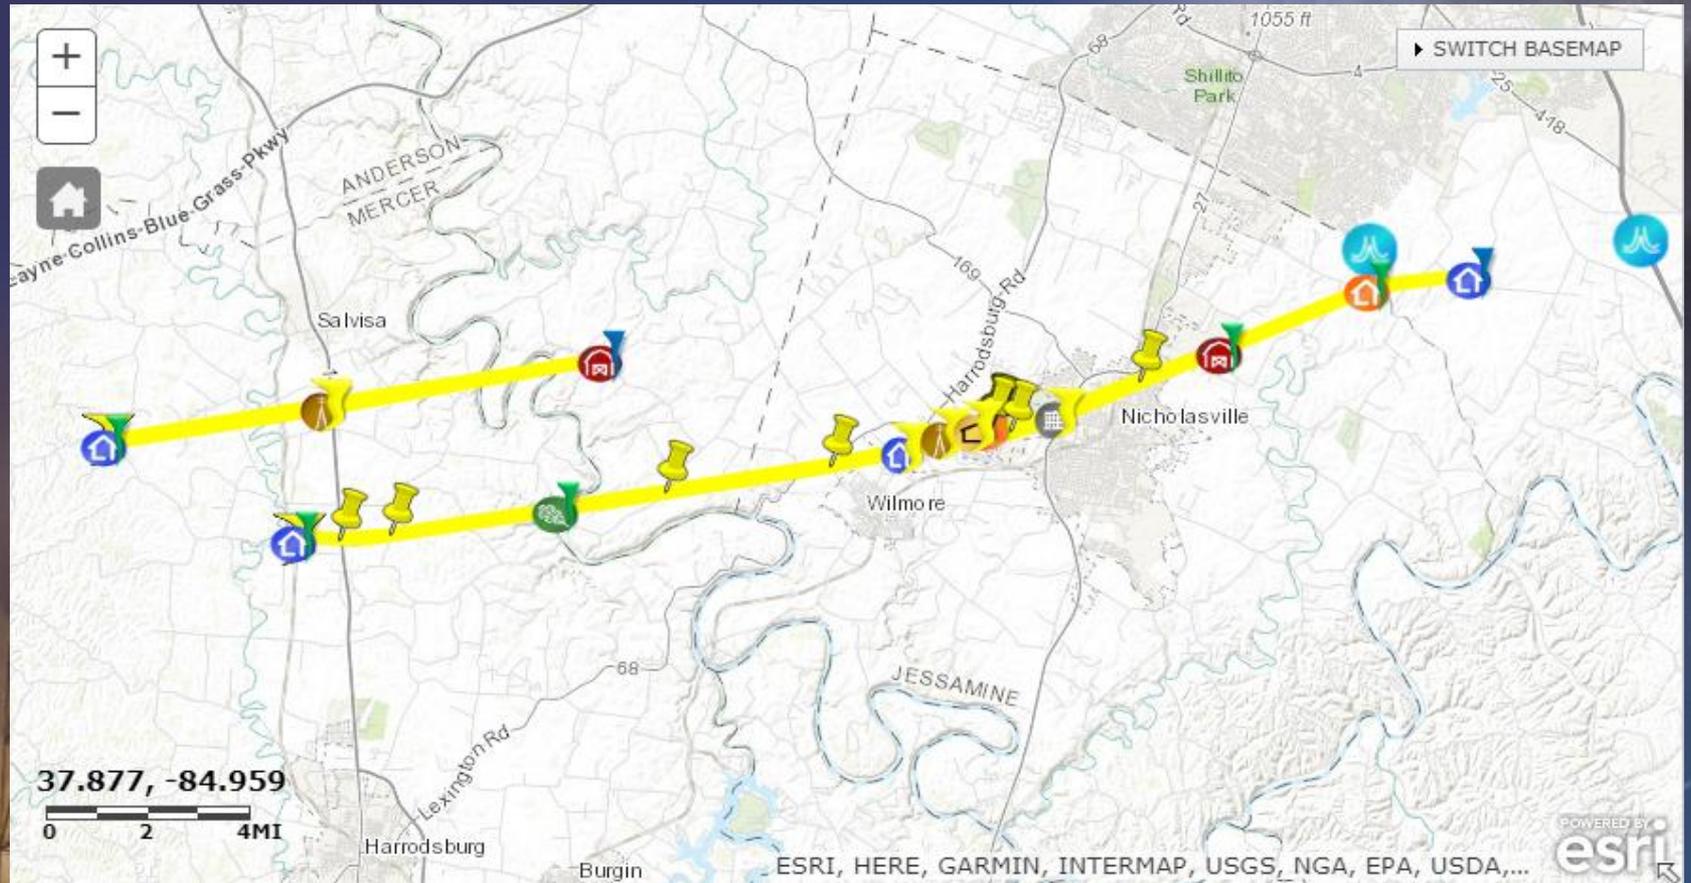
# Results

- **Reclassified straight line wind event to an F2 tornado**
- **Max winds of 145mph**
- **Path length of 24 miles over 4 counties**
- **Salvisa Tornado now has a 10 mile path with approximate starting and ending points.**
