NWS Guam

**Meteorological Report on the Effects of Super Typhoon
Mawar (02W) in Micronesia and the Marianas
20-28 May 2023**

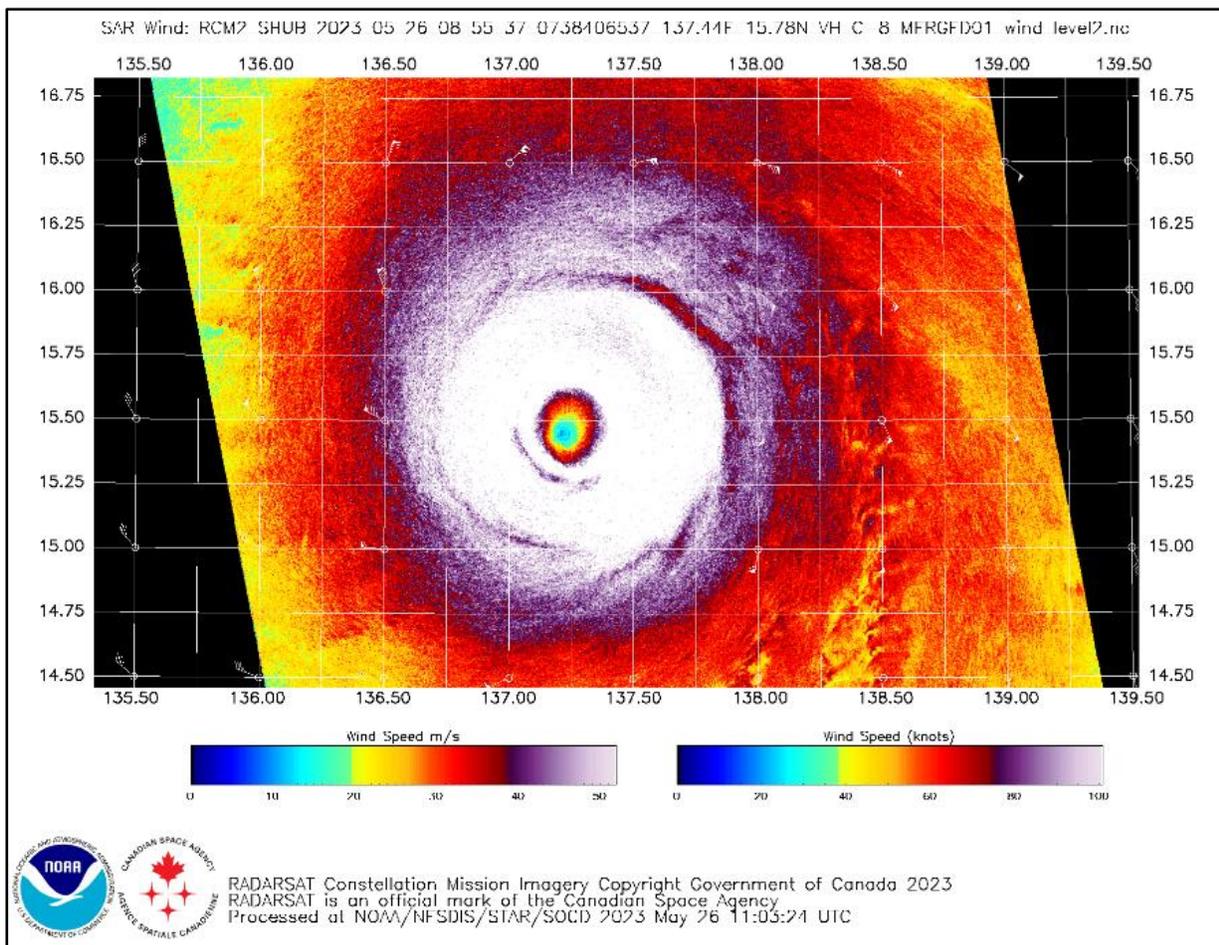
Figure 33: 26May/0856Z SAR pass over STY Mawar in the Philippine Sea west, west of the Marianas. The white shading indicates winds well in excess of 100 kt. The JTWC intensity of Mawar, at this time, was 155 KT (JTWC Bulletin #26).

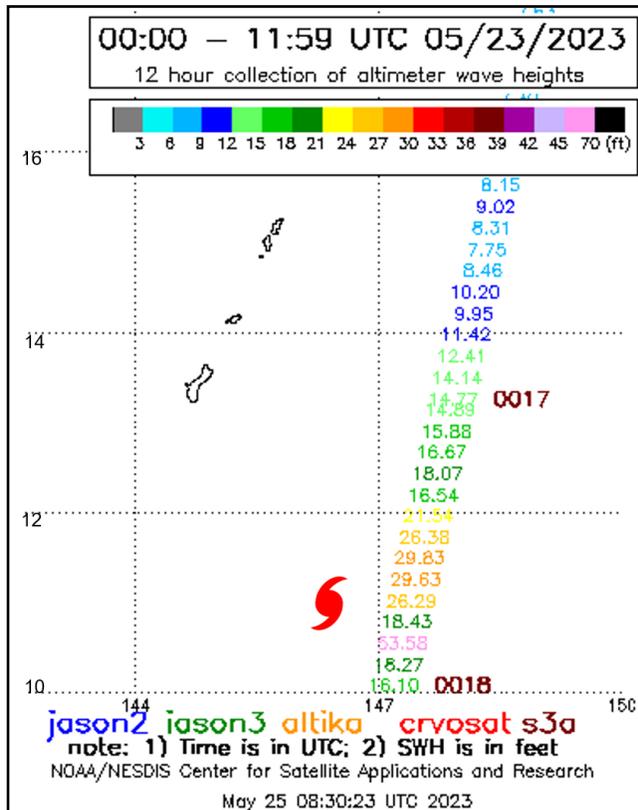
Figure 34: 23May/0017Z s3a altimetry pass over TY Mawar southeast of Guam indicating large seas reaching nearly 30 ft.

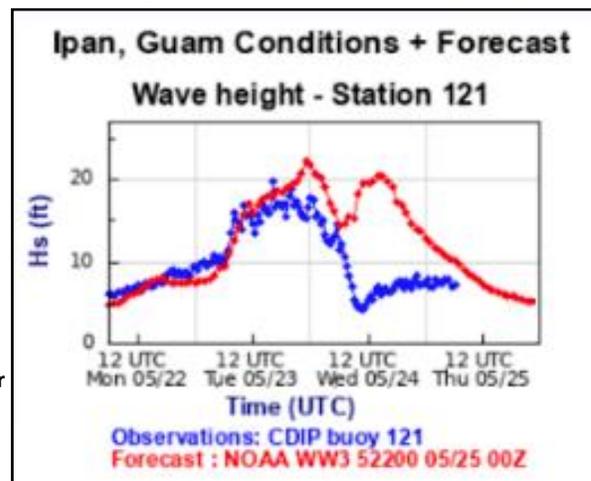
Figure 35: 23-25 May Ipan Buoy observations (blue) and Wave Watch 3 (red) wave height model guidance. Wave heights rapidly dropped at the buoy as winds became northerly and westerly.

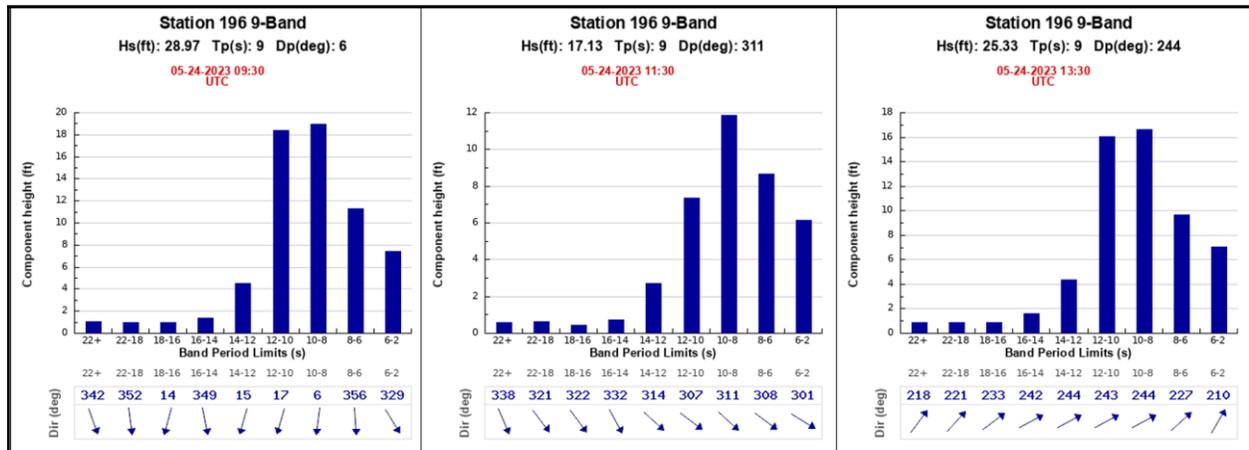
the north prior to 24May/11Z to large west-southwest swell after 12Z as shown in the 9-band plot sequence (Figure 36). This ramp up in WSW swell energy led to significant coastal erosion along the western side of Guam, particularly northern Guam. The most dramatic coastal effects were noted along the northwestern Guam coastline north of Tanguisson to the western side of Ritidian Point. This is where high water marks were observed up to nearly 15 feet above the normal water level along with an erosional step 3-5 feet tall in some locations. (Images included at the end of this report.)

Figure 36: Ritidian Buoy 9-Band Plots from 24 May at 0930Z (left), 1130Z (middle) and 1330Z (right). Significant wave height (Hs) dropped from 28.97ft to 17.13ft by 1130Z before steadily climbing to more than 25ft. During this time, swell directions shifted from north to northwest, then quickly out of west-southwest.

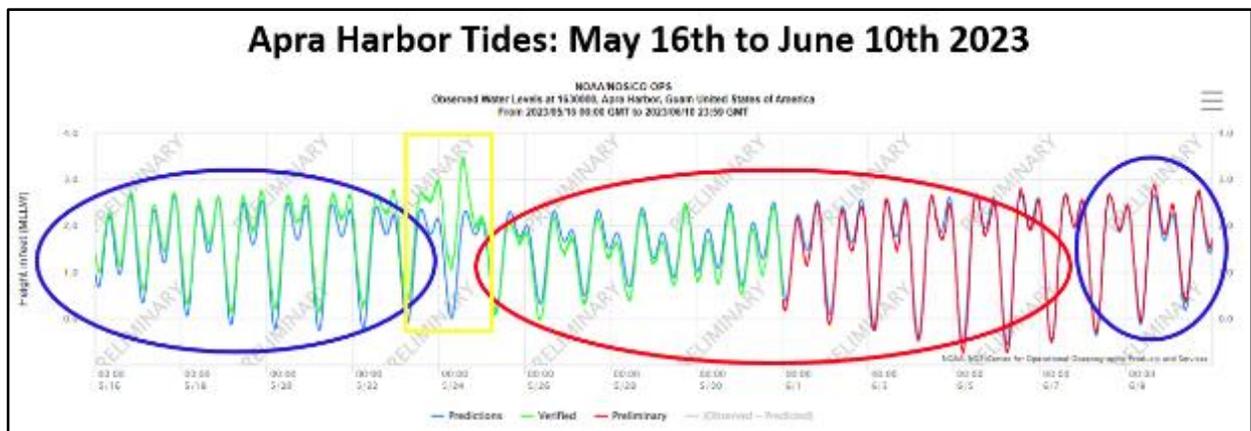
The passage of Mawar produced a unique signature in the Apra Harbor tide gauge data with nearly ten days of lower water levels following Mawar’s passage (Figure 37). Lower water levels were similarly observed following the passage of Typhoons Keith (1996), Paka (1997) and Pongsona (2002) over Guam, and Typhoon Sudal (2004) at Yap. Water levels gradually moderated back to pre-typhoon levels 1-2 weeks later.

Figure 37: Apra Harbor tide gauge data from May 16th through June 10th. The blue circles indicate observed tides (verified data in green, preliminary data in red) prior to and well after the passage of Mawar, which were/are above the predicted tide levels (blue). The spike in water levels directly tied to Mawar is shown with a yellow box. The red circle highlights a 10 day period following Mawar in which the tide data indicates lower water levels.

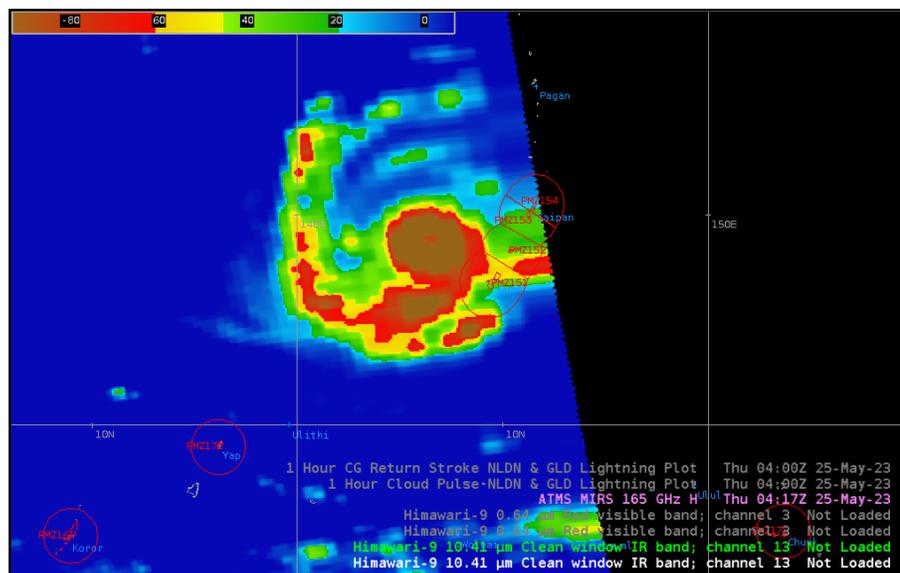
Figure 38: 25May/0417Z (Thursday 2:17pm ChST) ATMS 165GHz imagery depicting the convective core of Mawar pulling away to the west of the Marianas. via NWS Guam AWIPS during Mawar's intensification while departing from Guam.

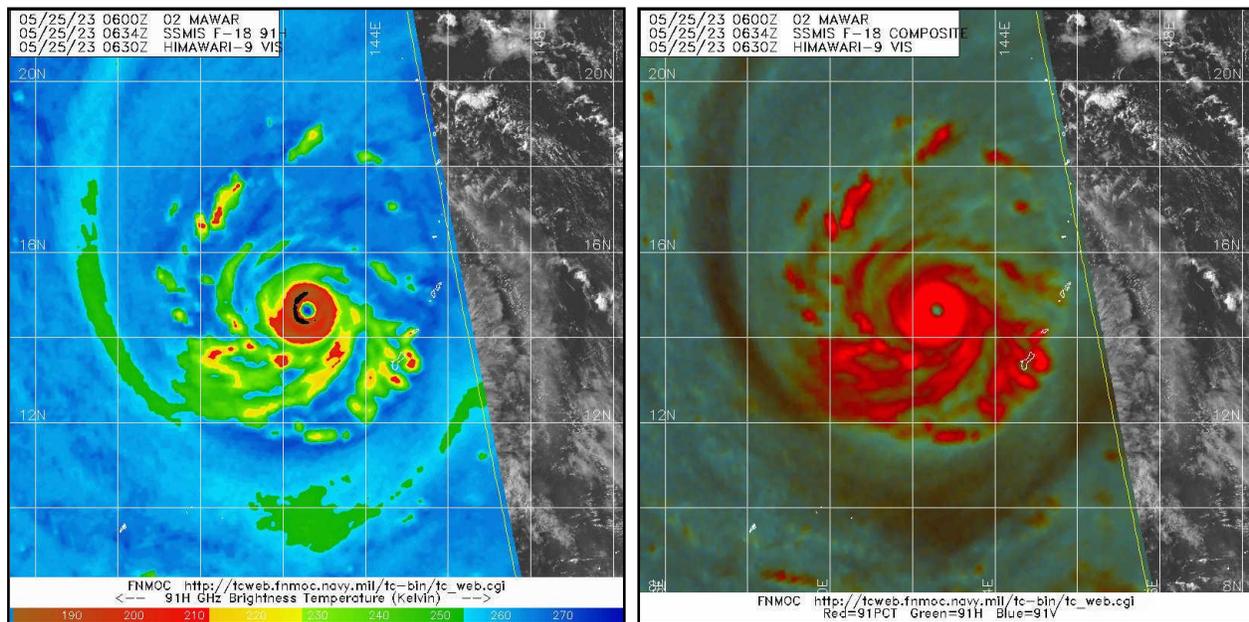
Figure 39 (left) and Figure 40 (right): 25May/0634Z (Thursday 4:34pm ChST) SSMIS 91GHz imagery (left) and composite (right) showing the convective core of Mawar well west of the Marianas. Heavy showers associated with peripheral convective bands are still in line to pass over the Mariana Islands.

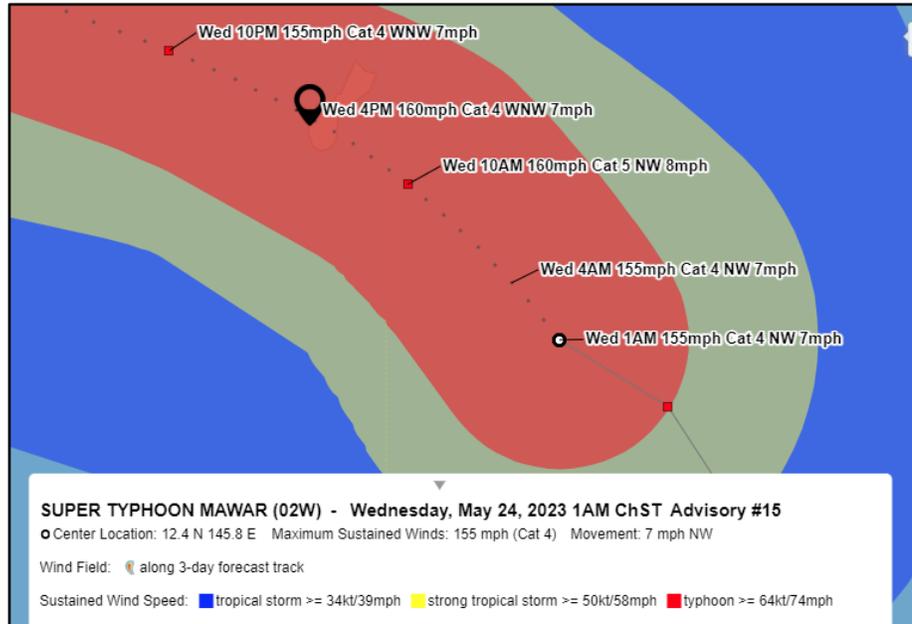
Figure 41: JTWC Bulletin #15 depicting a 160mph super typhoon approaching and passing over southern Guam. Such an approach could have brought potentially devastating coastal inundation to Guam’s low-lying southeastern shores.
