December 22, 2012 EF-0 Watsonville Tornado

At 7:00 AM PST on the morning of December 22, 2012 a weak waterspout/tornado moved inland from Monterey Bay into coastal Santa Cruz County near the town of Watsonville. Damage survey results conclude the damage to be consistent with a tornado of EF-0 intensity, produced by winds estimated at 75 MPH. Damage consisted of tree damage, and moderate to significant damage to several commercial greenhouses on a large farm about a quarter of a mile inland from Monterey Bay. From a combination

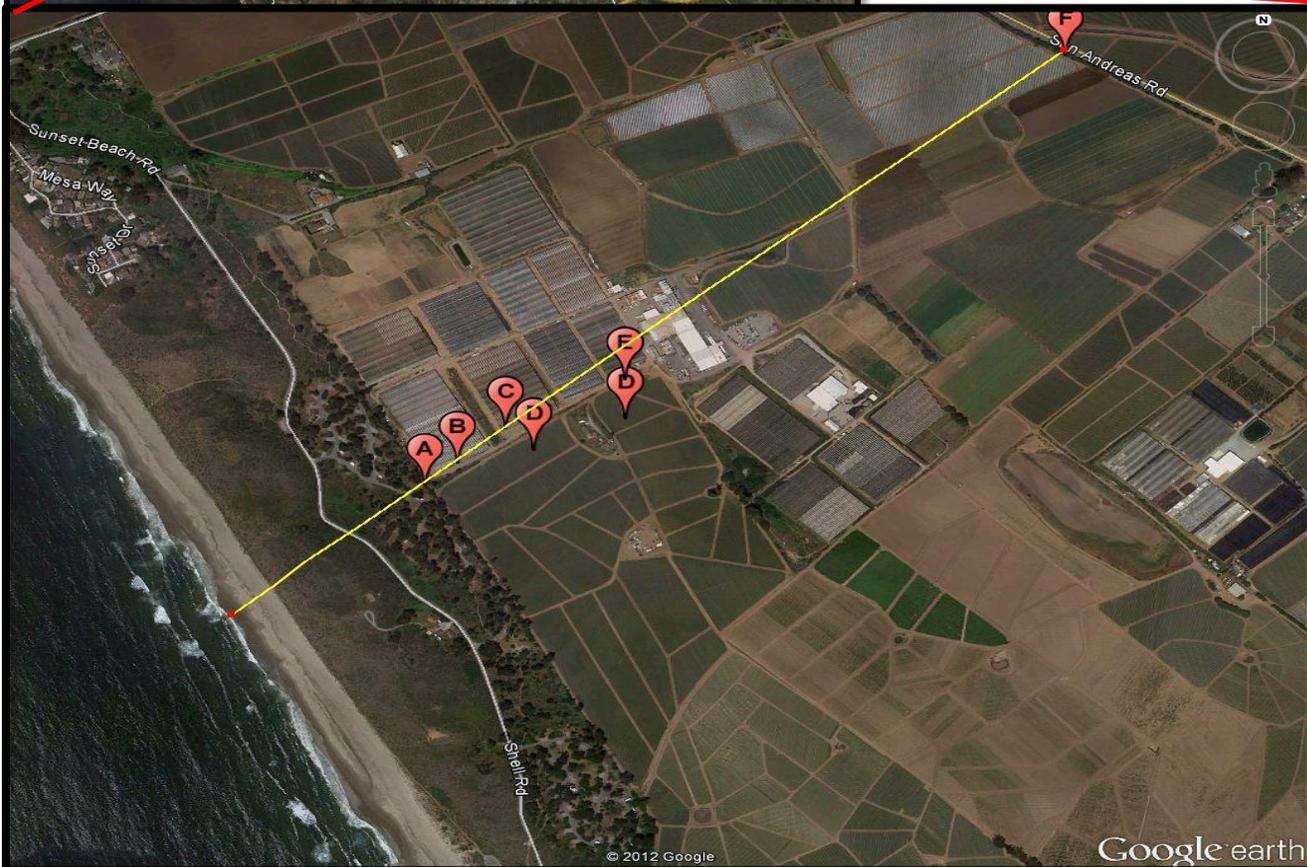
Description of points on path map:

- A) **Tree damage** reported by employees of farm – consisting of some trees uprooted, damaged, branches broken in small wooded area between farm and beach area. It is believed the tornado originated as a waterspout over Monterey Bay and came onshore at the beach and moved through the wooded area on its way inland.
- B) **Significant Greenhouse Damage**: Damage to commercial greenhouse structure. Fiberglass panels and plastic sheeting from structures were cracked and broken and thrown for several dozen yards around the site. Metal pole support structure of the greenhouse was collapsed, with some poles bent. Crops inside of greenhouse suffered damage from falling structure debris.
