# Indian River County/Sebastian F1 Tornado

## June 24, 2001

## Description

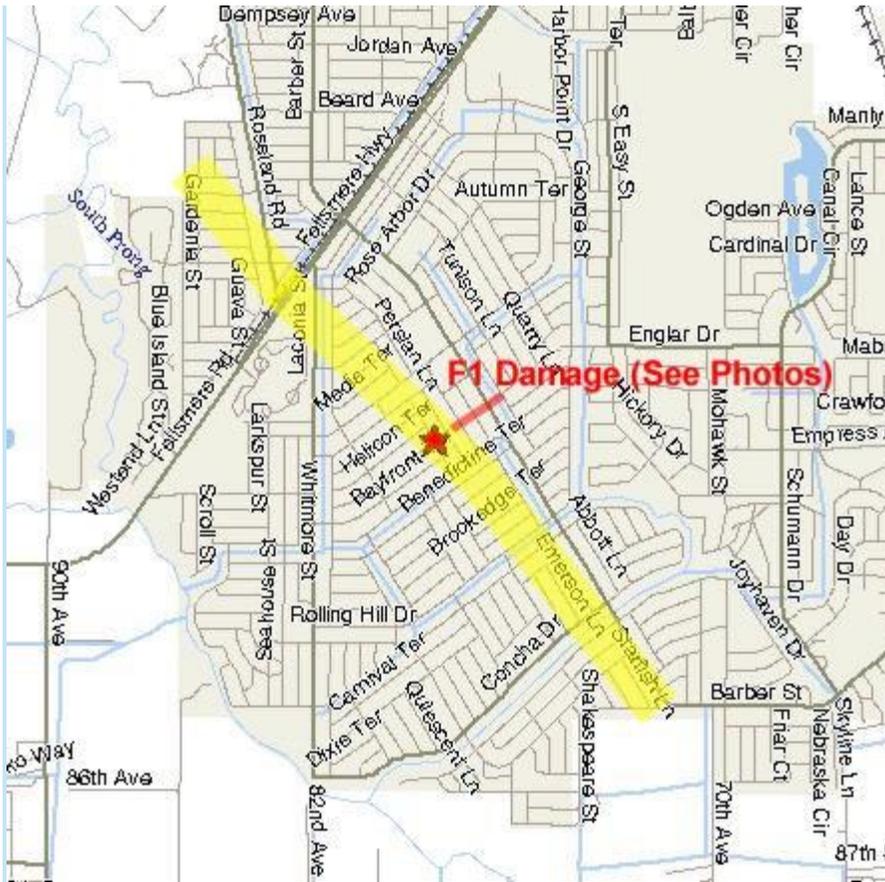
Damage swath center-point locations include...

Fellsmere Highway (CR 512) and Roseland Drive  
Croquet Lane and Capon Terrace  
Coverbrook Lane and Belfast Terrace  
Concha Drive and Barber Street  
Skyline Lane and Starfish Lane

The approximate damage path was derived from a National Weather Service ground survey.

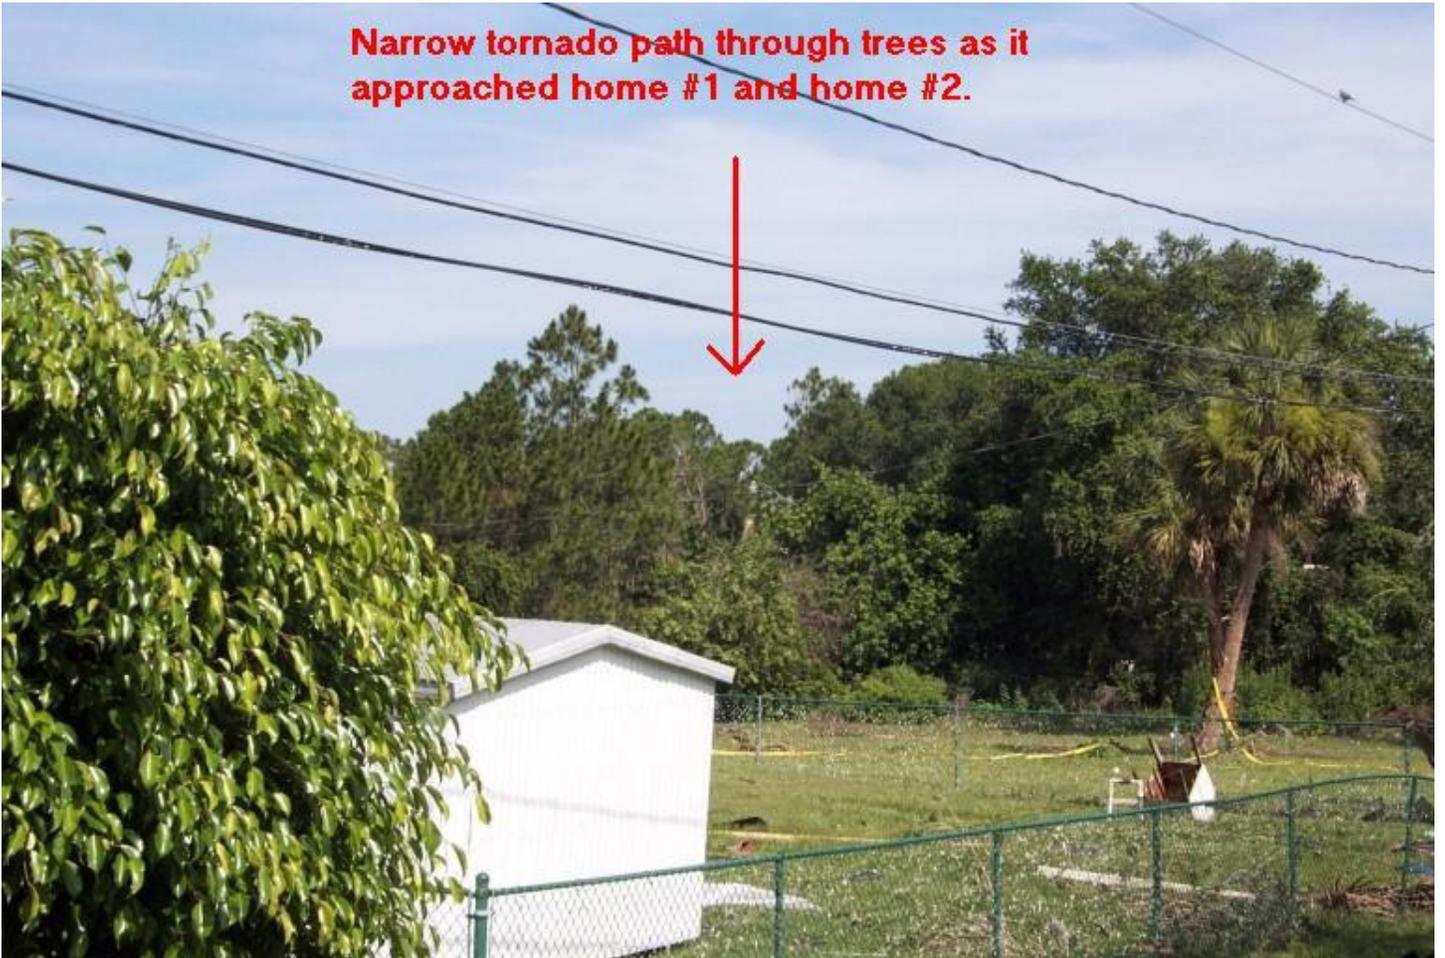
**Narrow tornado path through trees**

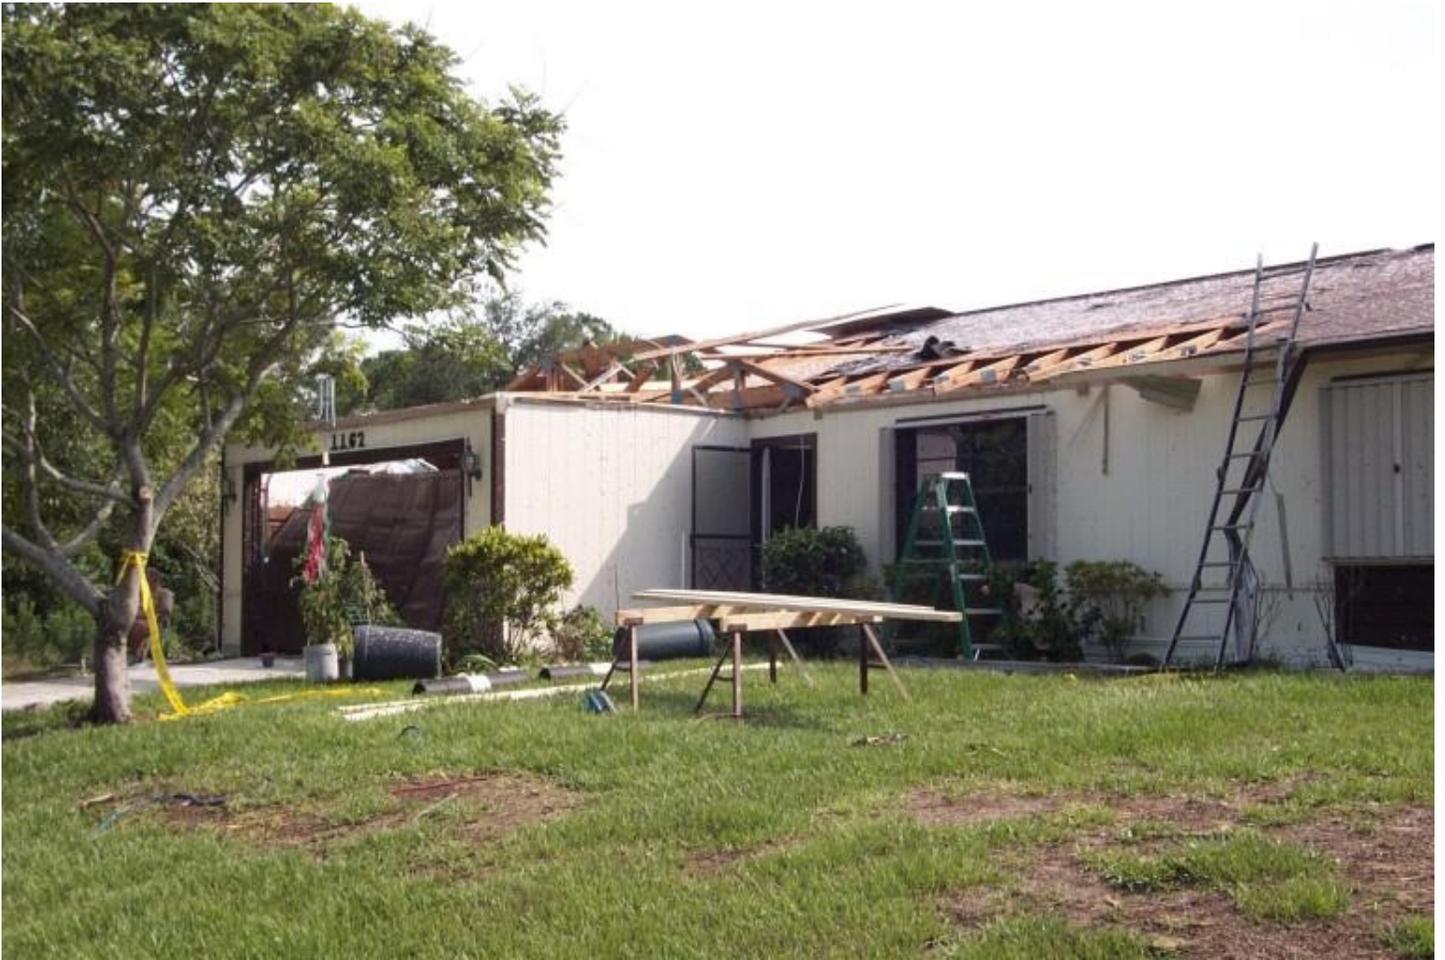
**Significant roof damage (F1) to home.**

Severe thunderstorms spawned a weak (F0-F1) tornado which was responsible for property damage in Indian River County. The event occurred during the afternoon on Sunday (06/24/01) between 240 pm and 300 pm. The thunderstorms which spawned the tornado had been relatively benign as they moved east across the peninsula. However, as the storms approached the Brevard and Indian River County coasts they erupted into strong to severe thunderstorms. A tornado warning was issued when weather radar indicated strong rotation developing within a storm over Sebastian. Soon afterwards, reports from Sebastian Police Department indicated damage consistent with that of a severe thunderstorm and associated weak tornado. A damage survey team was dispatched Monday morning to investigate. The survey revealed a narrow, two mile long tornado damage path (generally up to about 50 yards wide). The path was oriented northwest to southeast and extended across the western portion of Sebastian in the Sebastian Highlands area. Damage due to the tornado was mostly minor (F0), consisting of downed trees, power lines, traffic lights, screen houses, and minor roof damage. However, the tornado earned it's F1 classification by briefly gaining strength and removing a large portion of a residential roof on Croquet Lane.

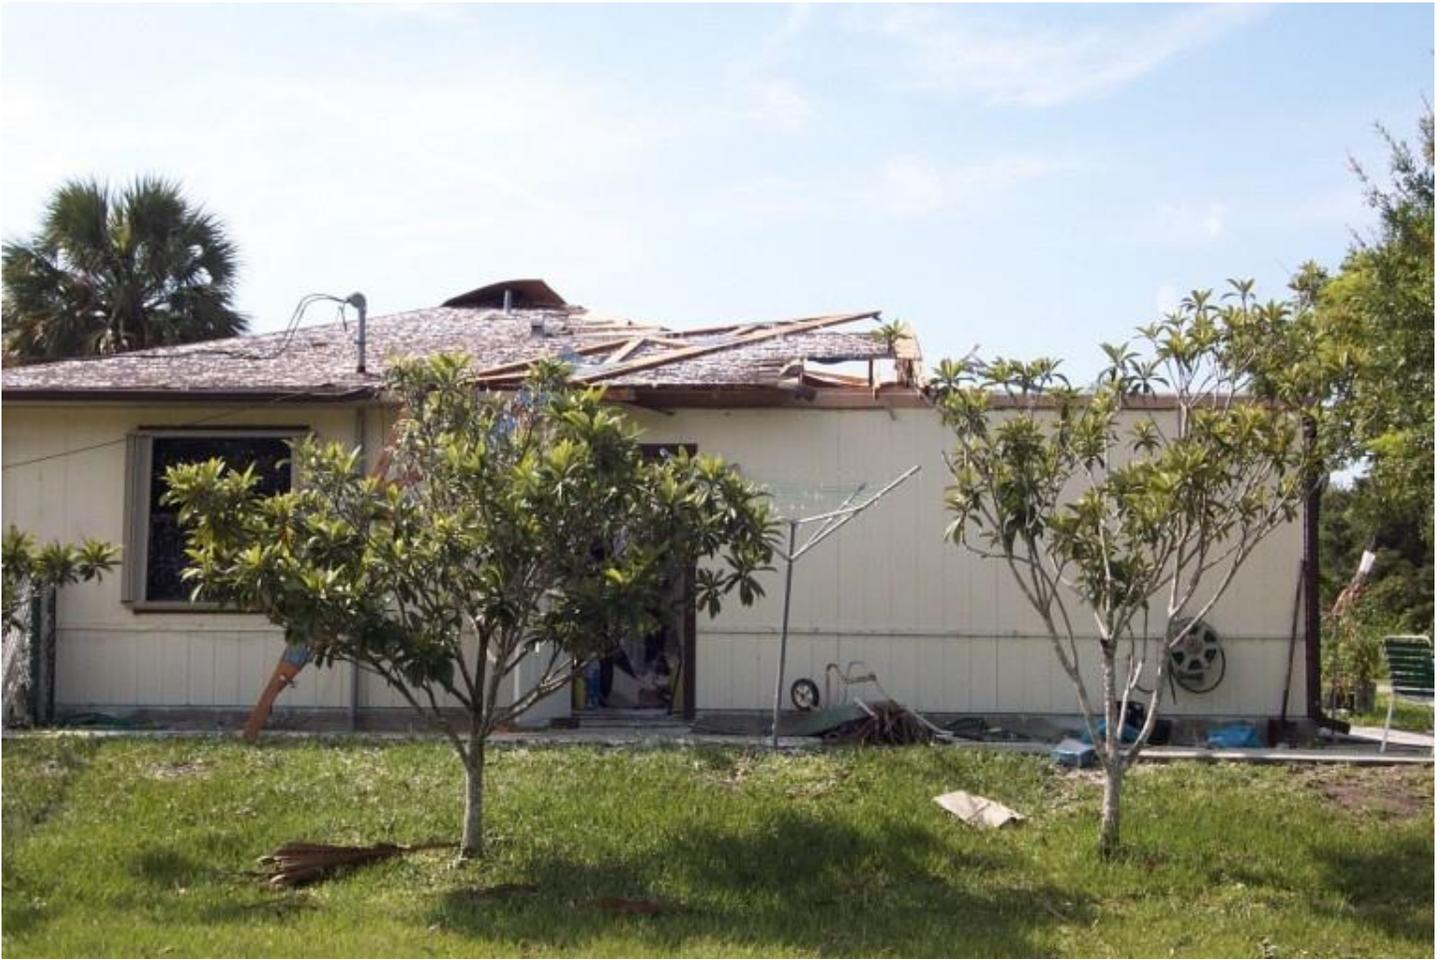
**Different perspective of roof damage to same home.**

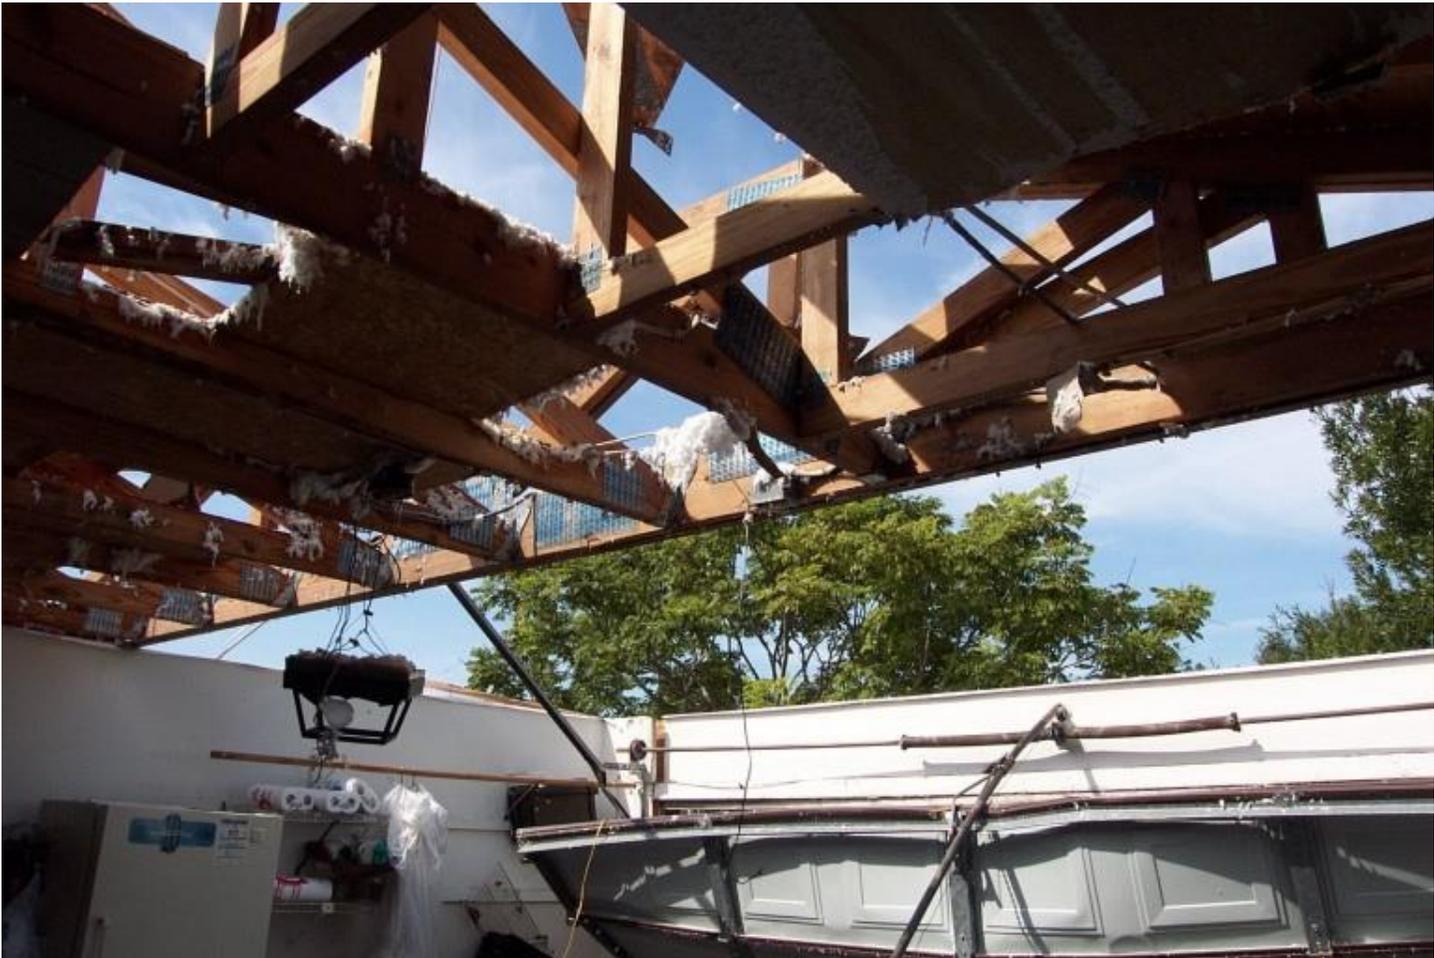
**Removed section of roof (inside view).**

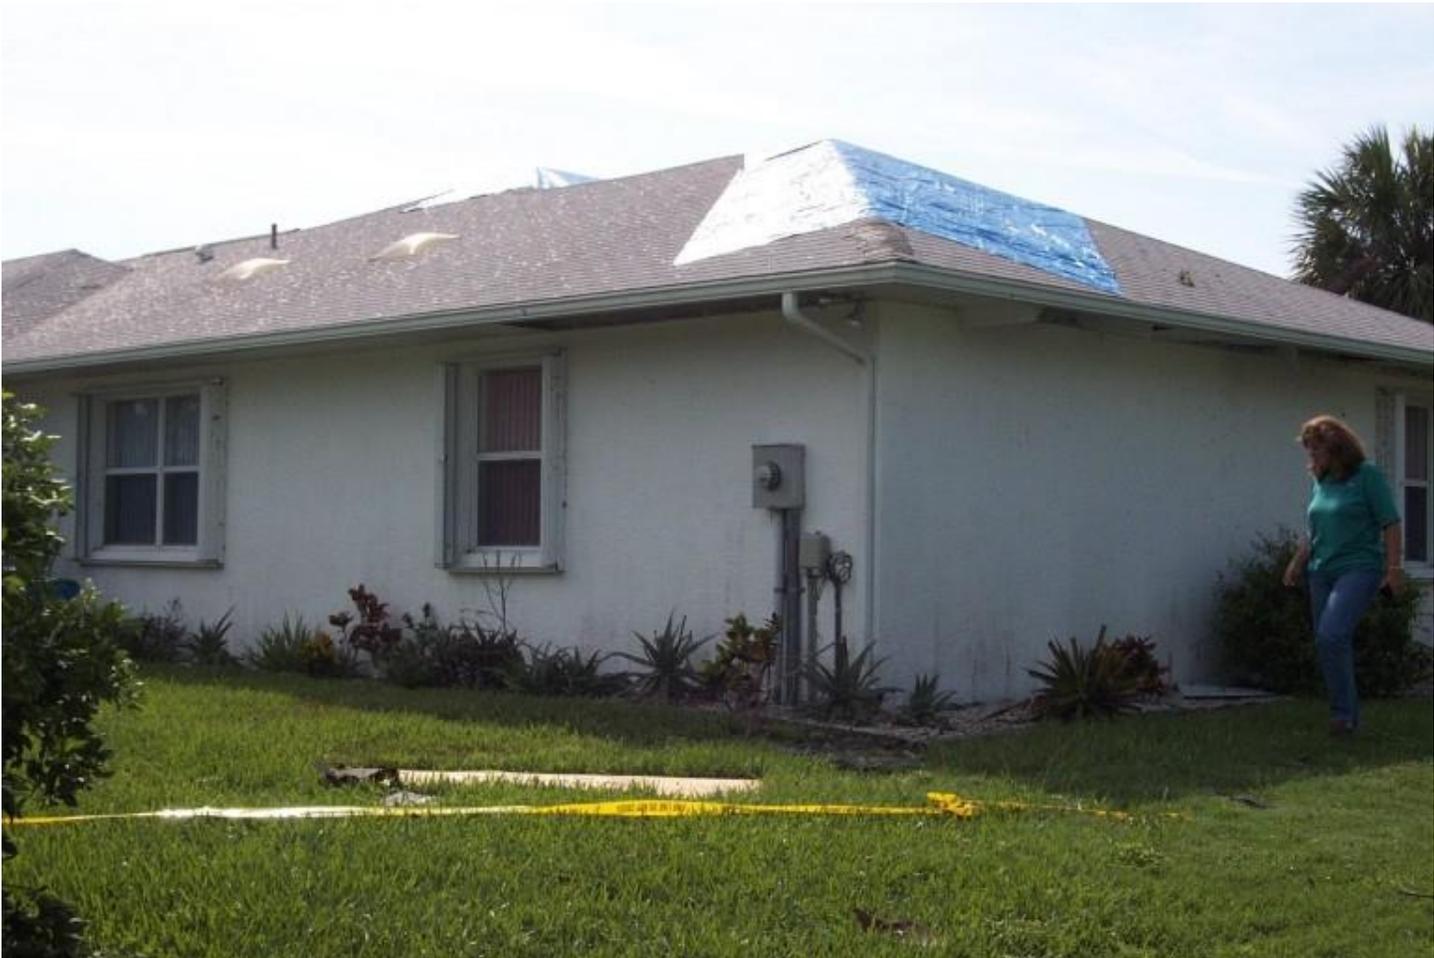
**Roof damage to back of nearby home.**

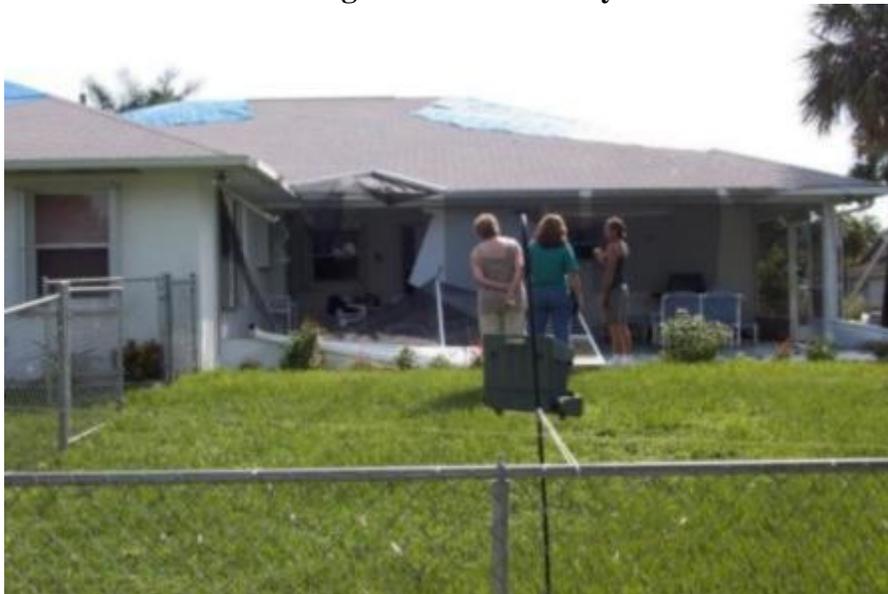
**Demolished screen house of nearby home.**

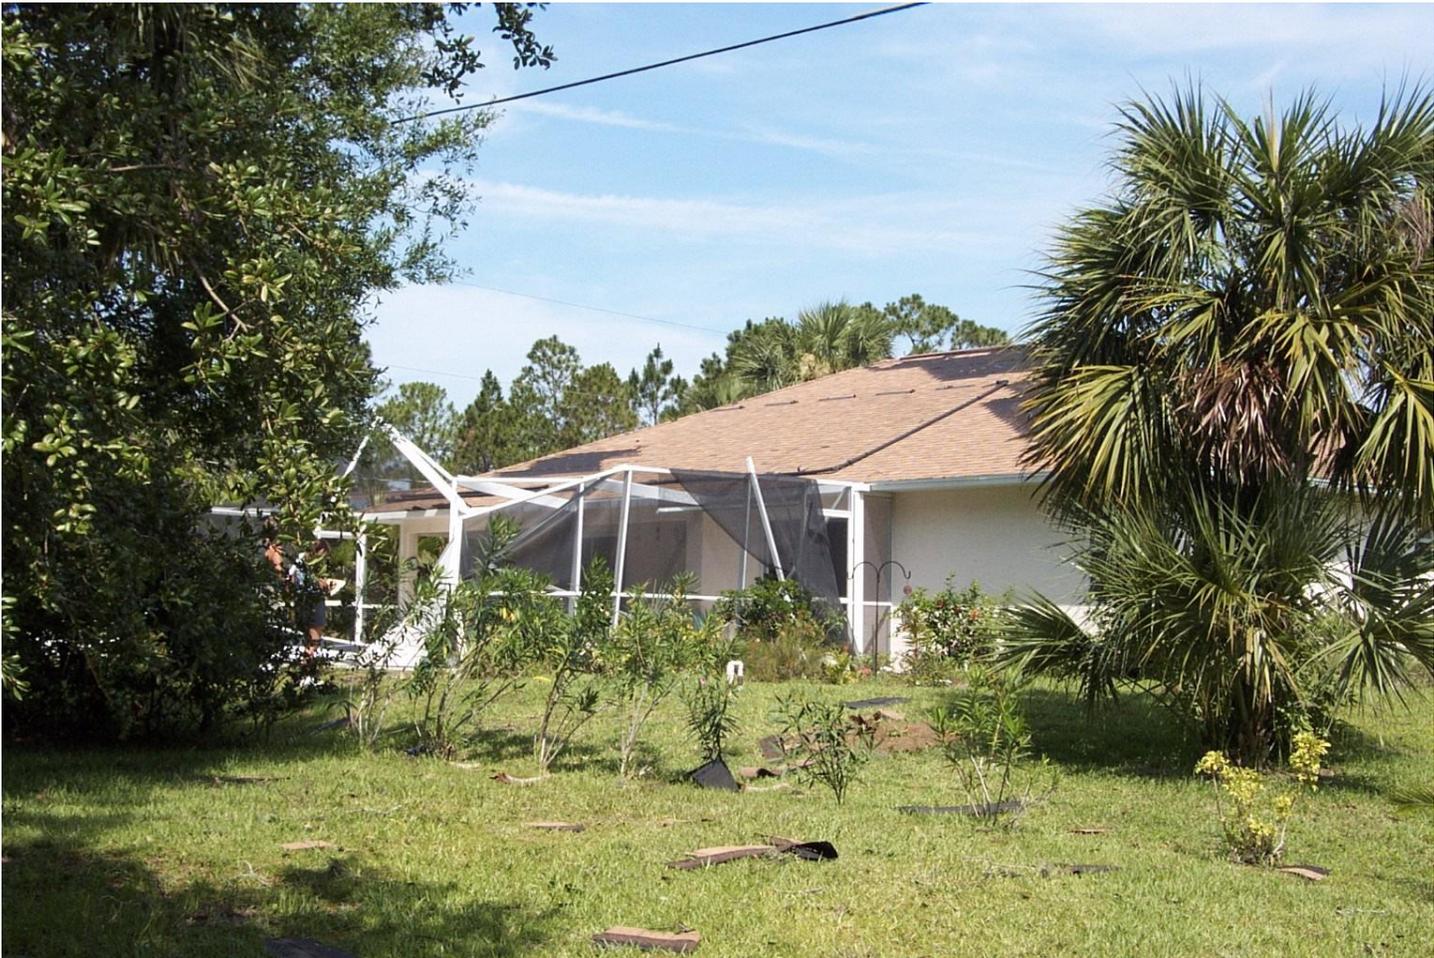
**Pool enclosure destroyed and roof damaged.**
