Diehlstadt, MO EF-2 Tornado

June 4, 2012

Tornado Damage Survey - Diehlstadt, MO

...DAMAGE SURVEY RESULTS FOR DIEHLSTADT MISSOURI...

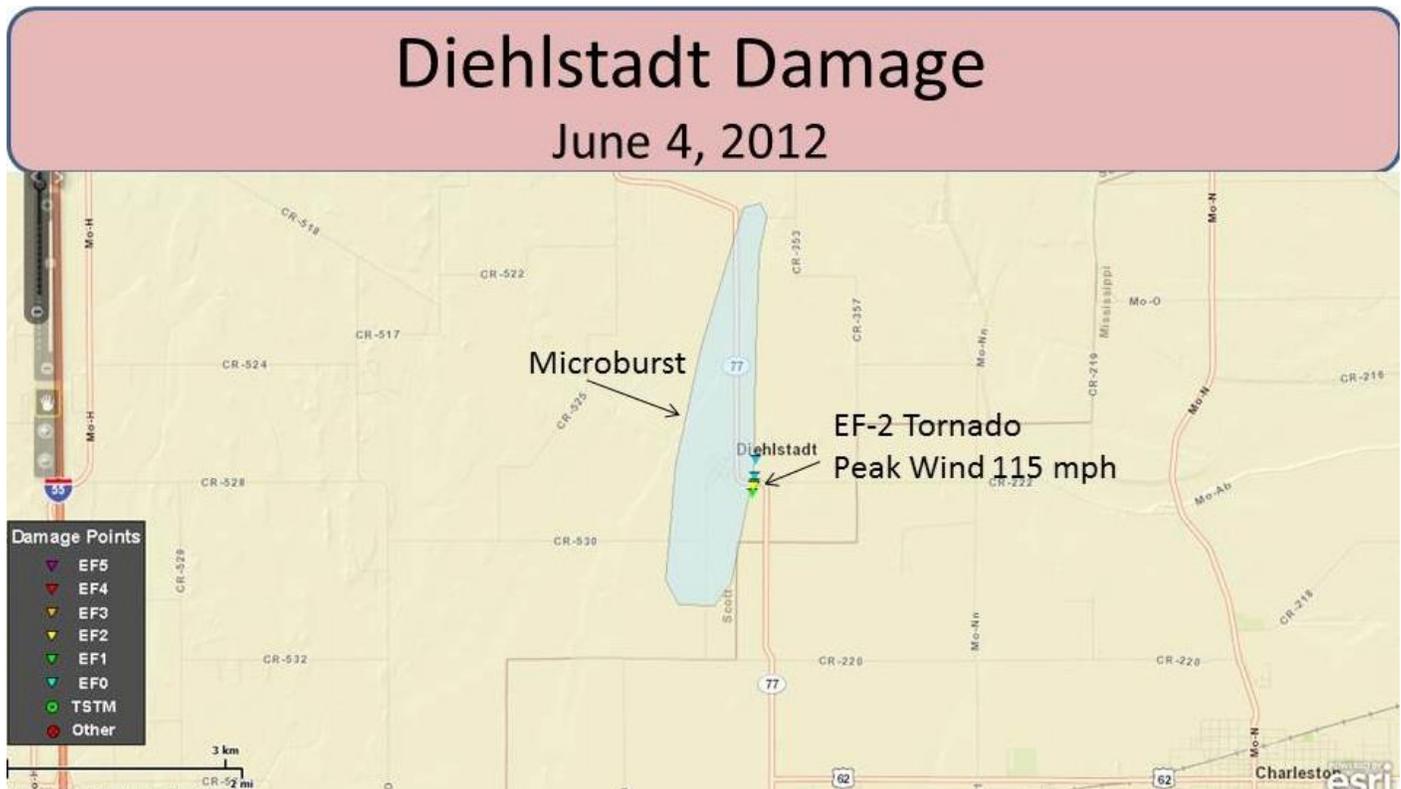
A map of the surveyed tornado and downburst is provided for reference:

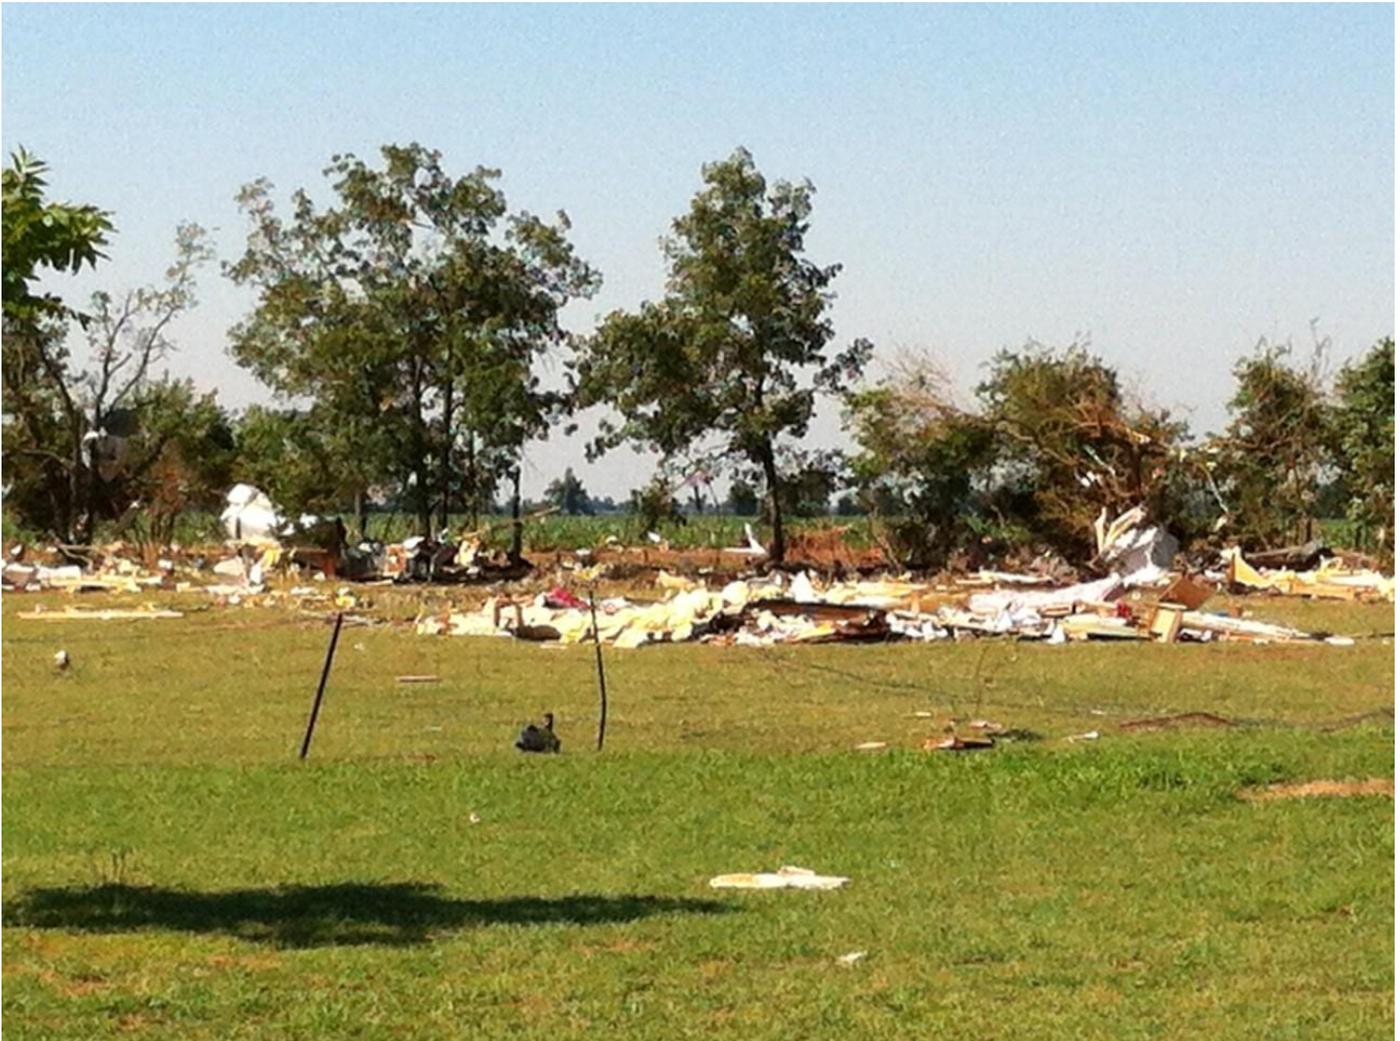
- * EVENT TYPE.....EF2 TORNADO
- * EVENT DATE.....MONDAY JUNE 4 2012
- * EVENT TIME.....844 PM CDT
- * EVENT LOCATION.....1/4 MILE NORTH OF DIEHLSTADT TO 1/4 MILE SOUTH OF DIEHLSTADT
- * PEAK WIND.....115 MPH
- * AVG. PATH WIDTH.....75 YARDS
- * PATH LENGTH.....0.5 MILES
- * INJURIES.....NONE
- * FATALITIES.....3
- * DAMAGE DETAIL.....A SINGLE WIDE MOBILE HOME WAS COMPLETELY DESTROYED AND SCATTERED WITH THE UNDERCARRIAGE BLOW APPROXIMATELY 100 YARDS FROM THE HOME SITE. SEVERAL LARGE

WAREHOUSE BUILDINGS WITH PARTIAL ROOF LOSS AND STRUCTURAL DAMAGE. SEVERAL TREE SNAPPED OR UPROOTED. FENCING AND SIGN BLOWN DOWN.

Image of mobile home demolished by EF-2 tornado in Diehlstadt, MO

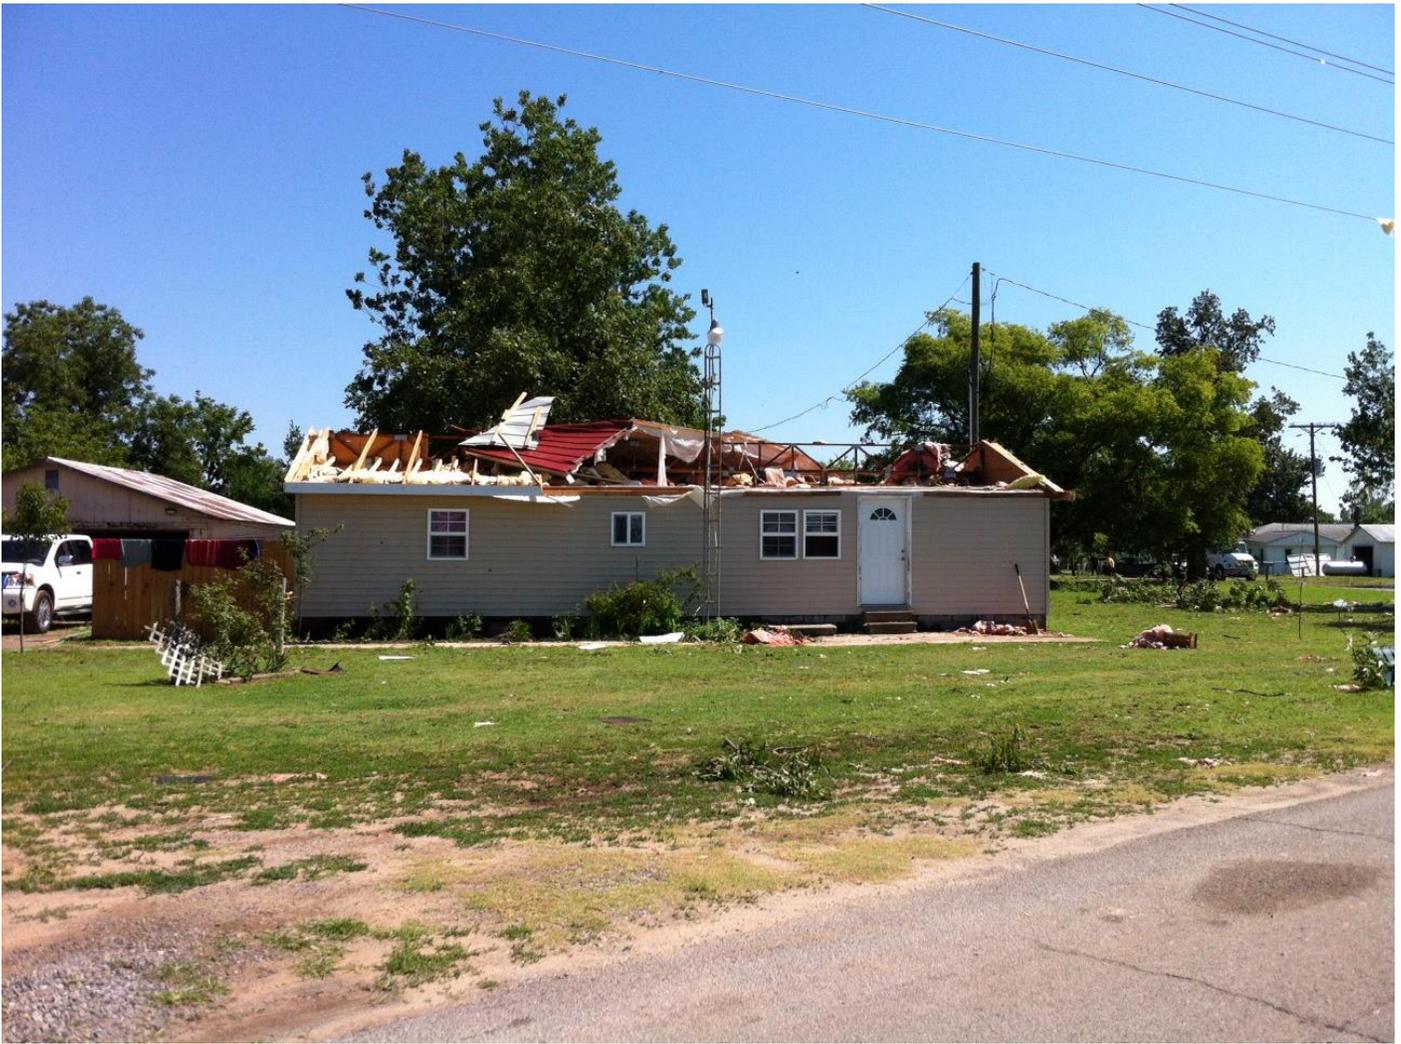
* EVENT TYPE.....DOWNBURST
* EVENT DATE.....MONDAY JUNE 4 2012
* EVENT TIME.....840 PM CDT
* EVENT LOCATION.....2.5 MILES NORTH OF DIEHLSTADT TO 1 MILE SOUTH OF DIEHLSTADT
* PEAK WIND.....100 MPH
* AVG. PATH WIDTH....1/2 MILE
* PATH LENGTH.....3.5 MILES
* INJURIES.....NONE
* FATALITIES.....NONE
* DAMAGE DETAIL.....52 HOMES DAMAGED WITH MOSTLY MINOR TO MODERATE ROOF DAMAGE. SEVERAL
BUSINESSES AND A CHURCH DAMAGED (STEEPLE BLOWN OFF). NUMEROUS OUTBUILDINGS AND OTHER
BUILDINGS DAMAGED. SEVERAL POWER POLES SNAPPED...MANY DOZENS OF TREES UPROOTED OR
SNAPPED. IRRIGATION SYSTEM WAS TOPPLED.

Image of mobile home damaged by downburst in Diehlstadt, MO
